**Virginia State University**  
**MS-4 Permit: VAR040119**  
**July 1, 2021 - June 30, 2022 Annual Report**

Prepared for  
**Virginia State University**  
Capital Outlay & Facilities Management  
PO Box 9414  
Virginia State University, VA 23806

October 1, 2022

Prepared by: Timmons Group  
1001 Boulders Parkway, Suite 300  
Richmond, VA 23225  
(804) 200-6500

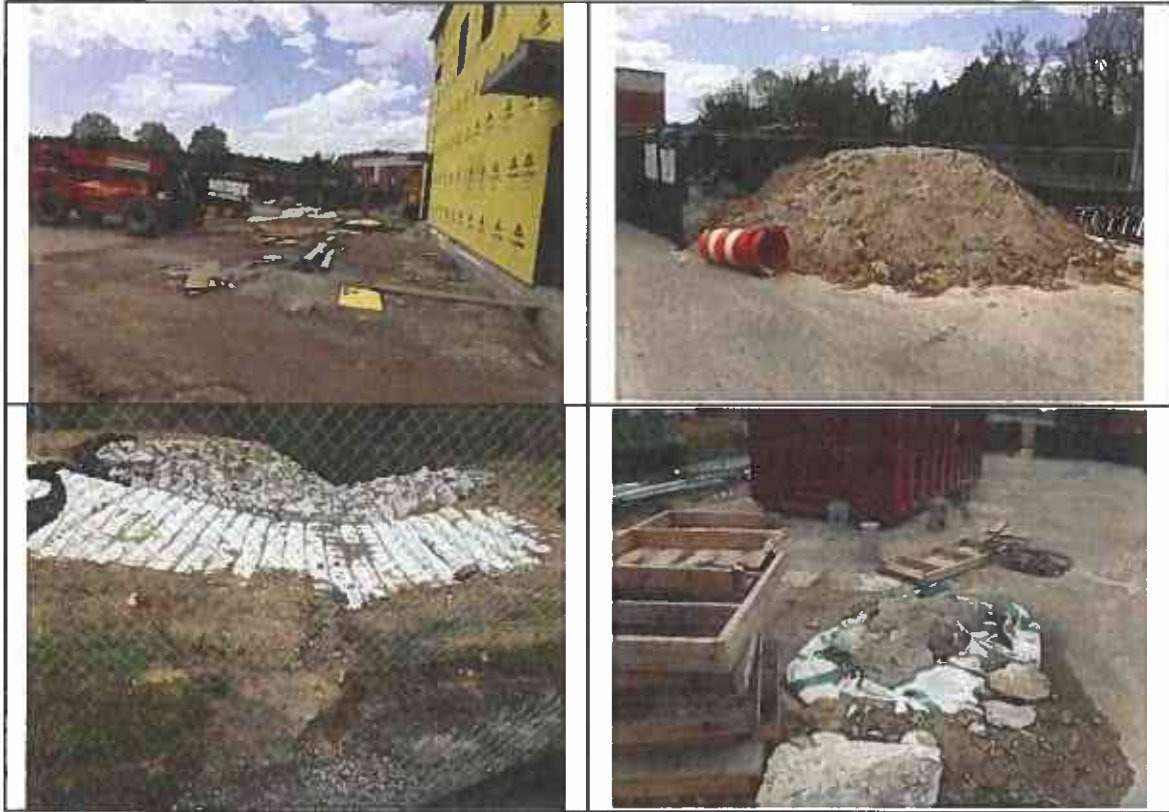
- ↑ #3 • VSU PM has discussed w/ Branch Collin + Dave.
- This is outside of fencing where VSU (JAT) coordinated work w/ Columbia Gas to fix an exposed Gas line; NOT Part of MT Carter Addition.
  - VSU PM (Debbri) will get with JAT TO have this area addressed
