**Virginia State University**  
**MS-4 Permit: VAR040119**  
**July 1, 2021 - June 30, 2022 Annual Report**

Prepared for  
**Virginia State University**  
Capital Outlay & Facilities Management  
PO Box 9414  
Virginia State University, VA 23806

October 1, 2022

Prepared by: Timmons Group  
1001 Boulders Parkway, Suite 300  
Richmond, VA 23225  
(804) 200-6500

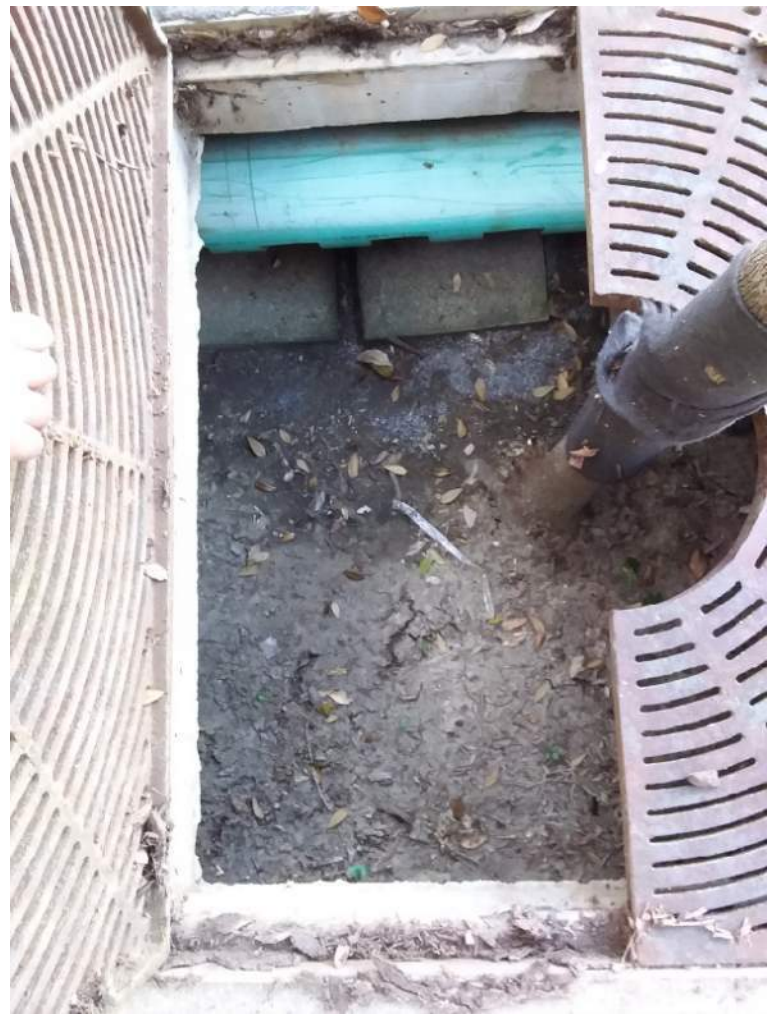
BMP #3- inside filterra

Notes: BMP #3 appeared to be functioning in degraded condition during the time of inspection. We found an excessive amount of sediment, trash and debris inside this filterra unit. Remove all accumulated sediment, trash and debris from filterra and install a new 3" mulch layer.

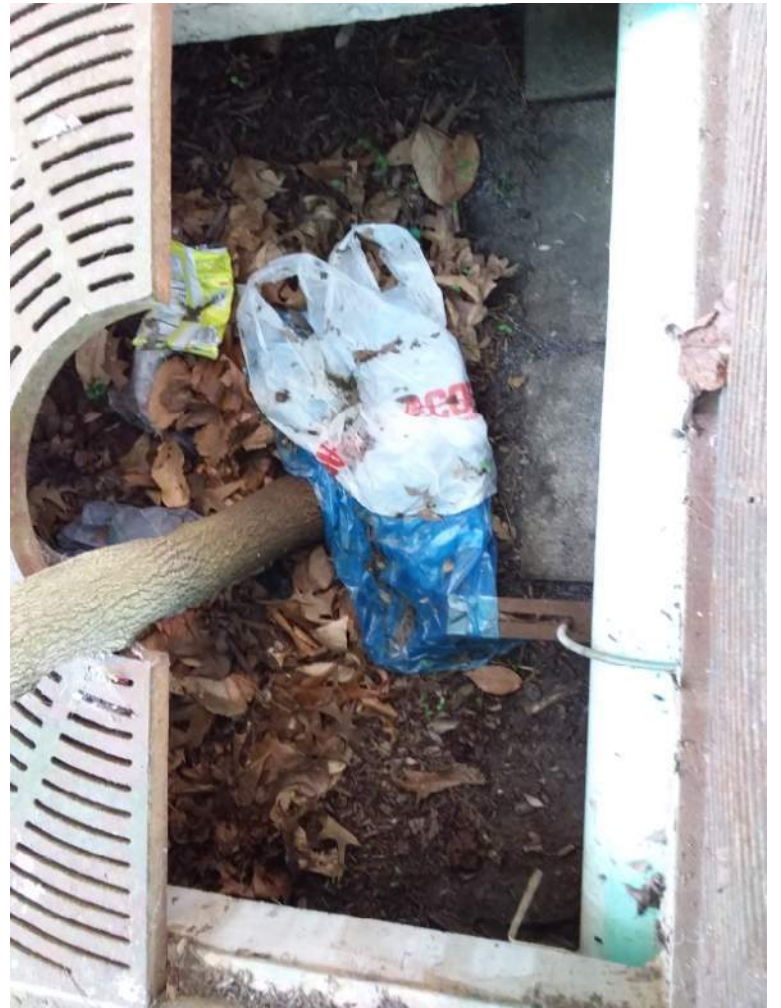
BMP #4- inside filterra

Notes: BMP #4 appeared to be functioning in degraded condition during the time of inspection. We found an excessive amount of sediment, trash and debris inside this filterra unit. Remove all accumulated sediment, trash and debris from filterra and install a new 3" mulch layer.

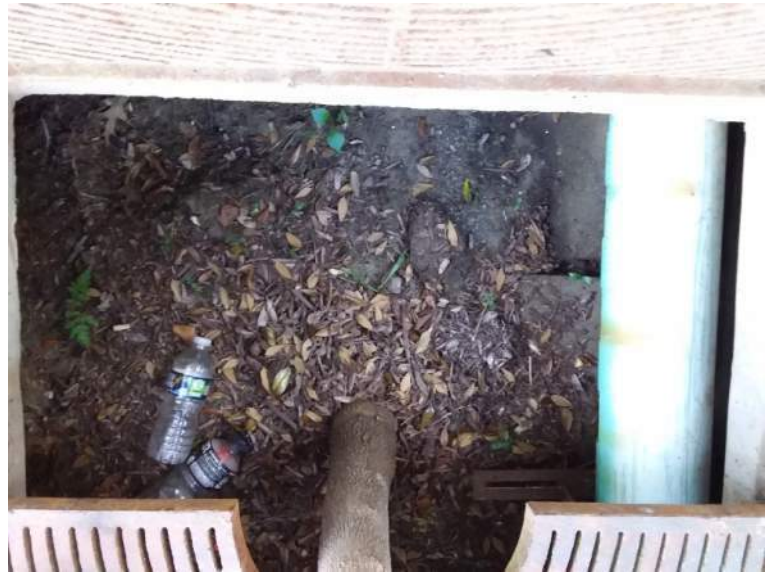
BMP #5- inside filterra

Notes: BMP #5 appeared to be functioning in degraded condition during the time of inspection. We found an excessive amount of sediment, trash and debris inside this filterra unit. Remove all accumulated sediment, trash and debris from filterra and install a new 3" mulch layer.

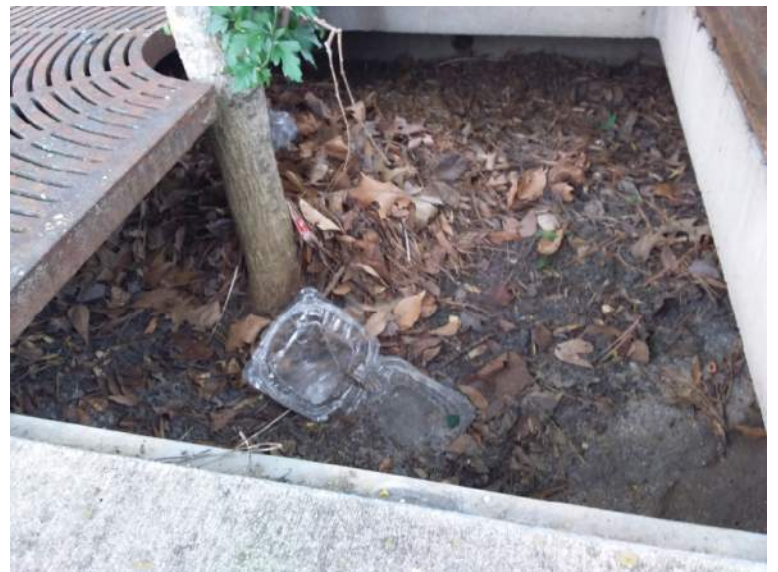
BMP #41- throat inlet

**Notes:** BMP #41 appeared to be functioning in degraded condition during the time of inspection. We found an excessive amount of sediment, trash and debris inside this filterra unit. Remove all accumulated sediment, trash and debris from filterra and install a new 3" mulch layer. Remove all inlet energy dissipater stones from throat/inlet and clean and replace.

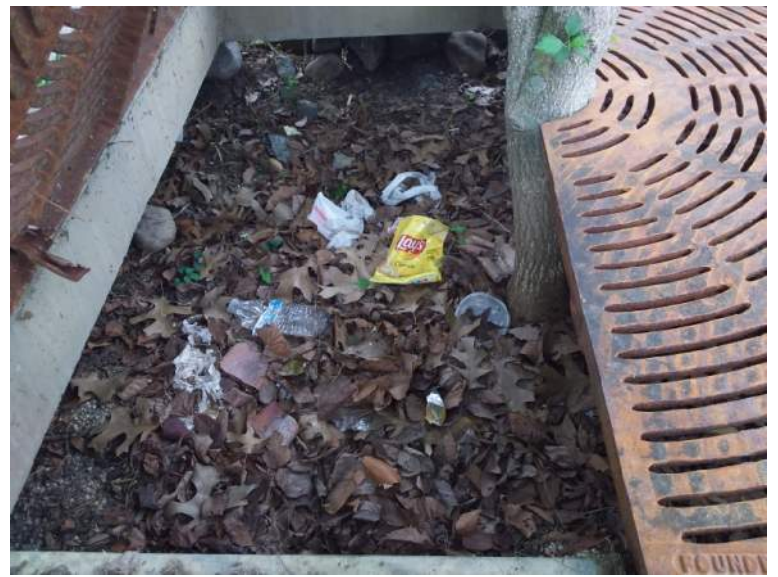
BMP #42- throat inlet

Notes: BMP #42 appeared to be functioning in degraded condition during the time of inspection. We found an excessive amount of sediment, trash and debris inside this filterra unit. Remove all accumulated sediment, trash and debris from filterra and install a new 3" mulch layer. Remove all inlet energy dissipater stones from throat/inlet and clean and replace.

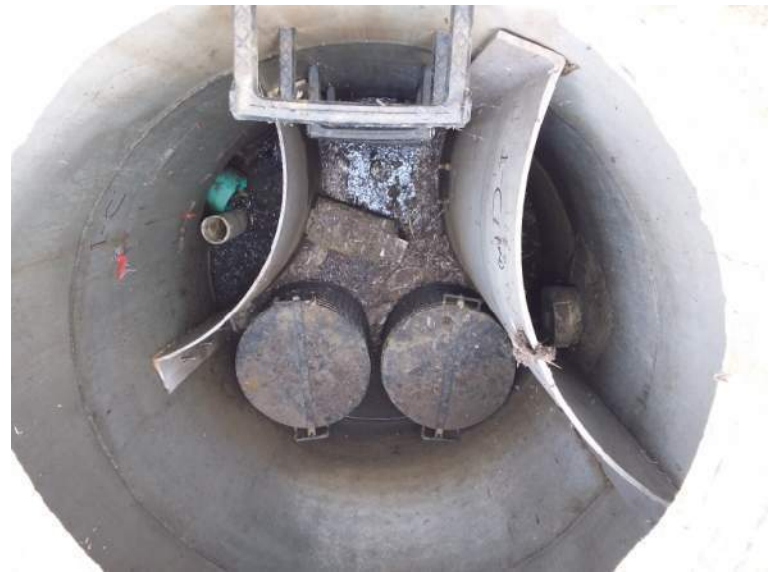
BMP #33- inside view

<b>Inspector Name:</b>				<b>Type of BMP:</b>		
<b>BMP ID #: 33</b>				<b>Date/Time:</b>		
				<b>Maintenance required?</b>		
<b>Component:</b>	<b>Yes</b>	<b>No</b>	<b>Conditions When Maintenance is Needed</b>	<b>Yes</b>	<b>No</b>	<b>Comments:</b>
The access manhole or access doors are functioning properly and are structurally sound						
Sediment and oil are present (provide depths)						
Floatable pollutant accumulation is present in the Pre-treatment Bay						
The Cartridge Bay is visually inspected for sediment depth (provide depth)*(If sediment depth is greater than 6 inches, maintenance is required						
Proper draindown is occurring in the Cartridge Bay *(If at least 40 hours of dry weather have elapsed, since the most recent runoff event and the Bay contains more than 3 inches of water above the sediment layer, the Sorbtive BRICKs required cleaning or replacement						
The internal components show no signs of damage

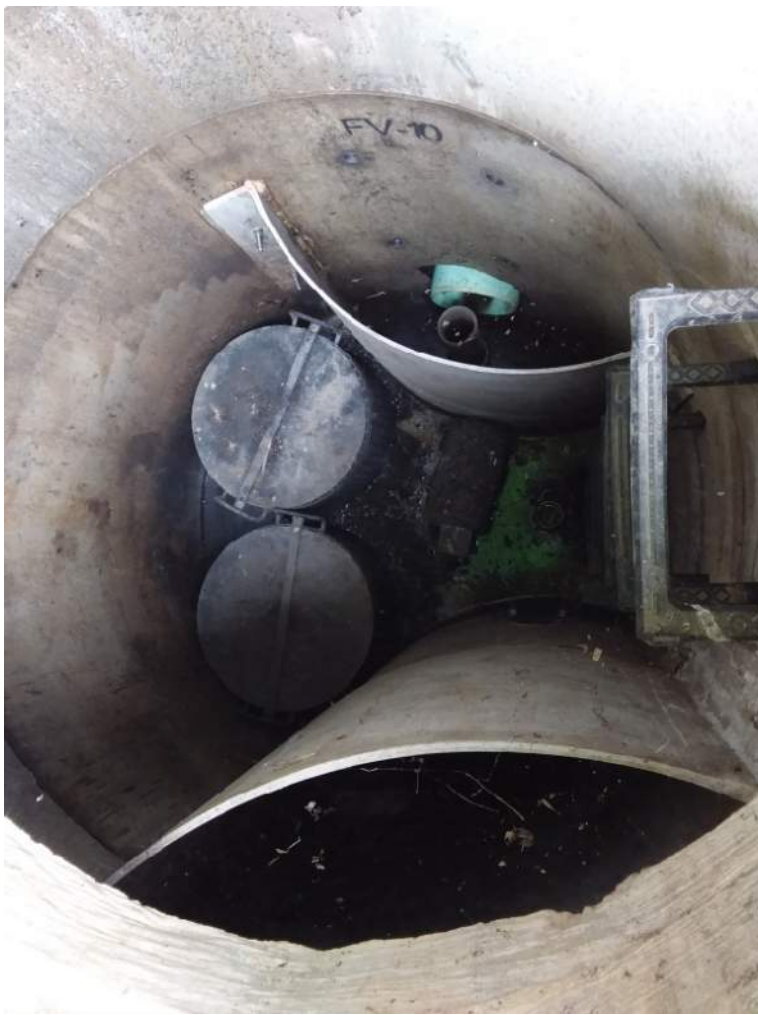
BMP #34- inside view

<b>Inspector Name:</b>				<b>Type of BMP:</b>		
<b>BMP ID #: 34</b>				<b>Date/Time:</b>		
				<b>Maintenance required?</b>		
<b>Component:</b>	<b>Yes</b>	<b>No</b>	<b>Conditions When Maintenance is Needed</b>	<b>Yes</b>	<b>No</b>	<b>Comments:</b>
The access manhole or access doors are functioning properly and are structurally sound						
Sediment and oil are present (provide depths)						
Floatable pollutant accumulation is present in the Pre-treatment Bay						
The Cartridge Bay is visually inspected for sediment depth (provide depth)*(If sediment depth is greater than 6 inches, maintenance is required						
Proper draindown is occurring in the Cartridge Bay *(If at least 40 hours of dry weather have elapsed, since the most recent runoff event and the Bay contains more than 3 inches of water above the sediment layer, the Sorbtive BRICKs required cleaning or replacement						
The internal components show no signs of damage

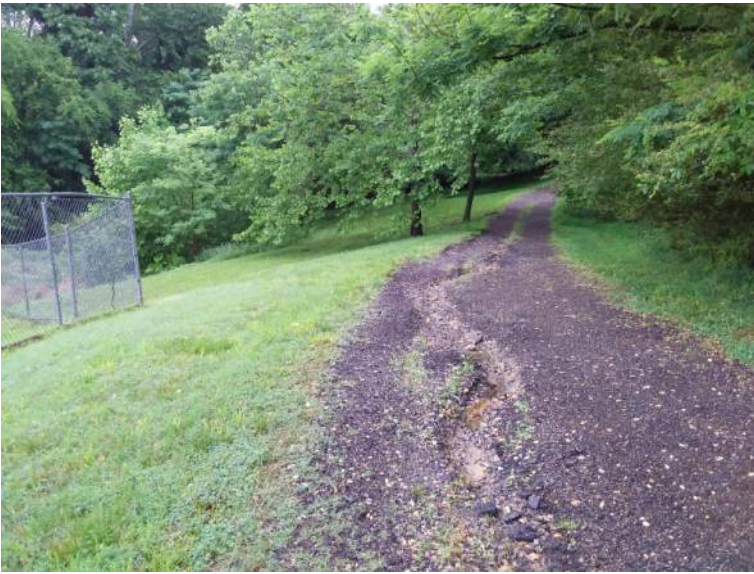
BMP #30- access road eroding and washing out

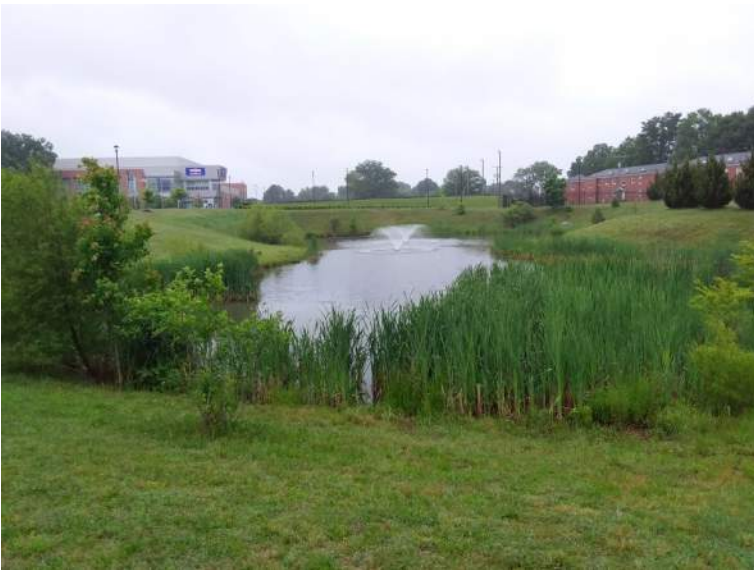
BMP #46- facing northwest

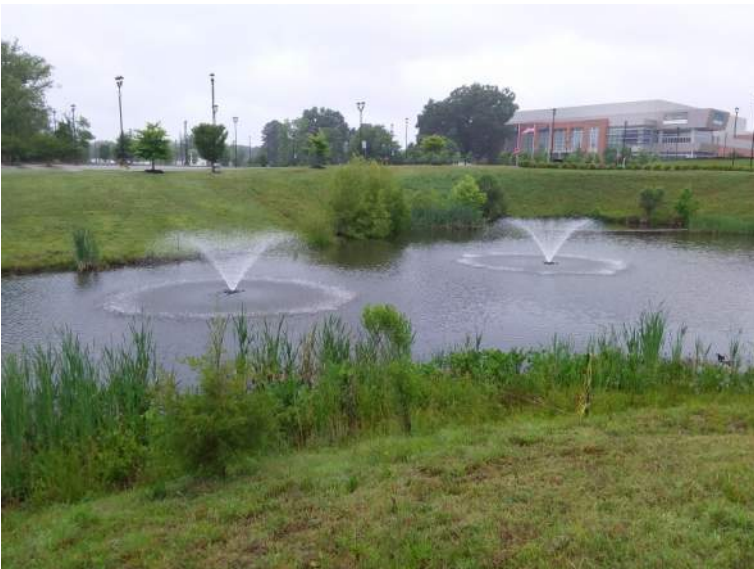
BMP #46- both fountains are operating properly

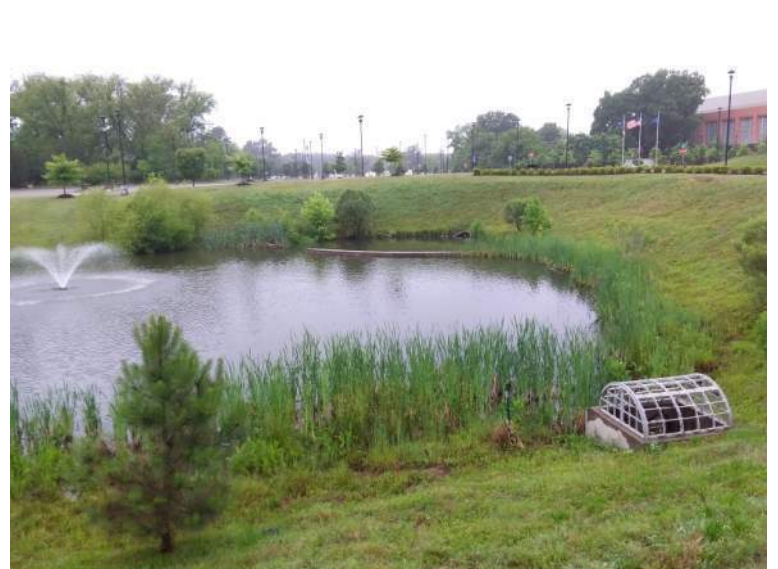
BMP #46- viewpoint looking towards outlet structure

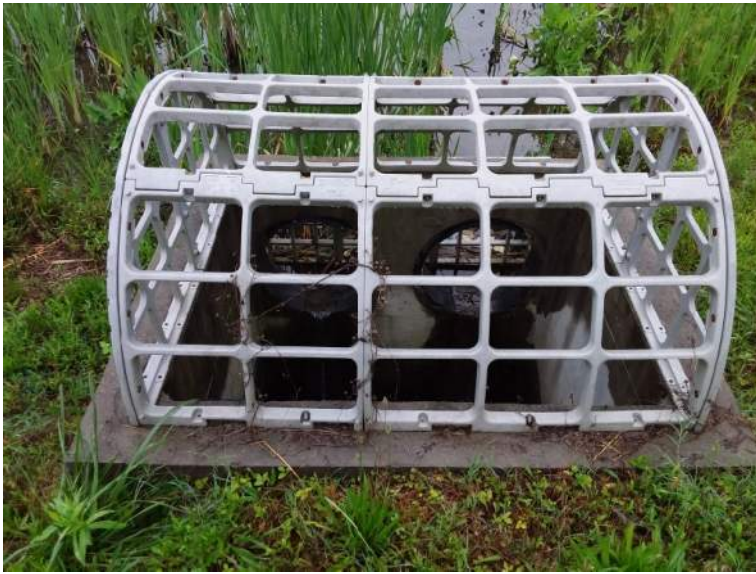
BMP #46- close up of outlet structure

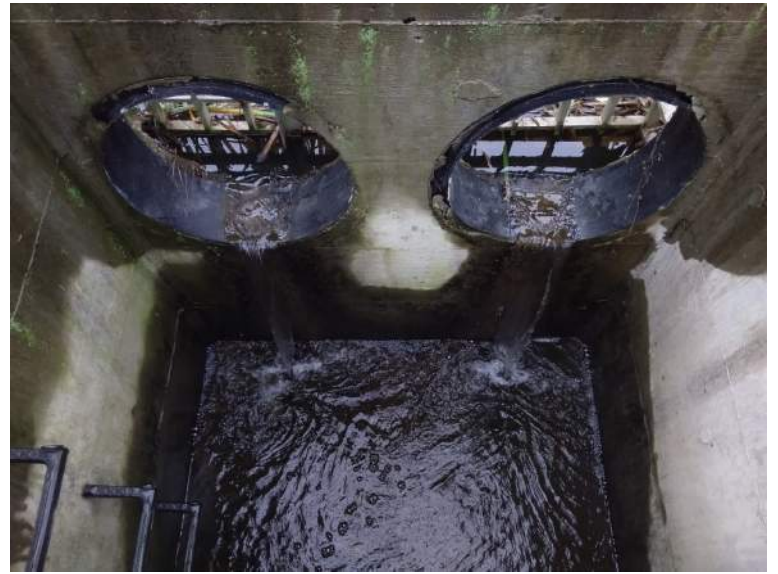
BMP #46- inside view of outlet structure

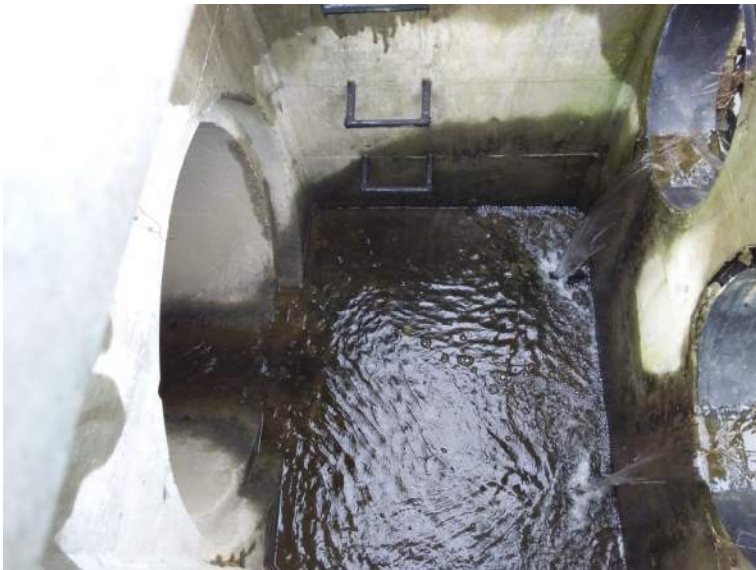
BMP #46- inside view of outlet structure

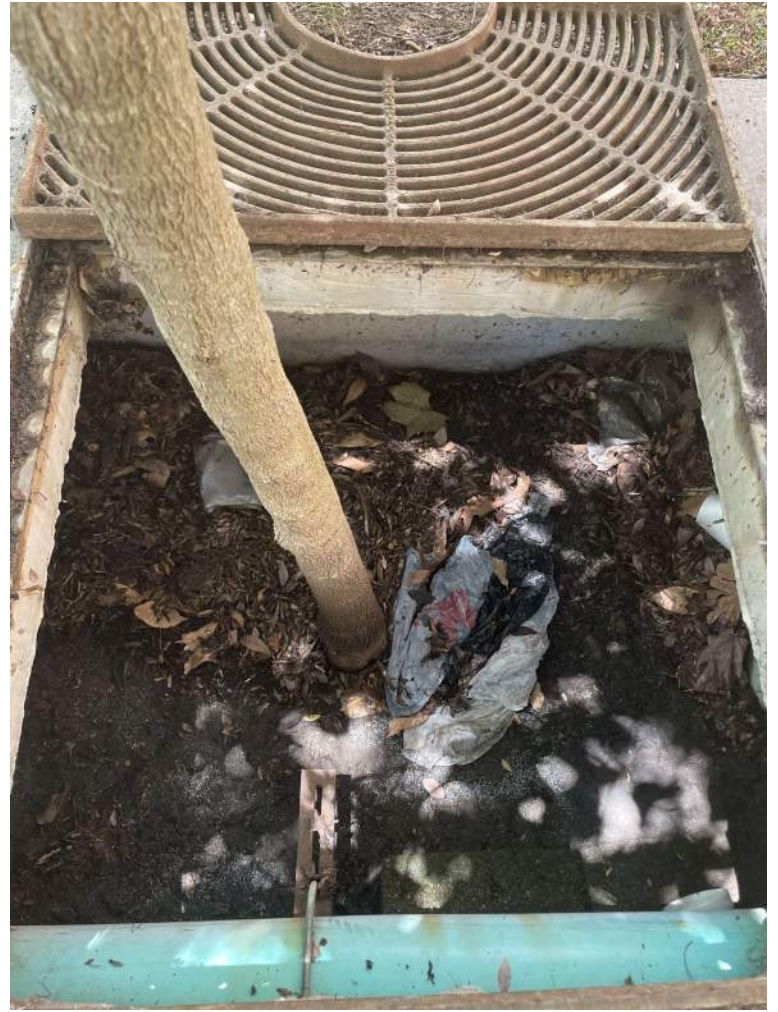
BMP#1- before maintenance

COMPLETION NOTES	<p>Completed maintenance of Roof Filterras (12 total) and Inlet Filterras (10 total). Removed trash and debris from facilities. Installed new mulch.</p>
------------------	------------------------------------------------------------------------------------------------------------------------------------------------------------------

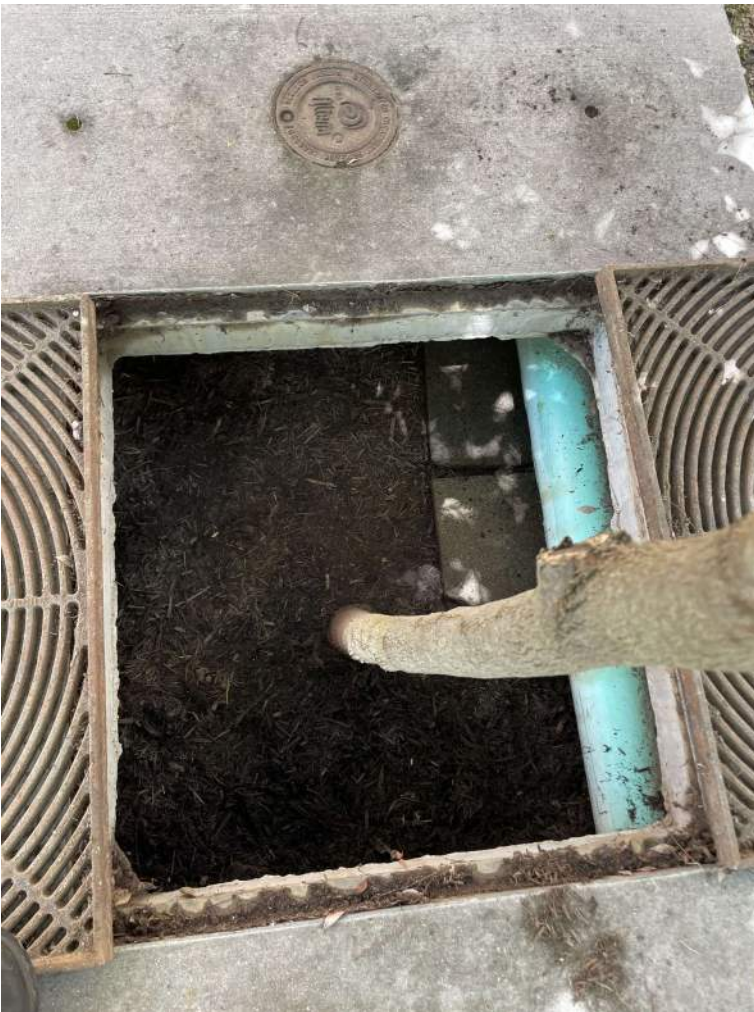
BMP #1- after maintenance

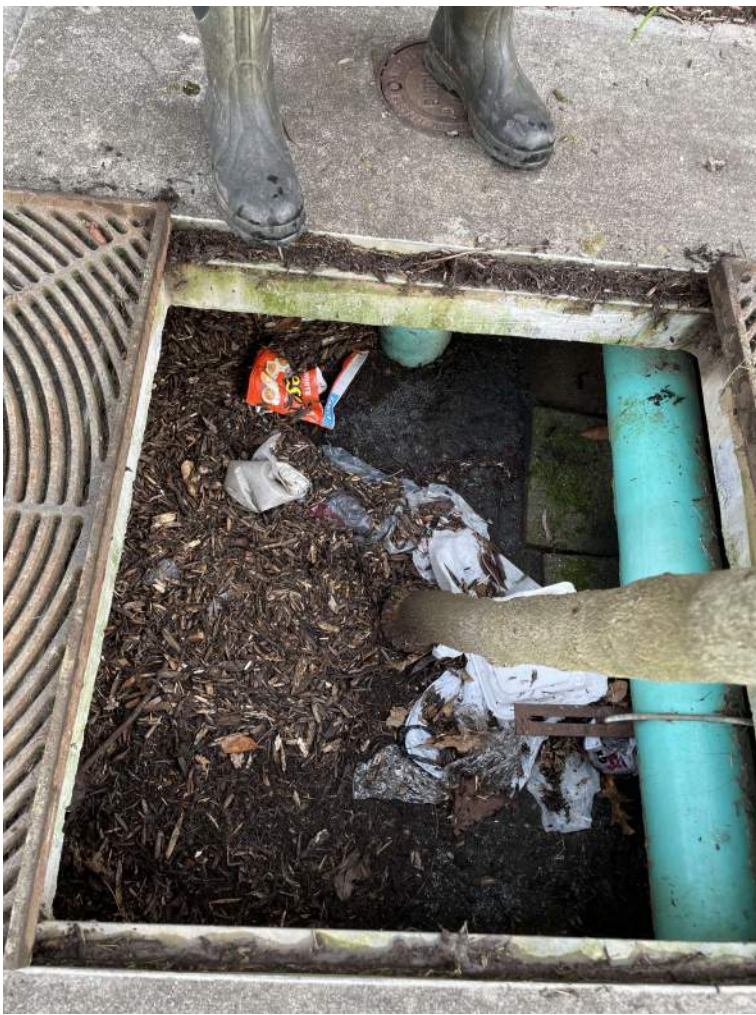
BMP #2- before maintenance

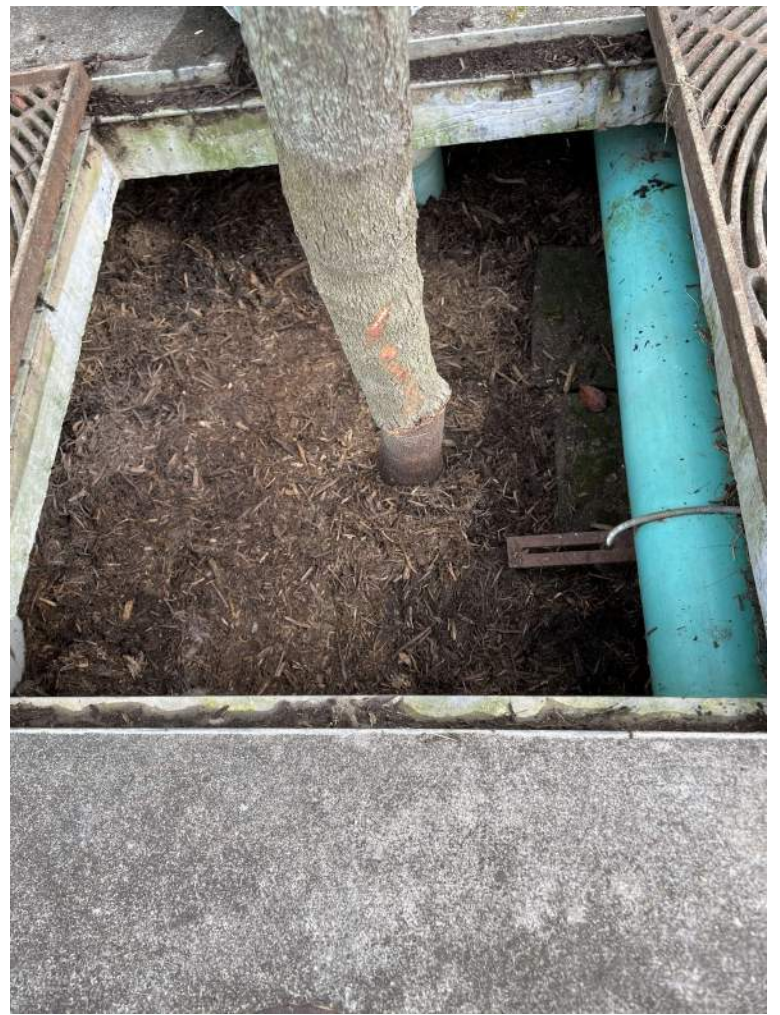
BMP #2- after maintenance

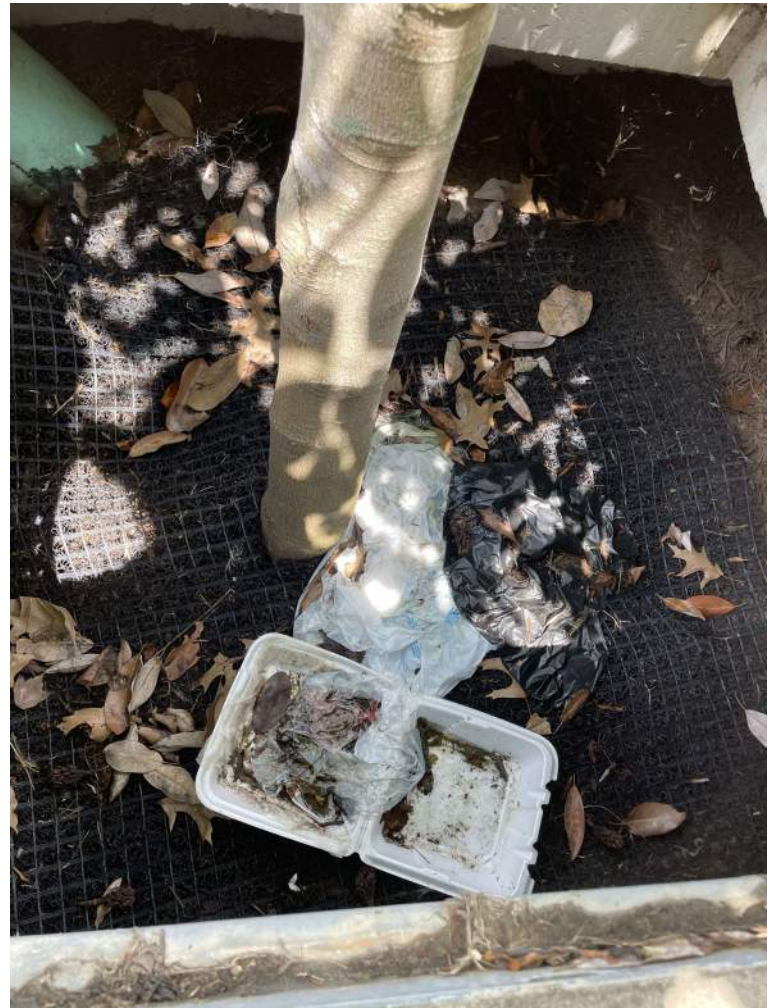
BMP #3- before maintenance

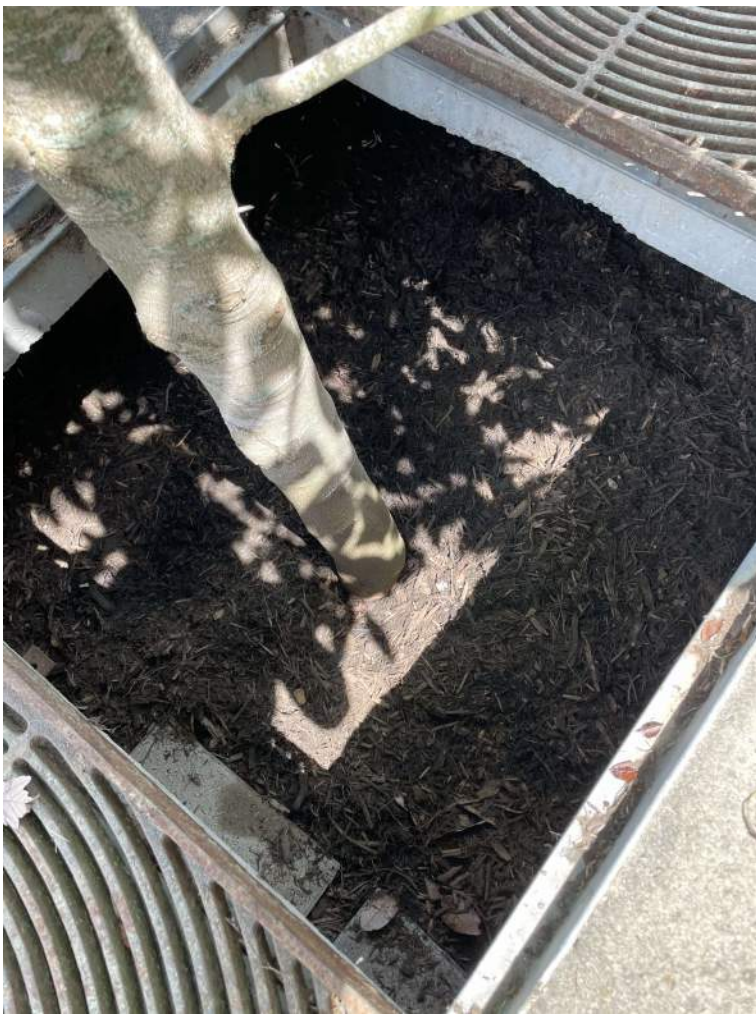
BMP #3- after maintenance

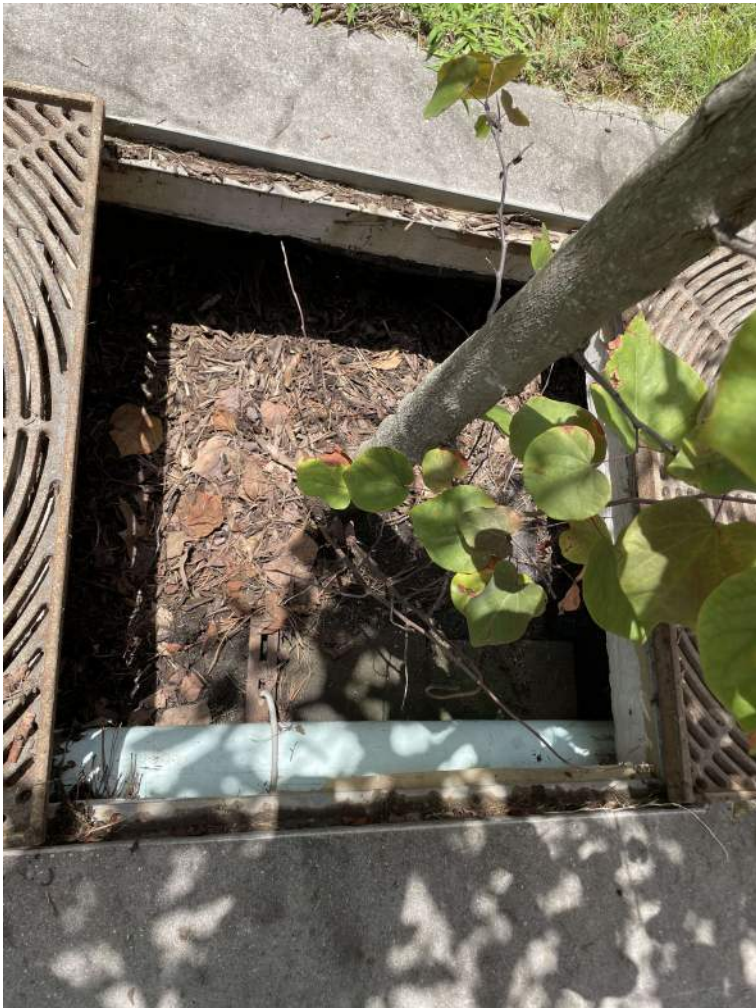
BMP #4- before maintenance

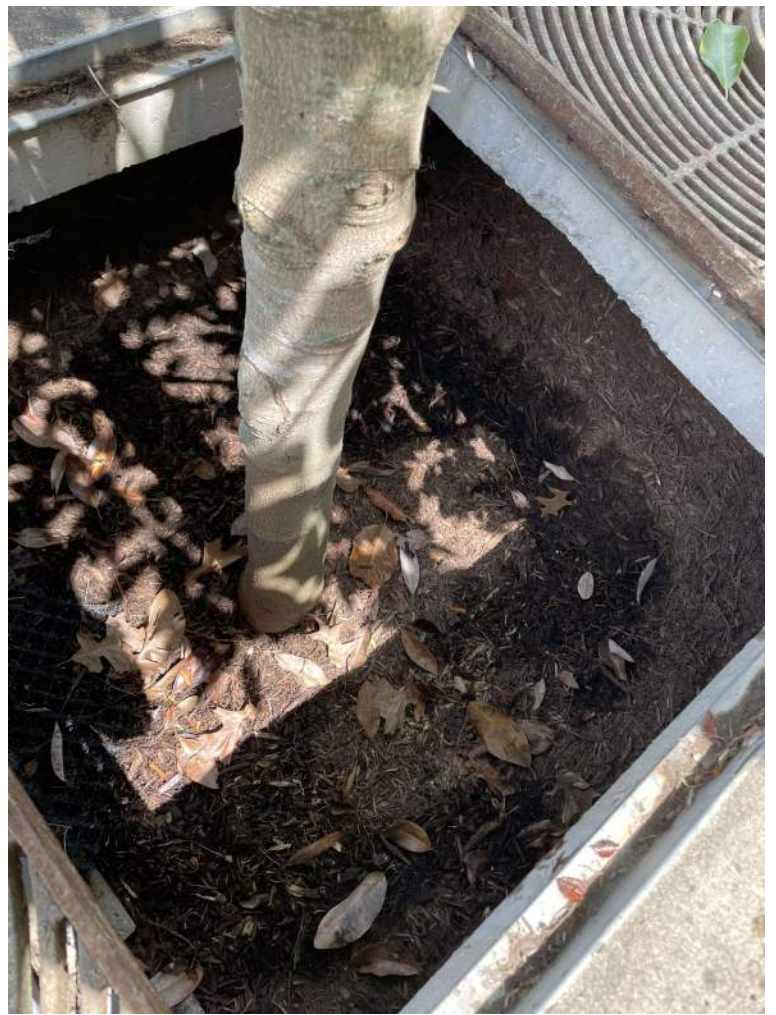
BMP #5- before maintenance

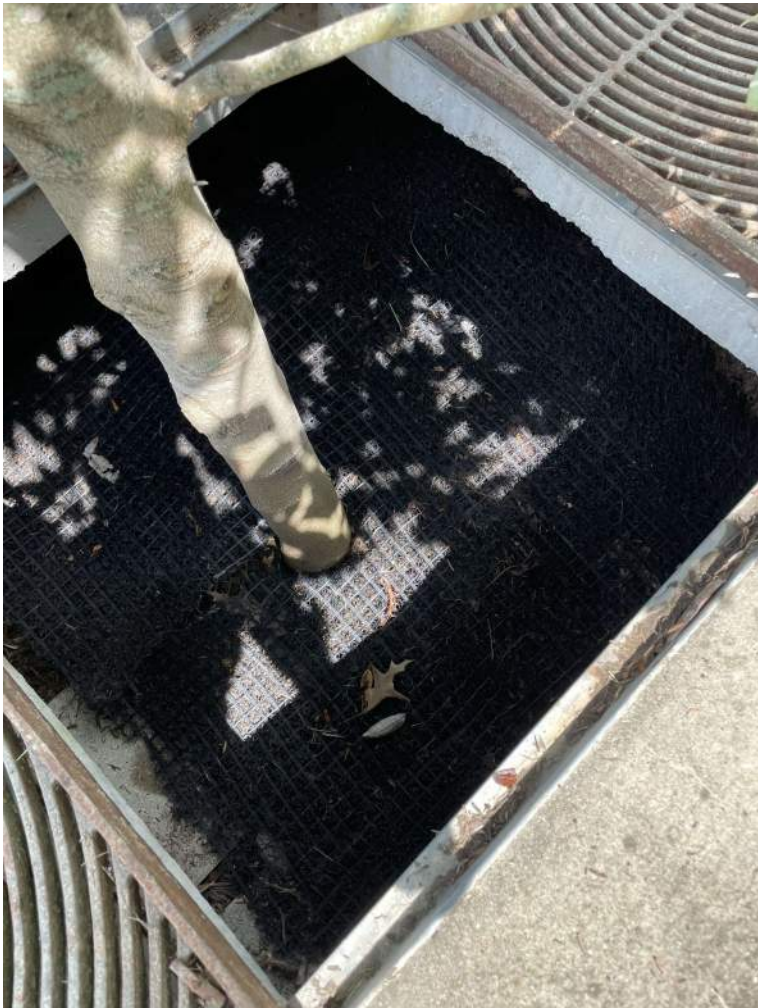
BMP #5- after maintenance

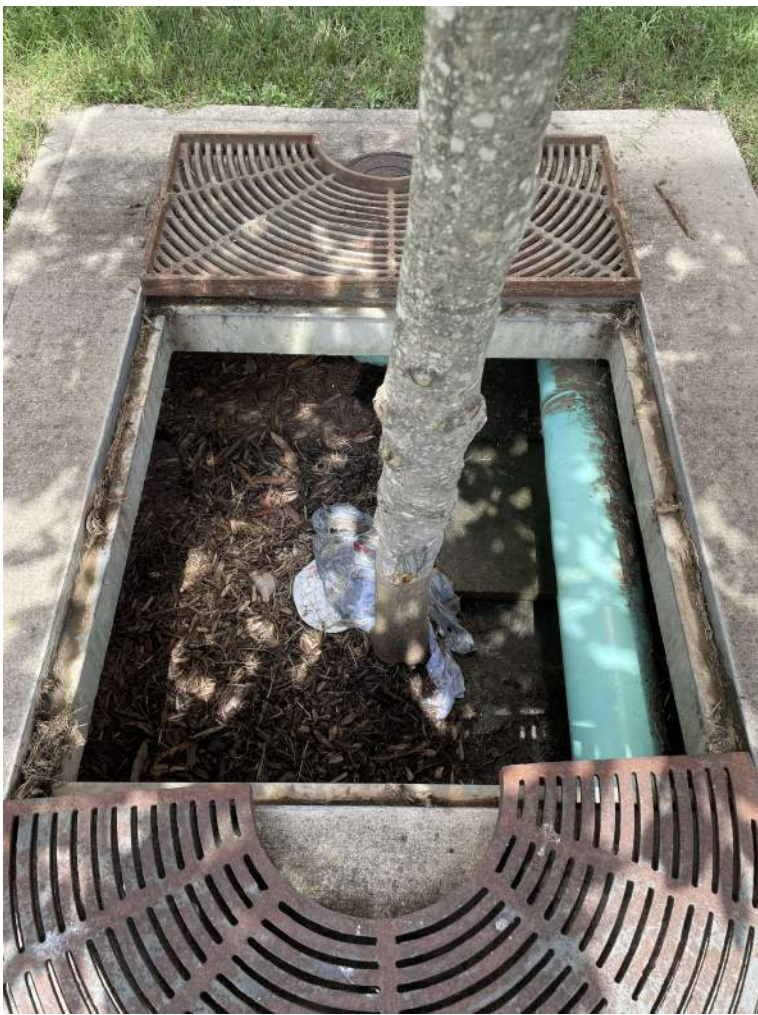
BMP #6- before maintenance

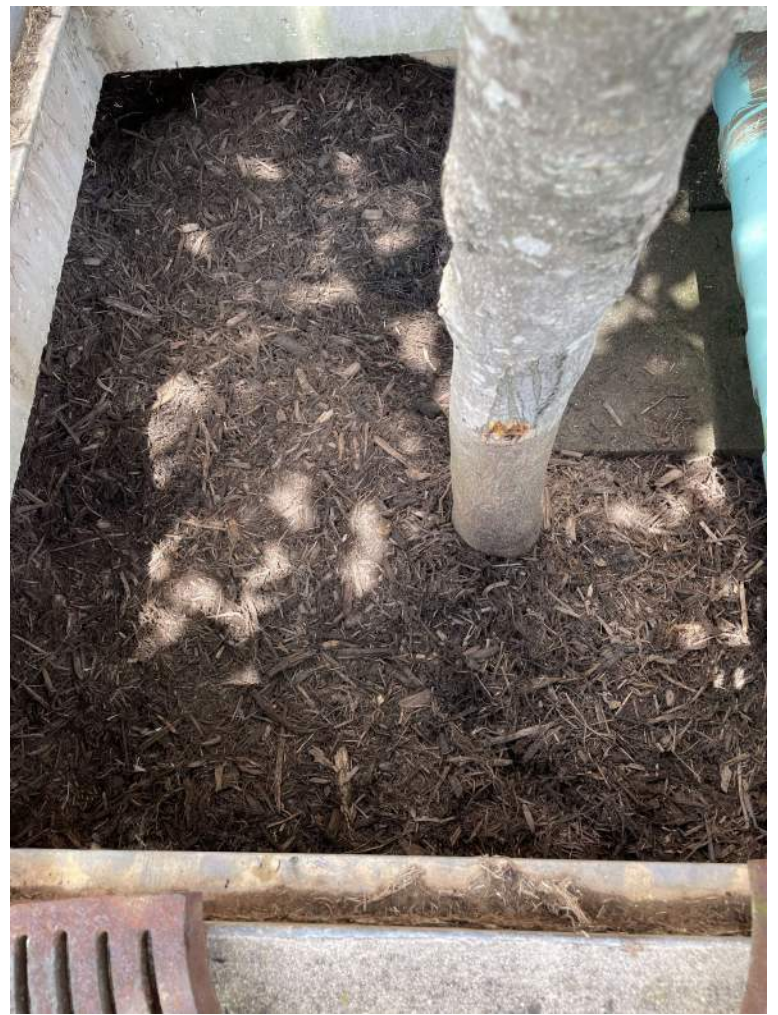
BMP #6- after maintenance

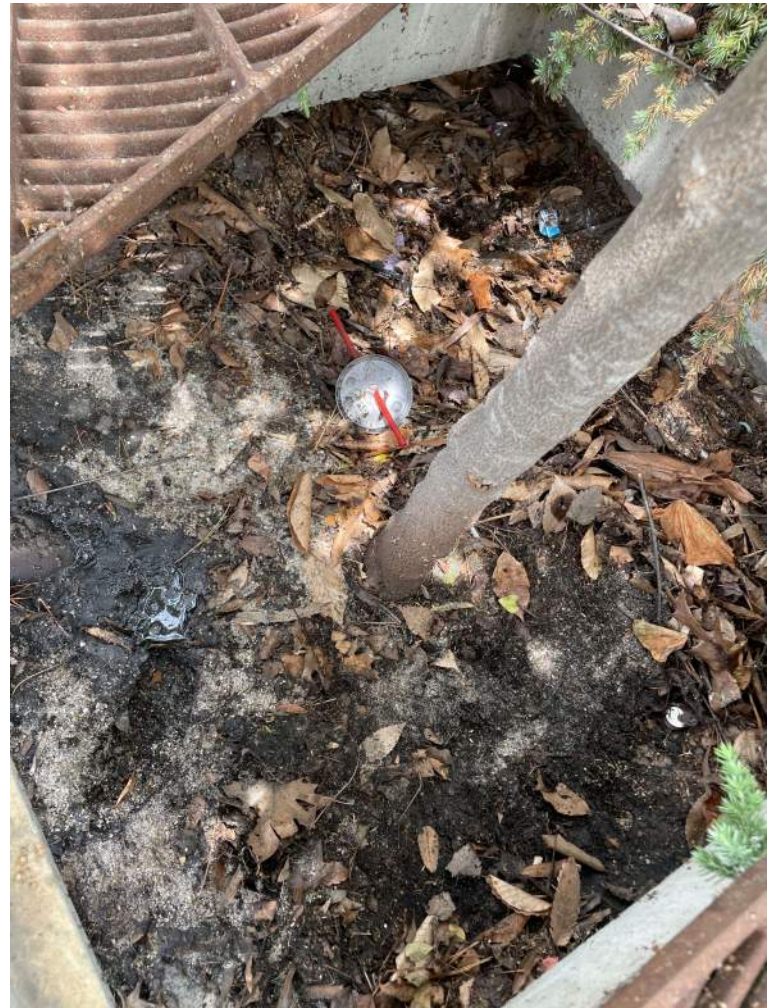
BMP #7- before maintenance

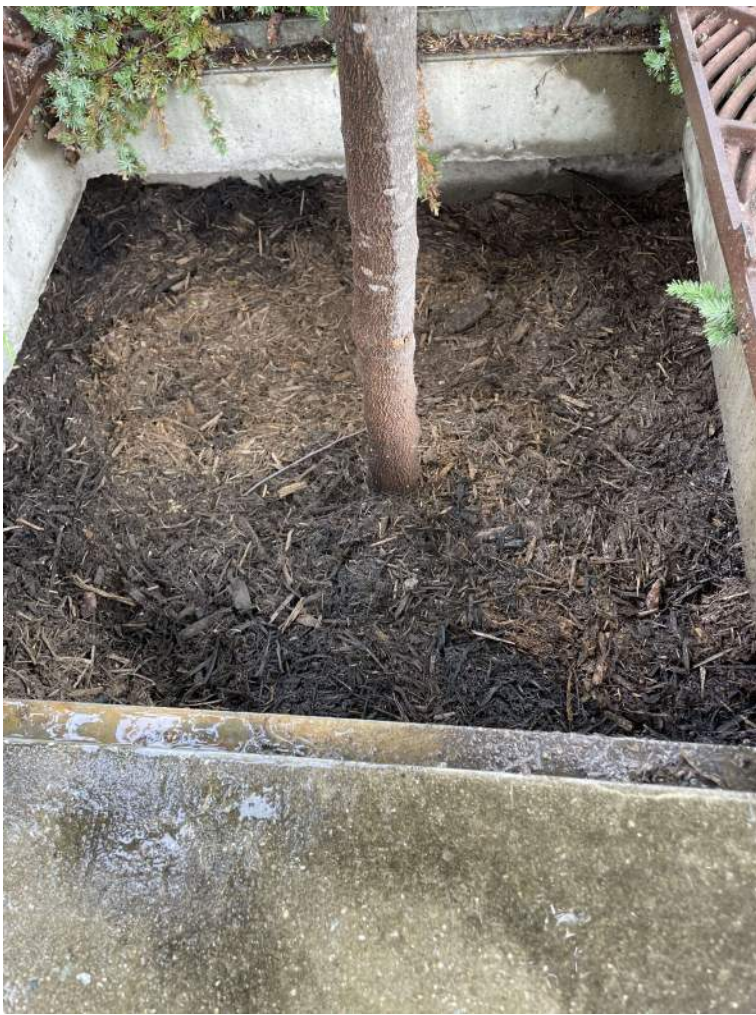
BMP #7- after maintenance

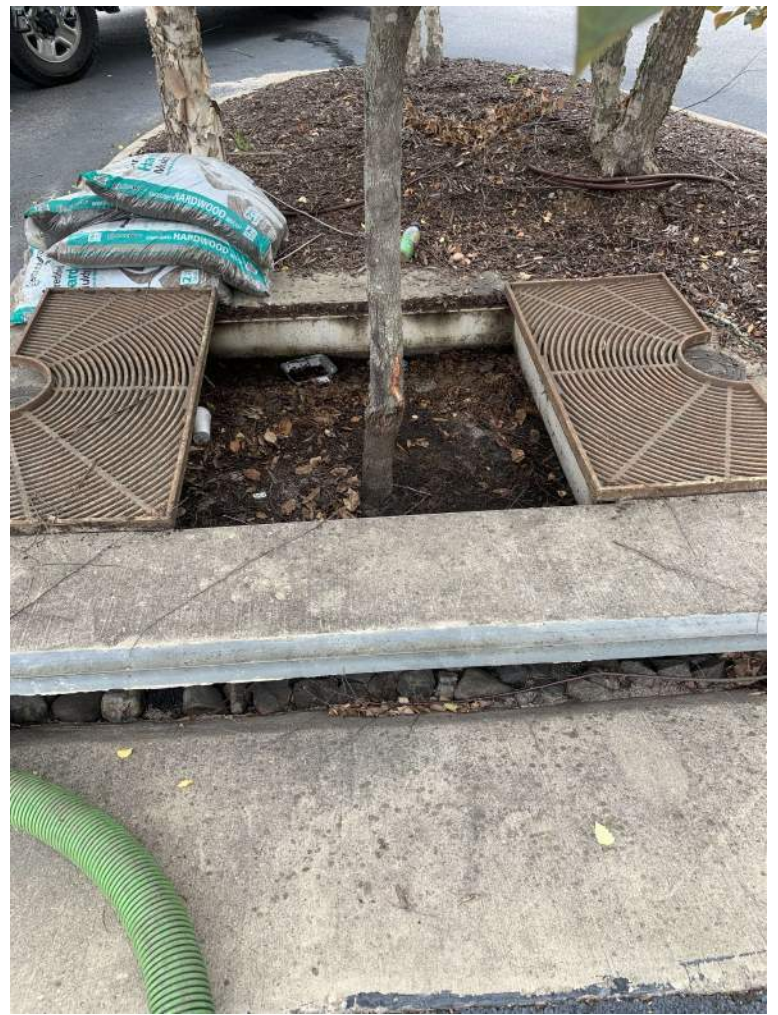
BMP #8- before maintenance

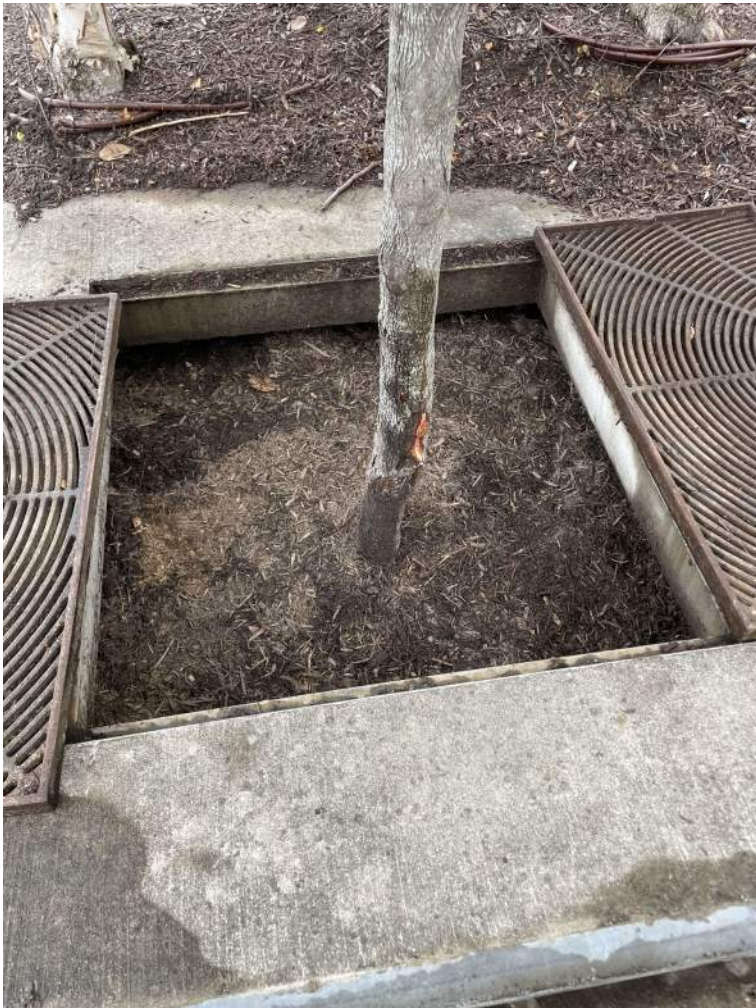
BMP #8- after maintenance

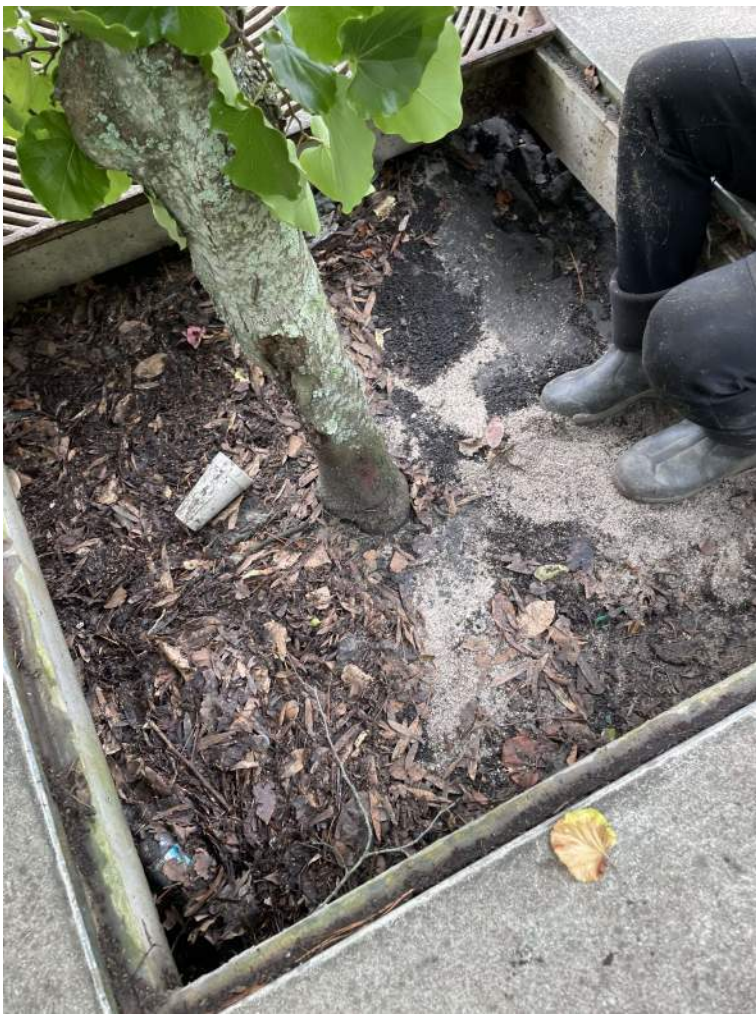
BMP #9- before maintenance

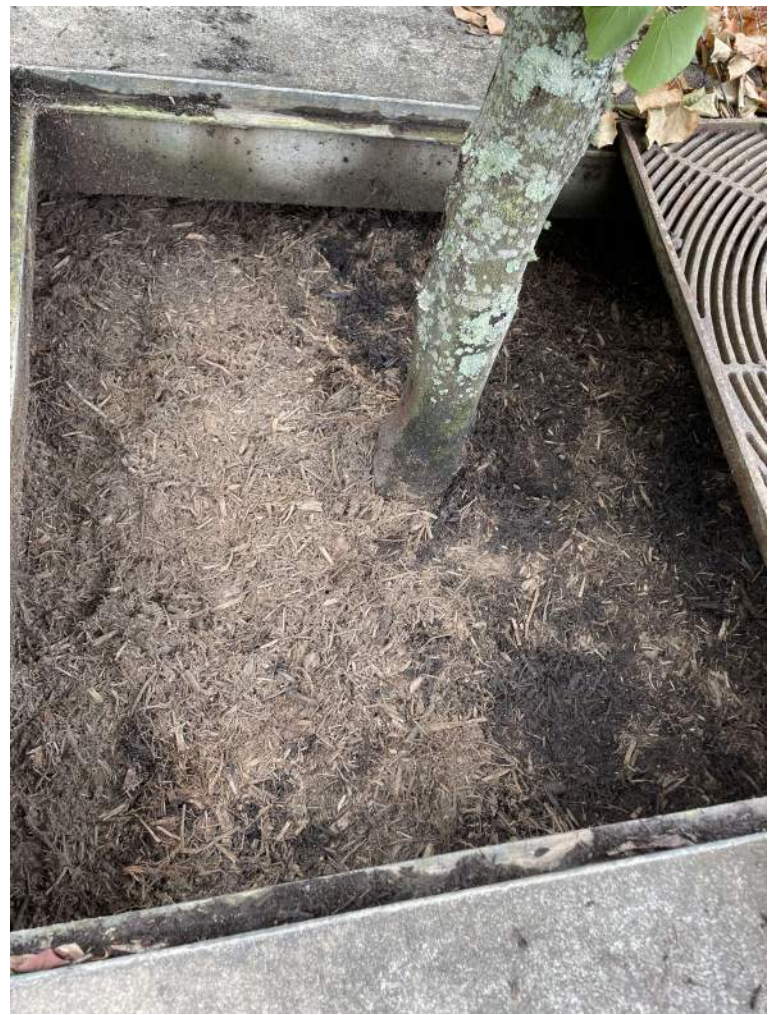
BMP #9- after maintenance

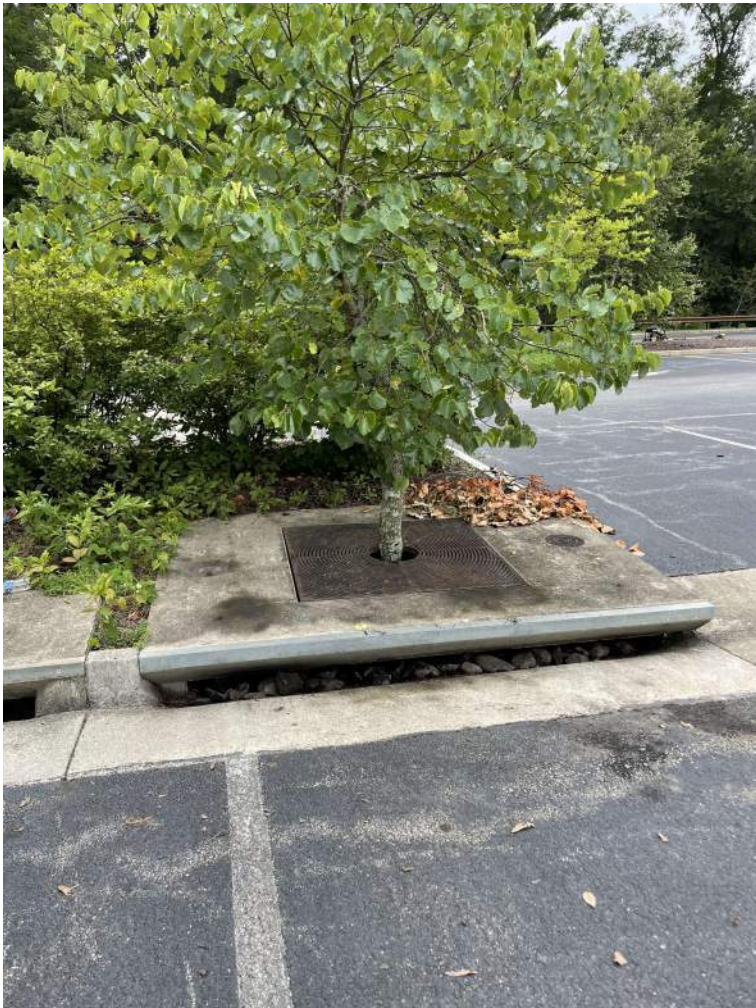
BMP #9- after maintenance
