**Virginia State University**  
**MS-4 Permit: VAR040119**  
**July 1, 2021 - June 30, 2022 Annual Report**

Prepared for  
**Virginia State University**  
Capital Outlay & Facilities Management  
PO Box 9414  
Virginia State University, VA 23806

October 1, 2022

Prepared by: Timmons Group  
1001 Boulders Parkway, Suite 300  
Richmond, VA 23225  
(804) 200-6500

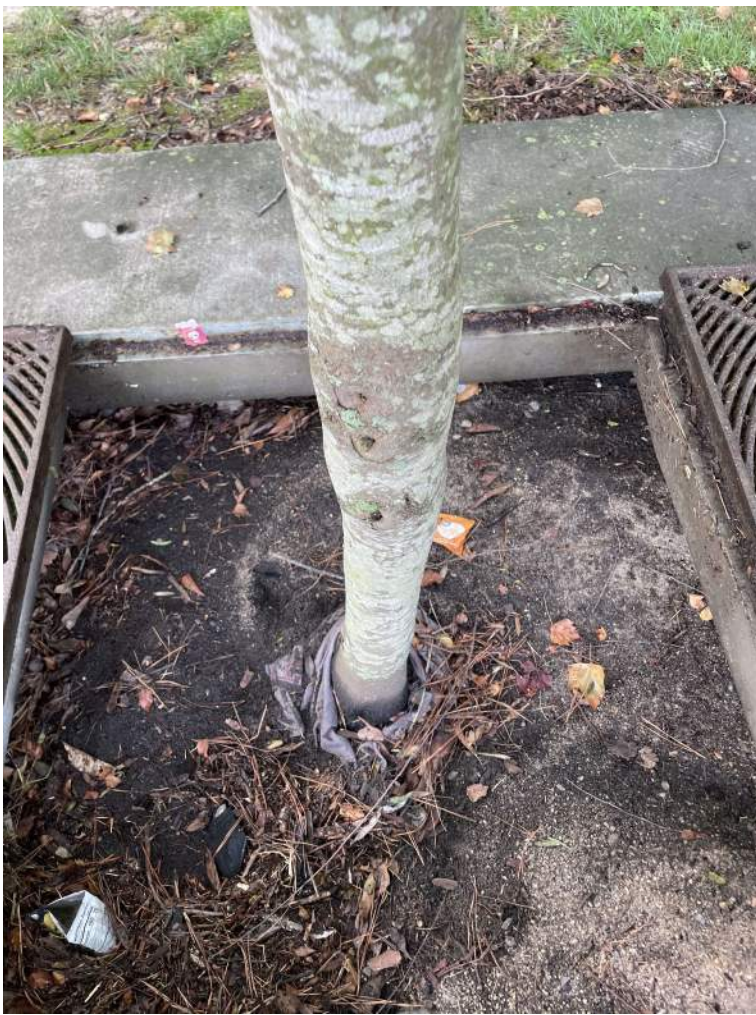
BMP #10- before maintenance

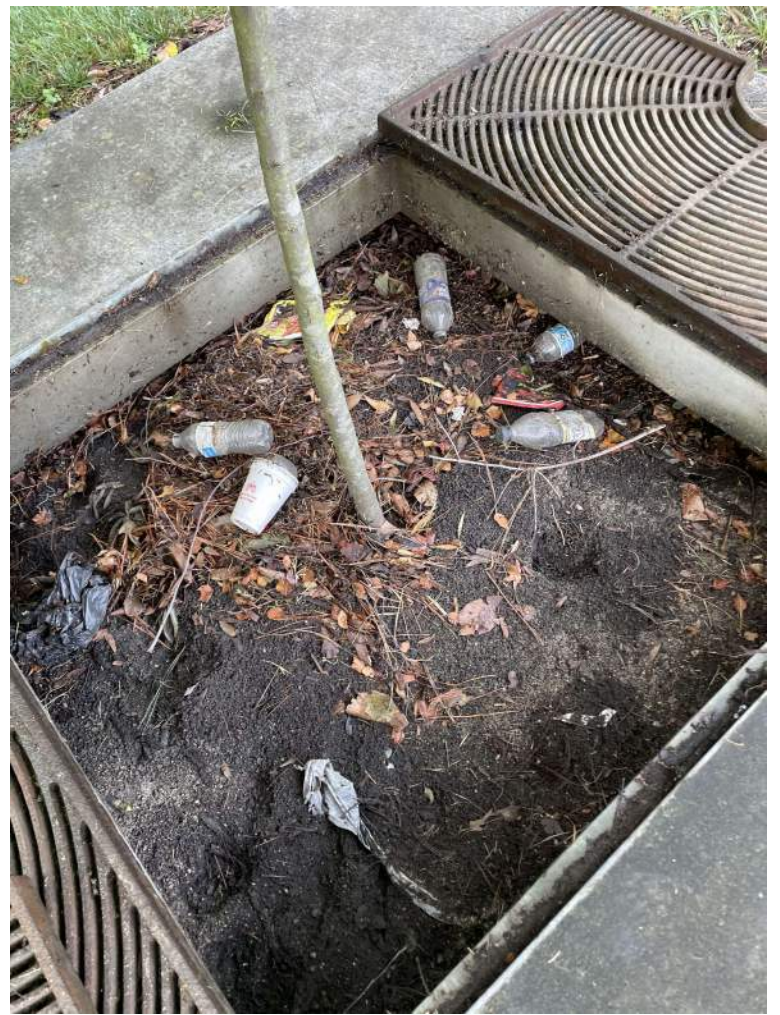
BMP #10- before maintenance

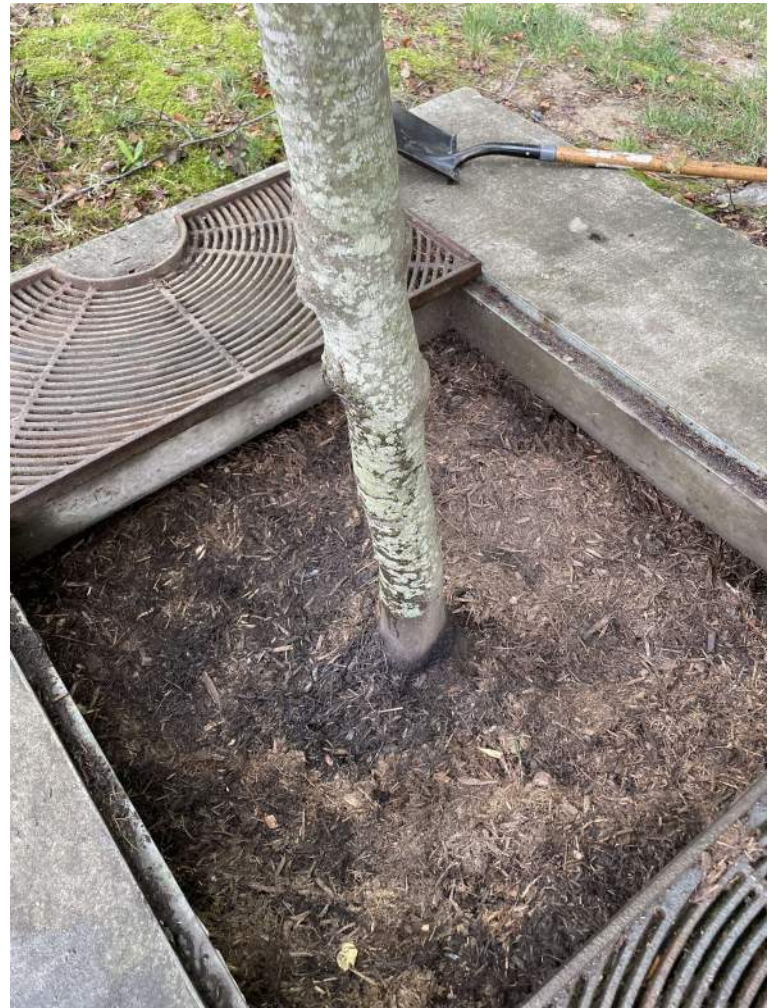
BMP #10- after maintenance

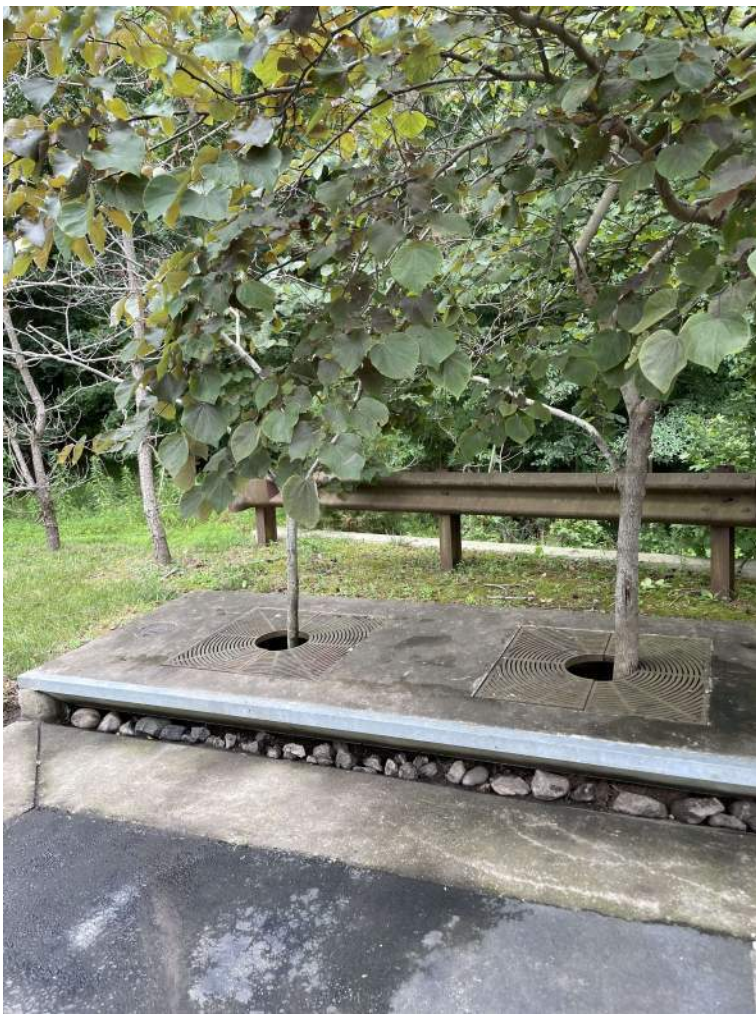
BMP #10- after maintenance

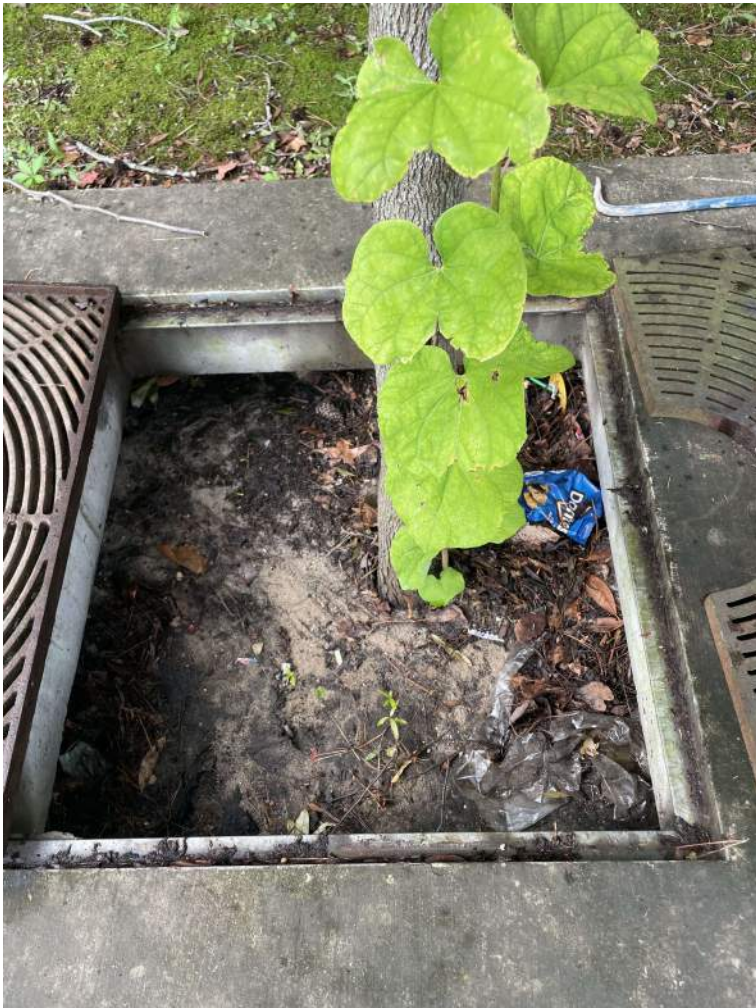
BMP #11- before maintenance

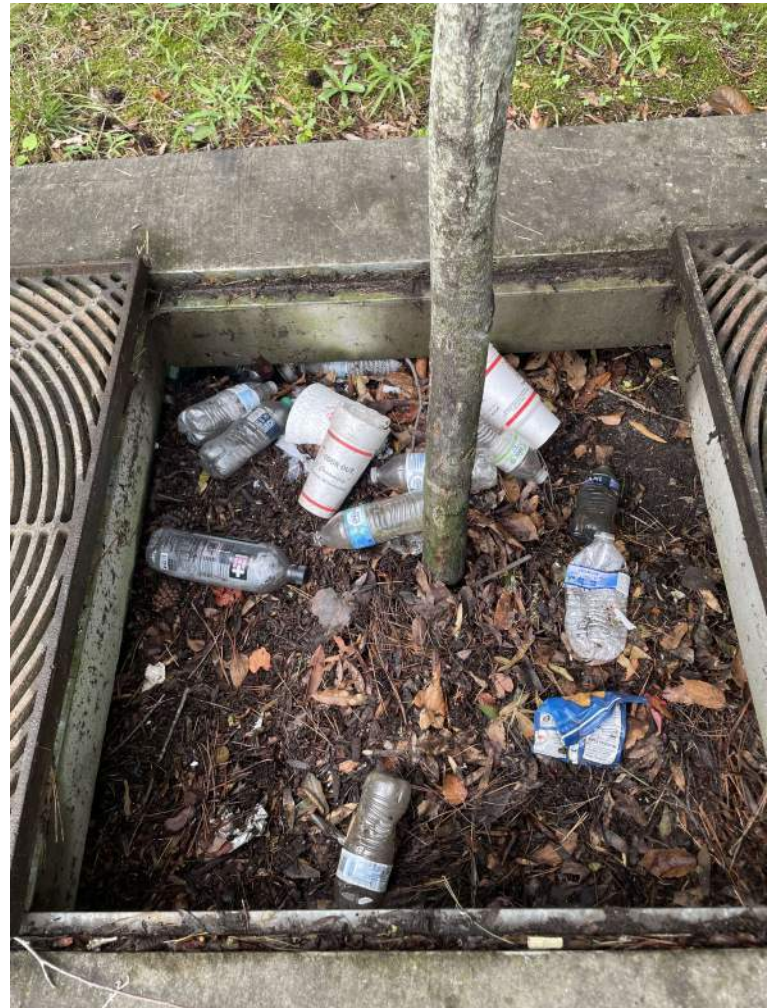
BMP #11- before maintenance

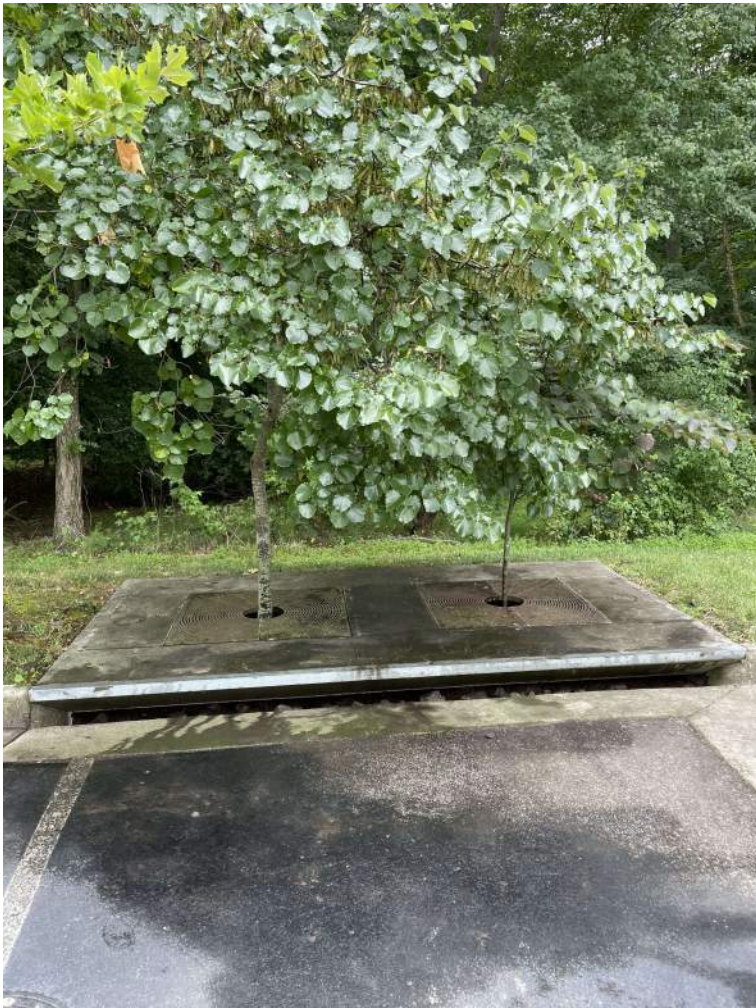
BMP #11- after maintenance

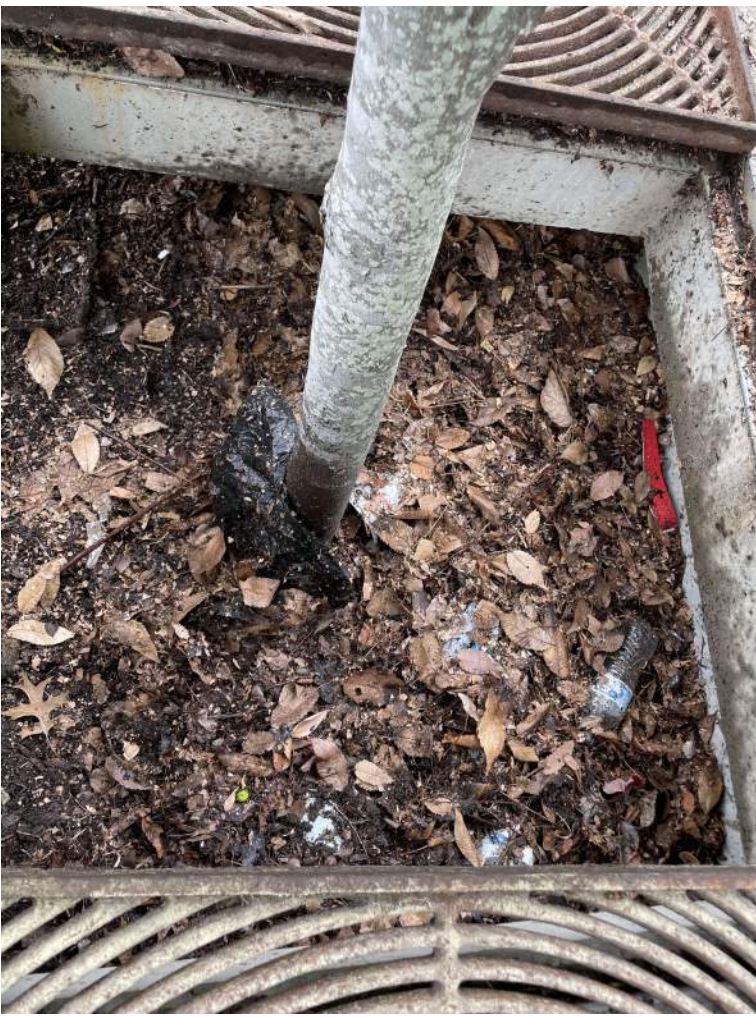
BMP #12- before maintenance

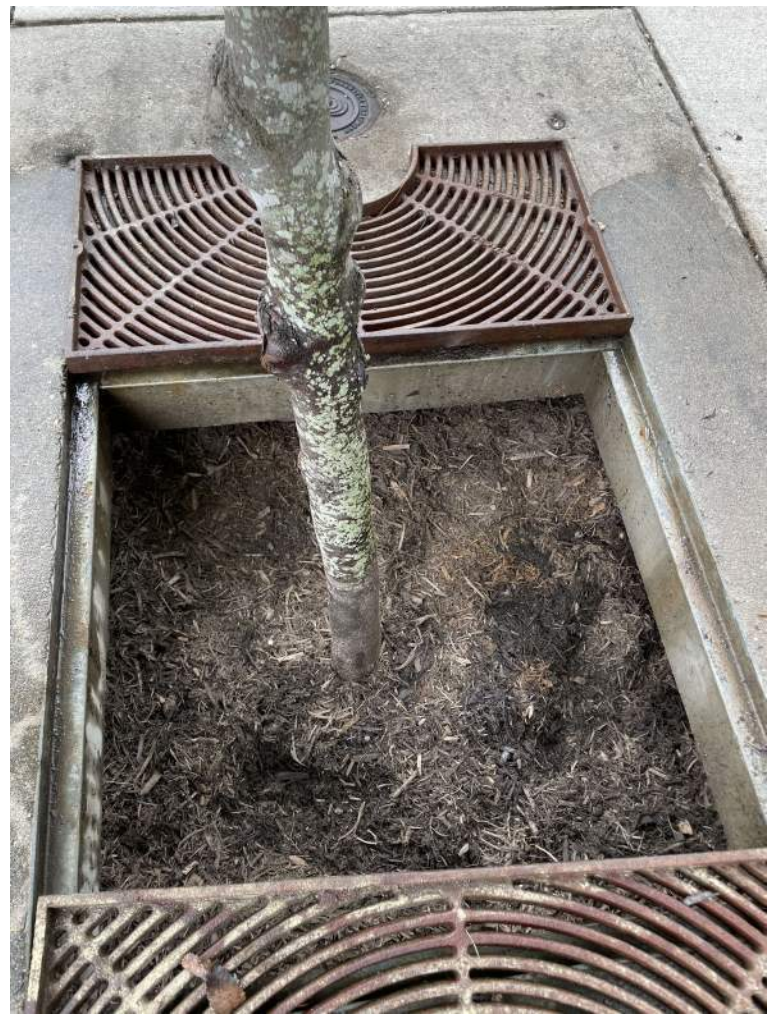
BMP #12- after maintenance

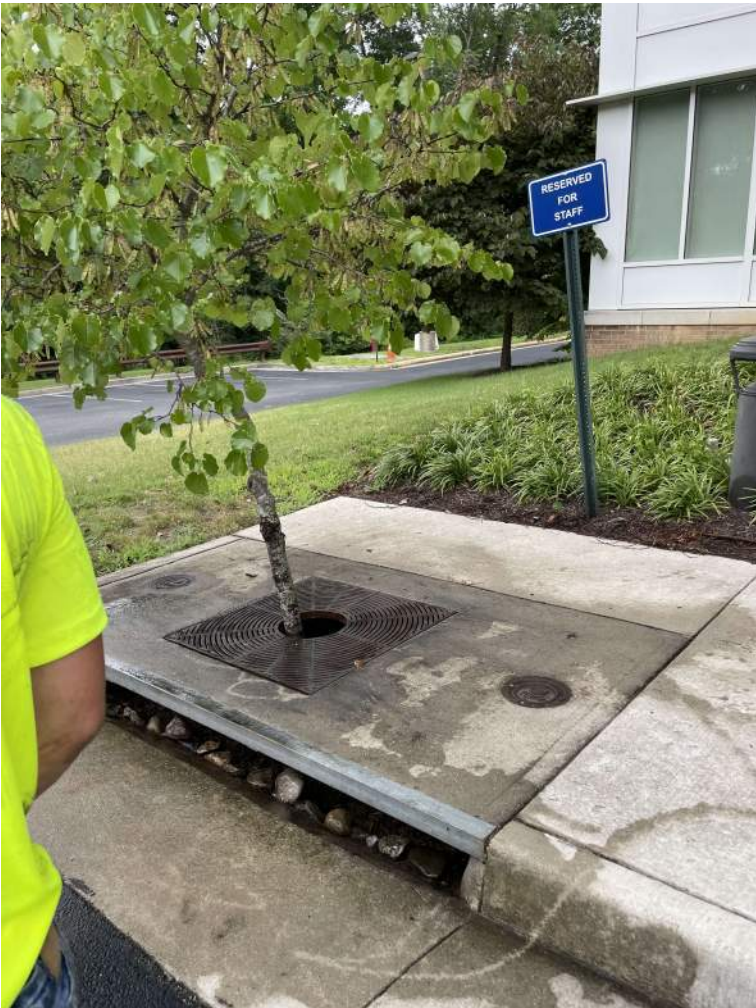
BMP #12- after maintenance

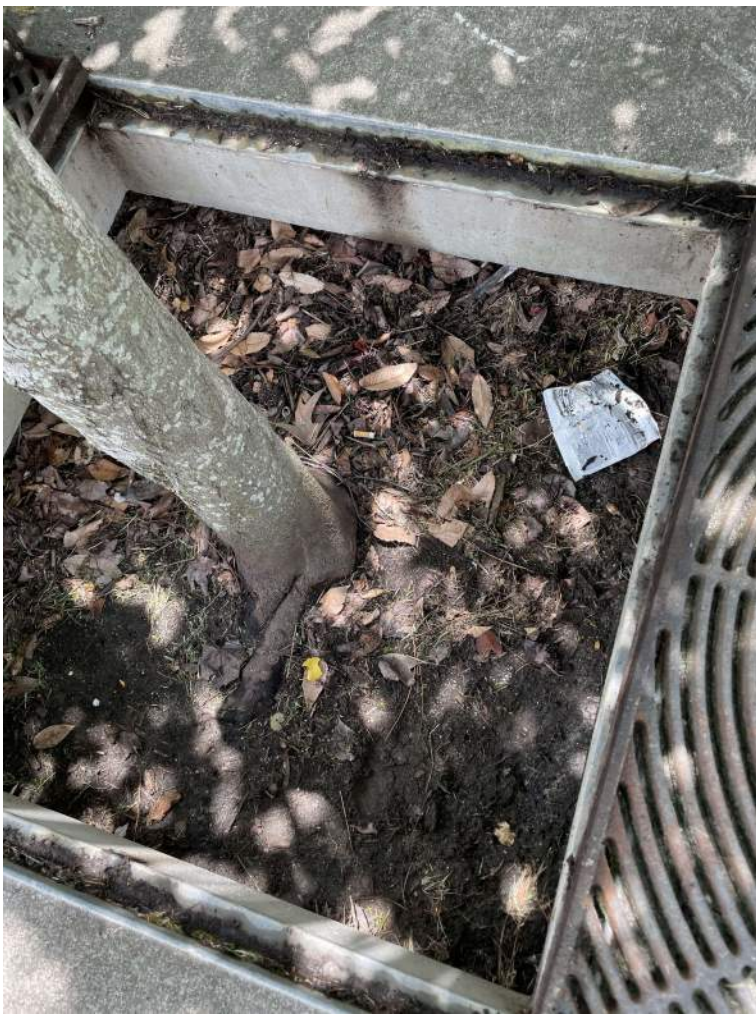
BMP #13- before maintenance

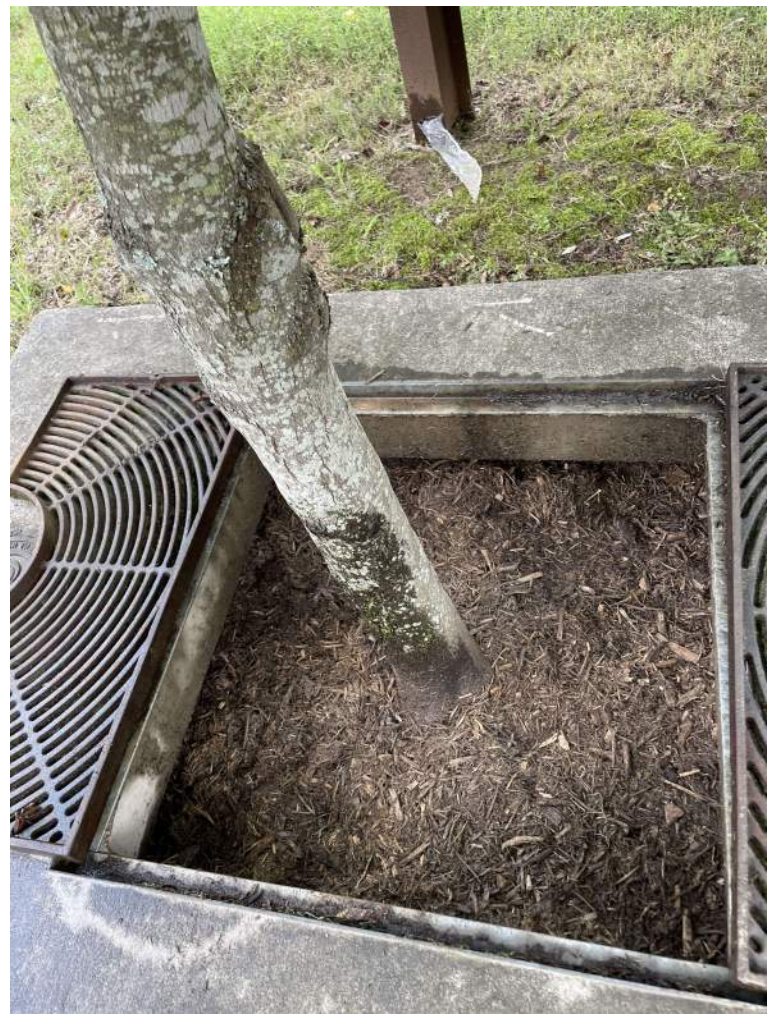
BMP #13- after maintenance

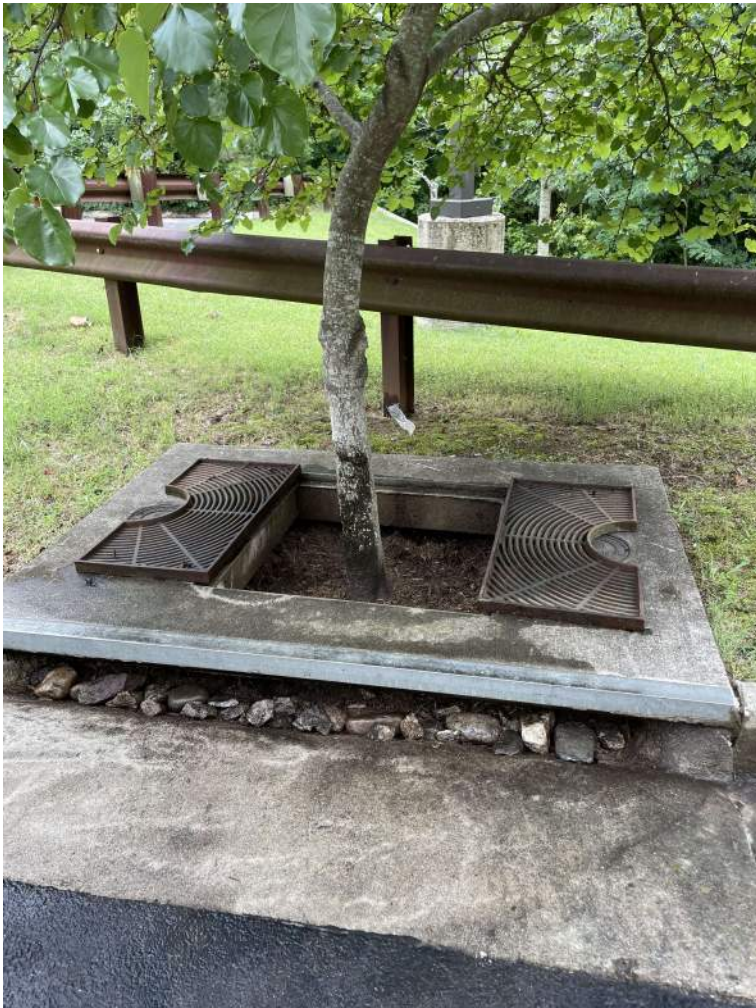
BMP #13- after maintenance

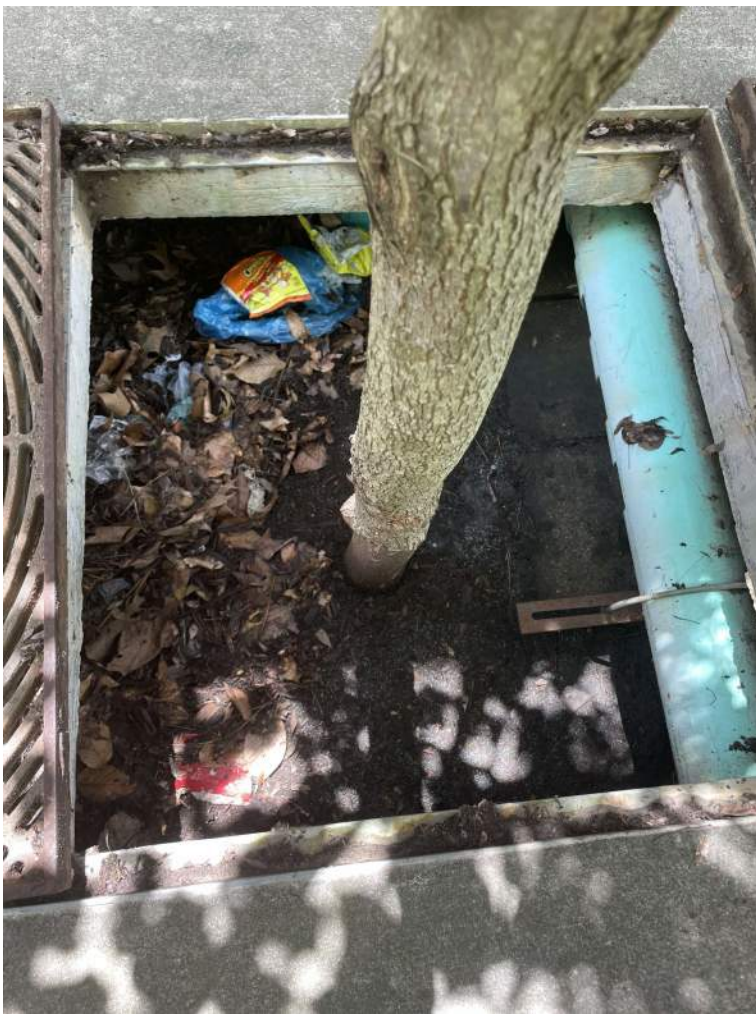
BMP #16- before maintenance

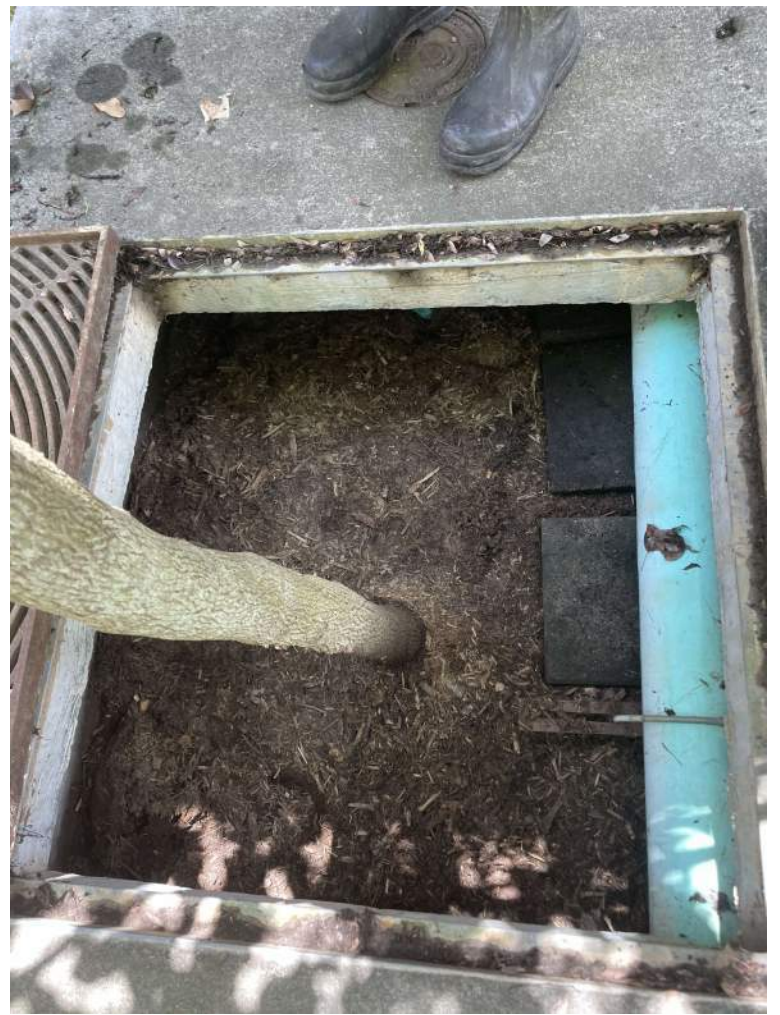
BMP #16- after maintenance

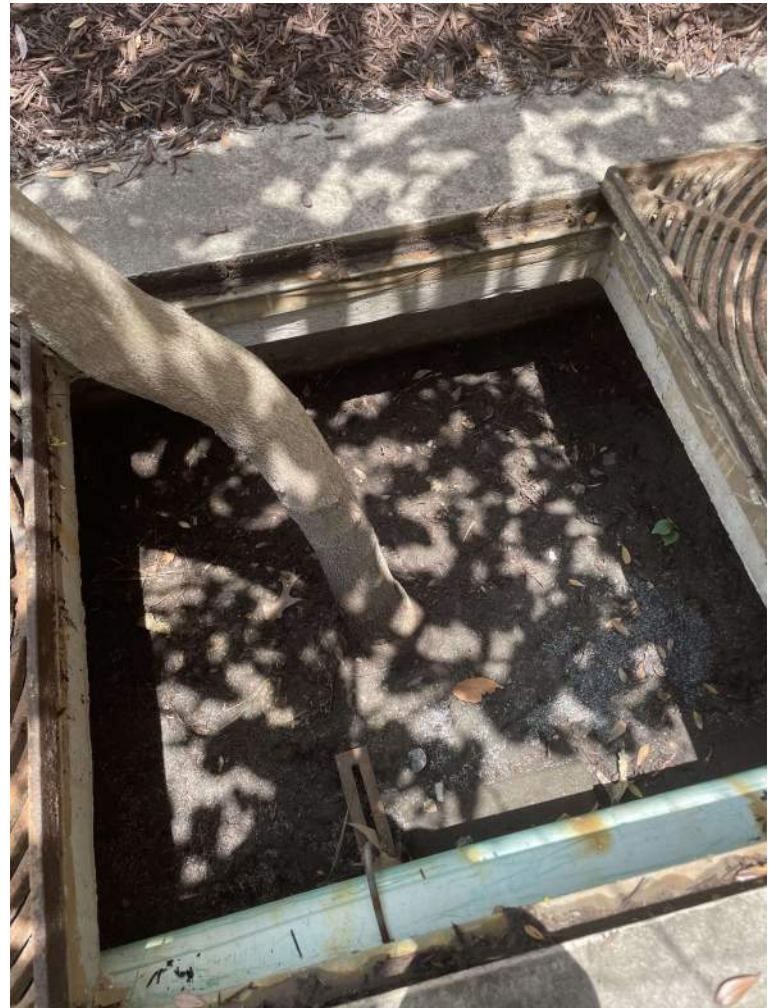
BMP #17- before maintenance

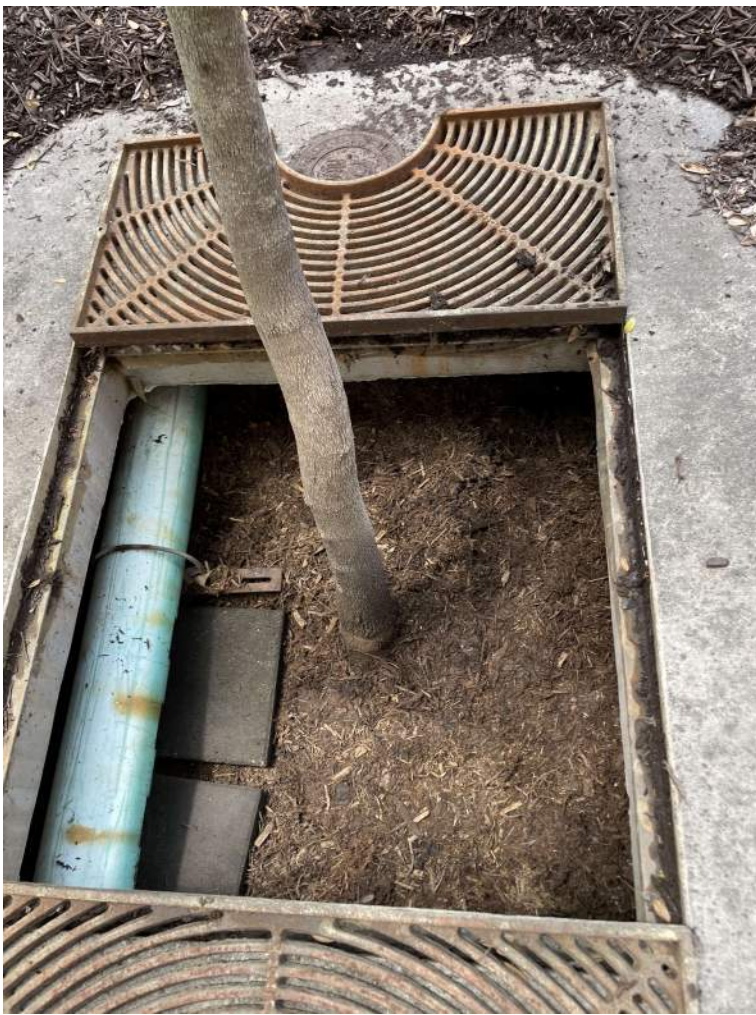
BMP #17- after maintenance

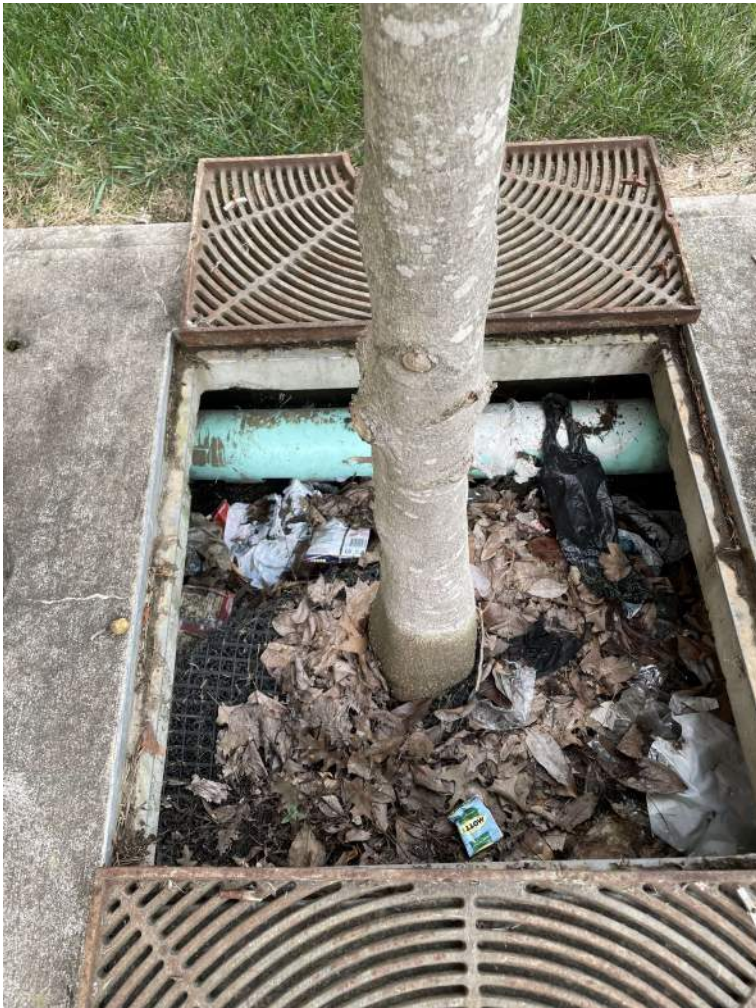
BMP #18- before maintenance

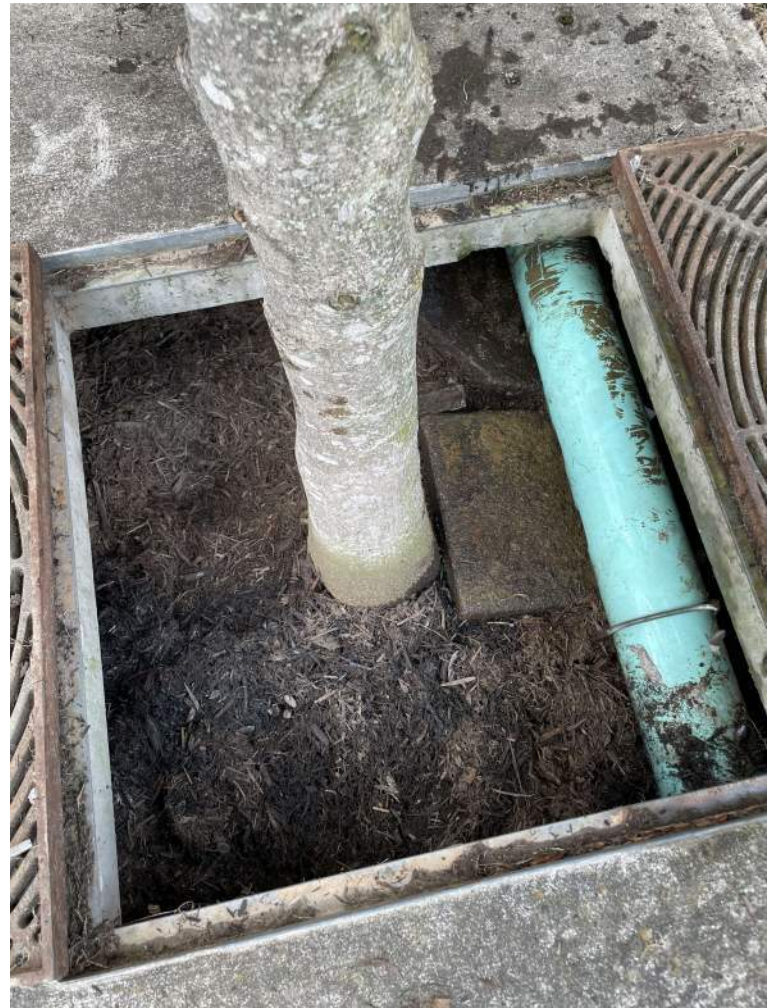
BMP #18- after maintenance

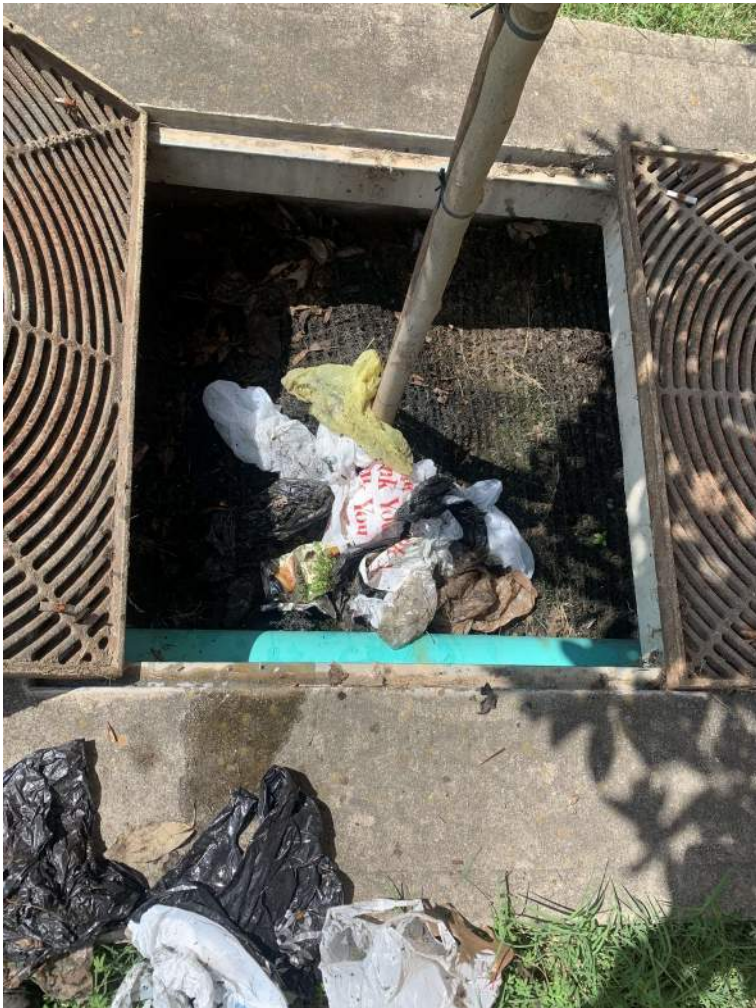
BMP #19- before maintenance

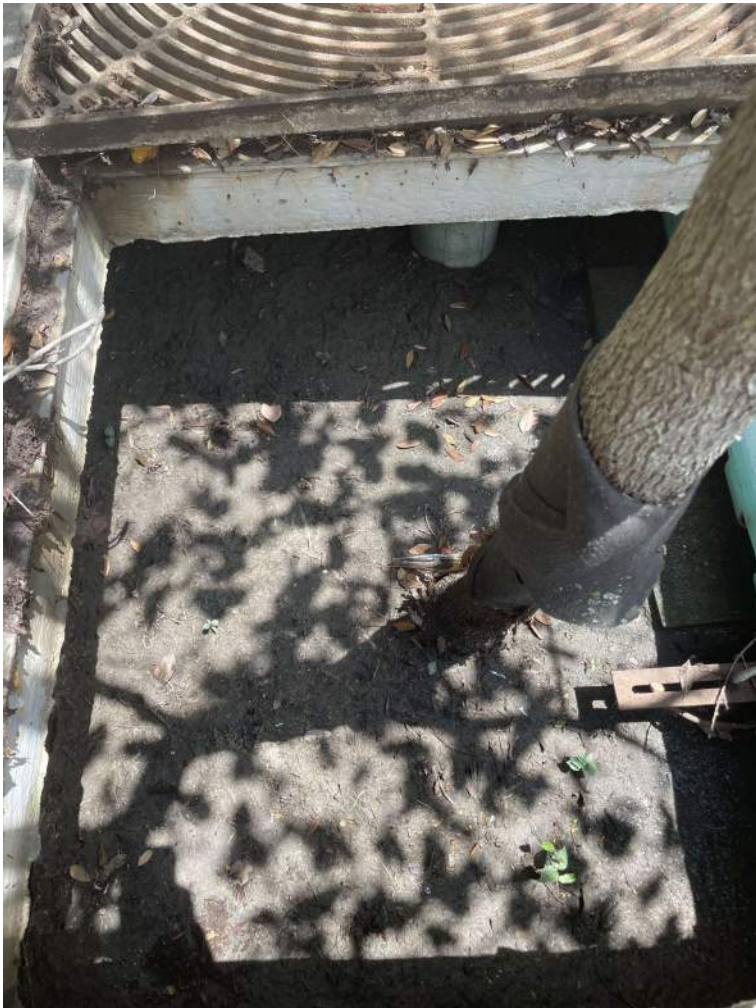
BMP #21- before maintenance

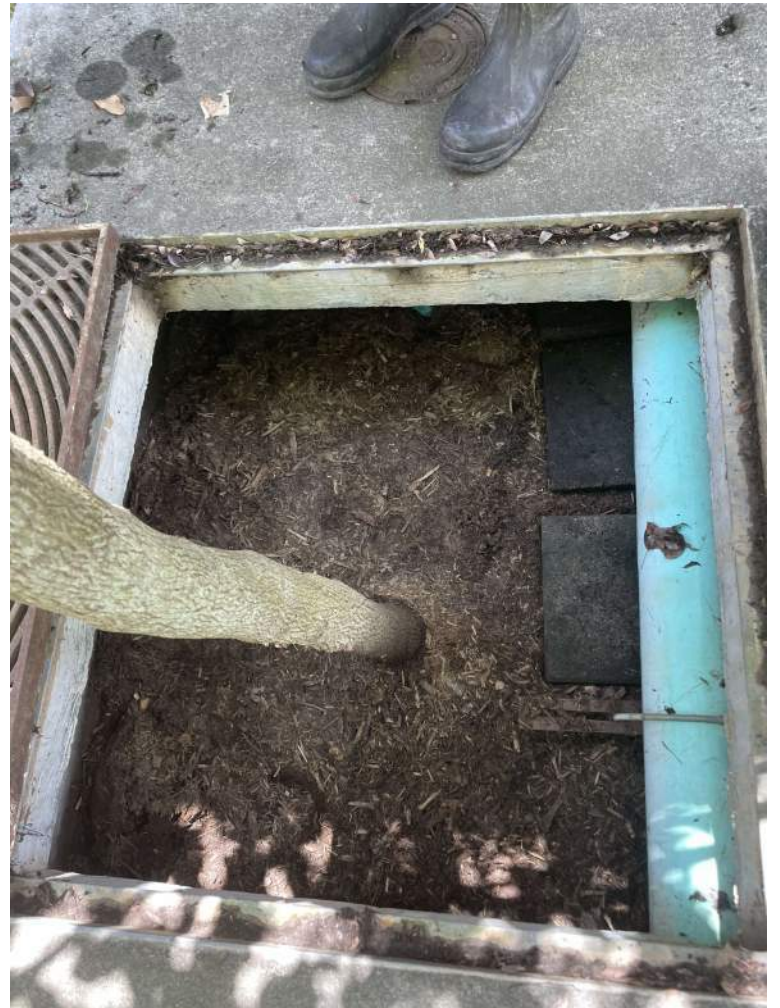
BMP #21- after maintenance

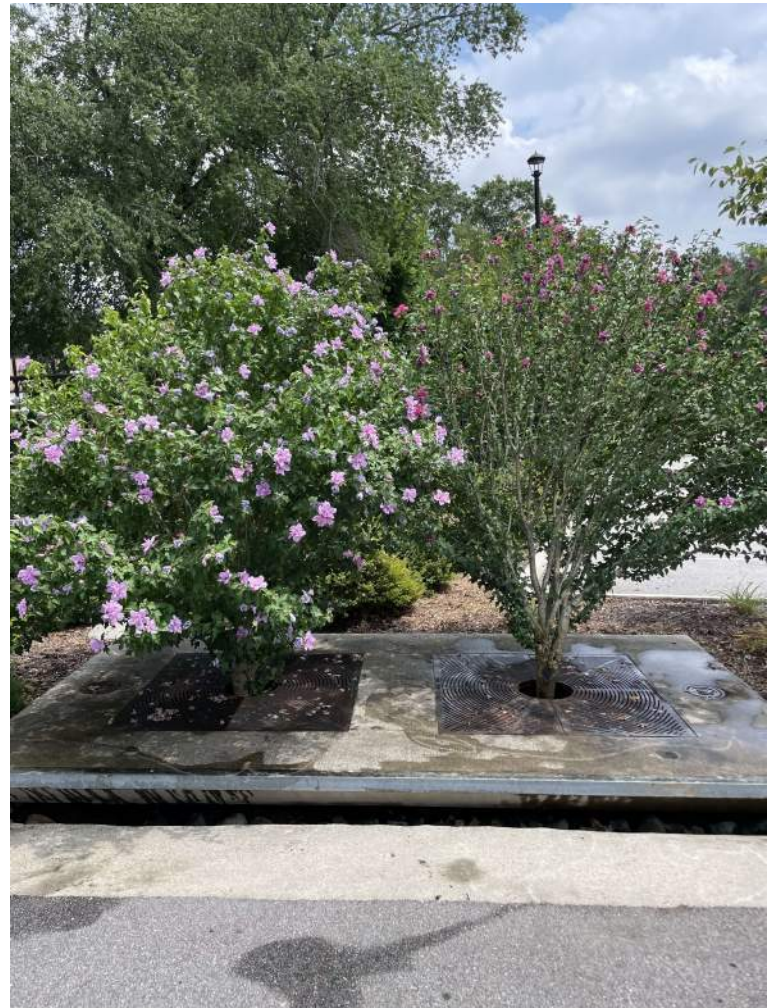
BMP #41- After maintenance

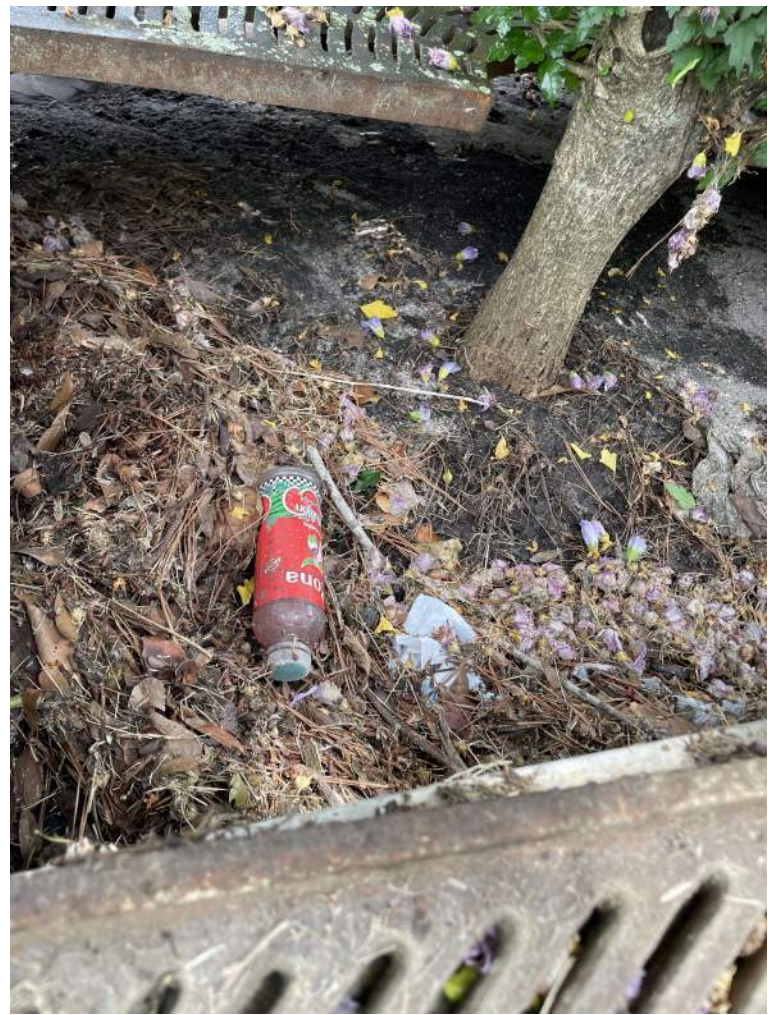
BMP #42- before maintenance

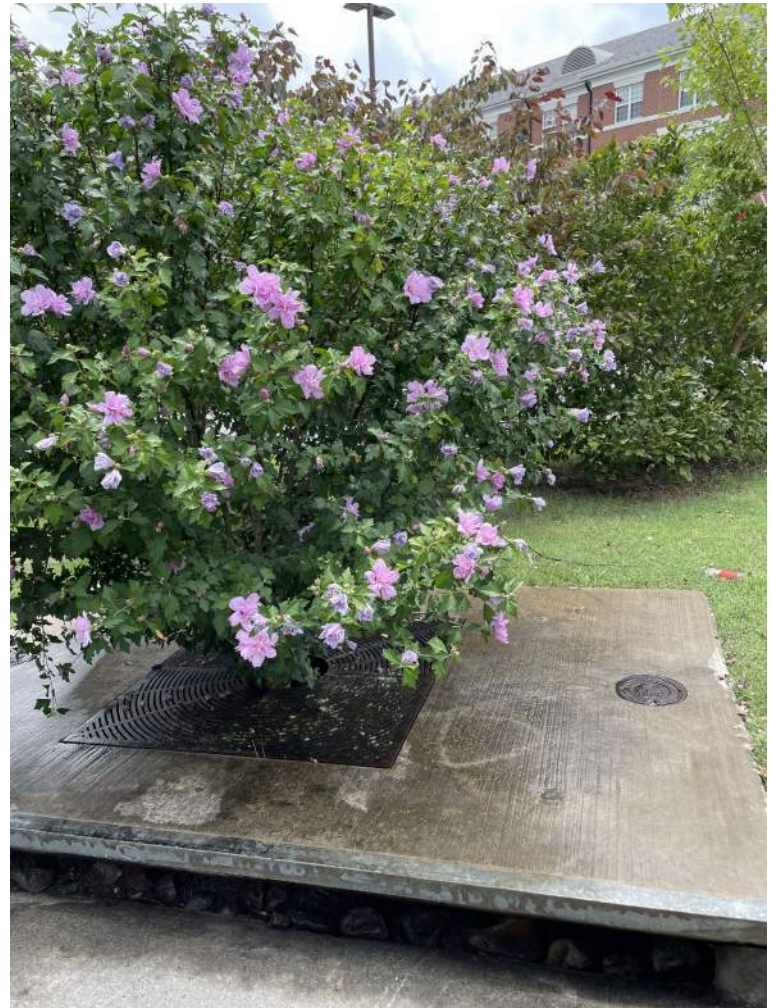
BMP #42- after maintenance

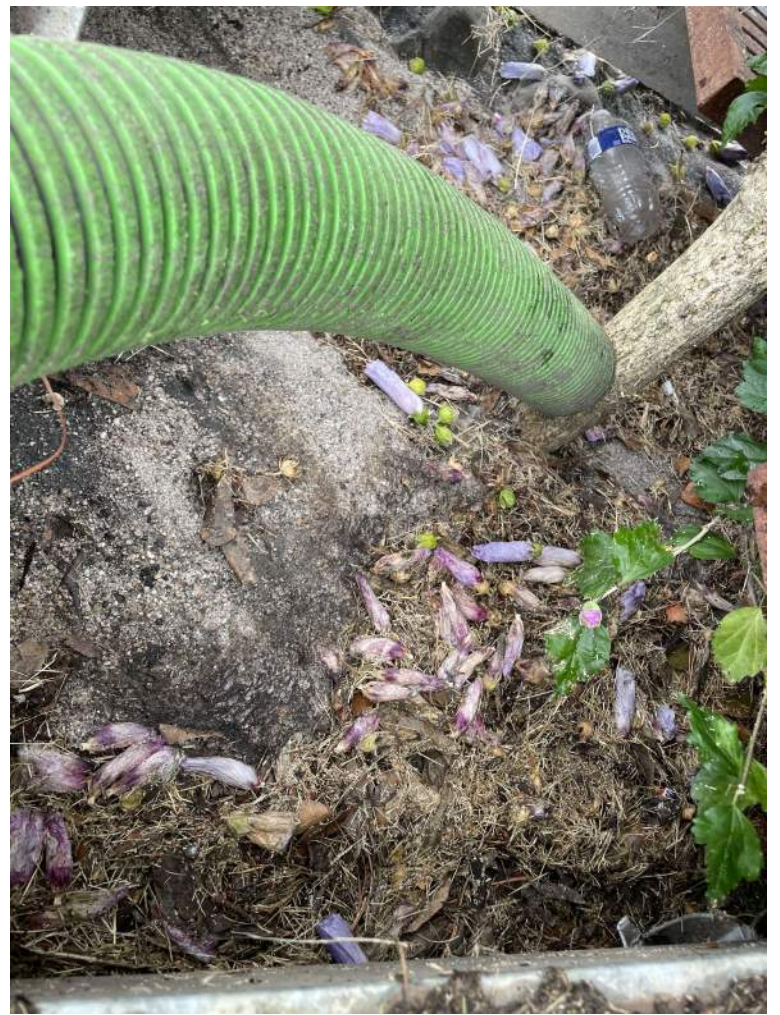
BMP #44- before maintenance

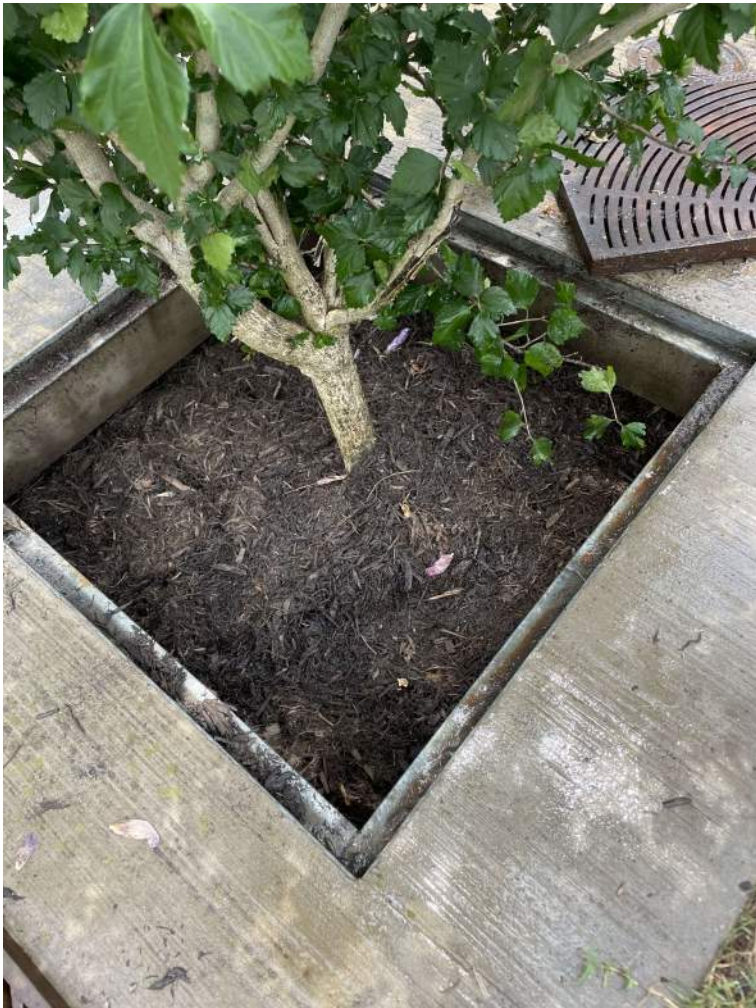
BMP #44- after maintenance
