**Virginia State University**  
**MS-4 Permit: VAR040119**  
**July 1, 2021 - June 30, 2022 Annual Report**

Prepared for  
**Virginia State University**  
Capital Outlay & Facilities Management  
PO Box 9414  
Virginia State University, VA 23806

October 1, 2022

Prepared by: Timmons Group  
1001 Boulders Parkway, Suite 300  
Richmond, VA 23225  
(804) 200-6500

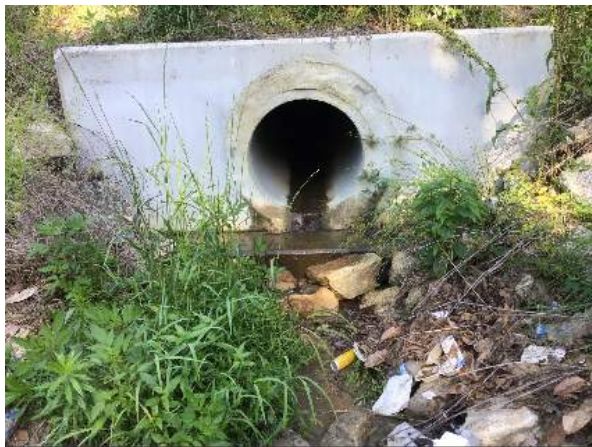
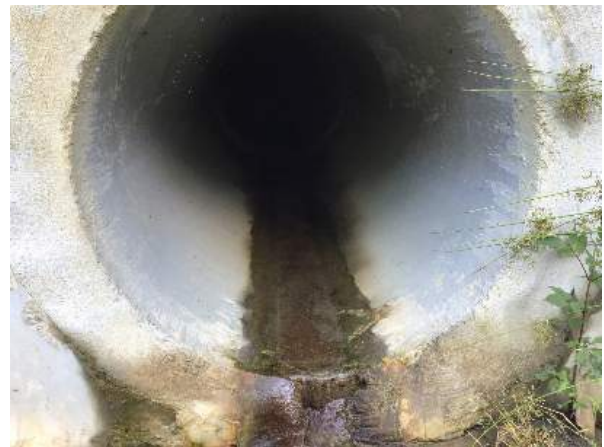
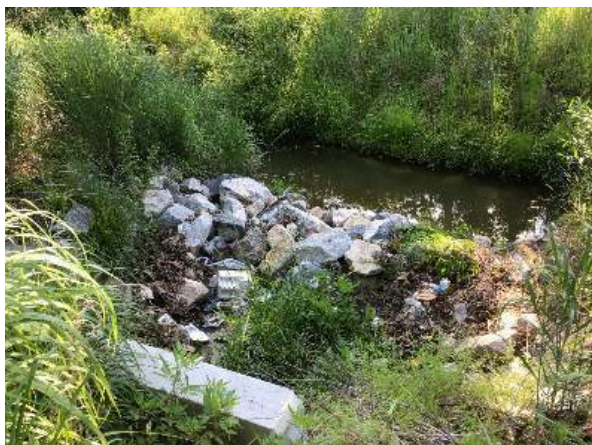
Outfall ID: 01	Date: 05/31/2022	Time: 8:49am	Inspector: Jessica Slagle & Hailey Fry
----------------	------------------	--------------	----------------------------------------

Indicator	Present?	Description	Relative Severity Index (1-3)
Odor	No	NA	NA
Turbidity	No	See Severity Index	NA
Floatables	No	NA	NA
Deposits/Stains	No	NA	NA
Poor Pool Quality	Yes	Sediment	1
Pipe Benthic Growth	No	NA	NA

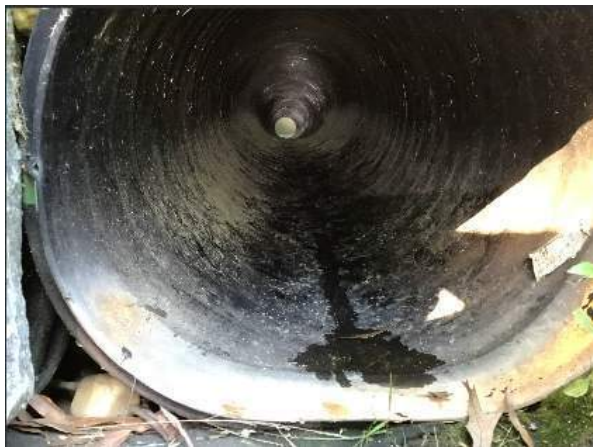
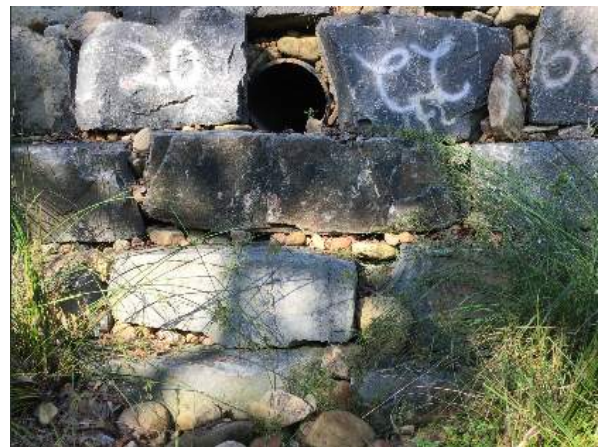
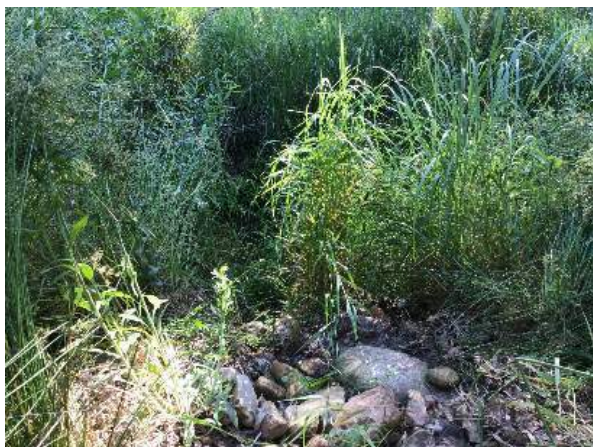
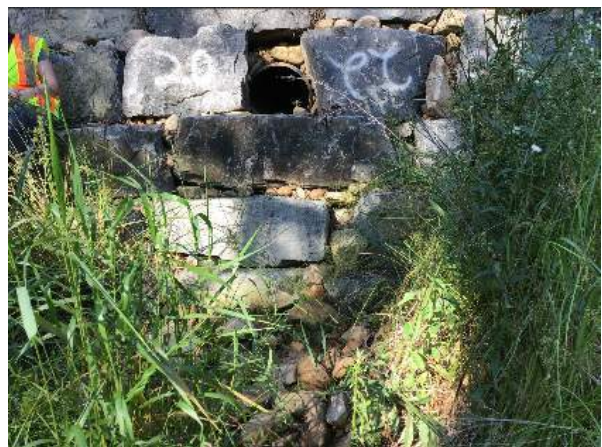
Outfall ID: 02	Date: 05/31/2022	Time: 08:57am	Inspector: Jessica Slagle & Hailey Fry
----------------	------------------	---------------	----------------------------------------

POTENTIAL POLLUTANT INDICATORS			
Indicator	Present?	Description	Relative Severity Index (1-3)
Odor	No	NA	NA
Turbidity	No	See Severity Index	NA
Floatables	No	NA	NA
Deposits/Stains	<b>Yes</b>	Flowline	2
Poor Pool Quality	<b>Yes</b>	Suds, floatables, debris	2
Pipe Benthic Growth	<b>Yes</b>	Brown, green	2

Notes:  
 Not suspected of an illicit discharge because the flow rate has been steady over the course of many years, there was no smell or turbidity, and investigation upstream could not determine a source. No changes to the flow were found upstream within the investigated reach or drainage area. Construction was found to be present in the contributing drainage area. Green and brown algae was present in pipe toward top of flowline. Some trash and debris present in the outfall pool that is recommended to be removed.

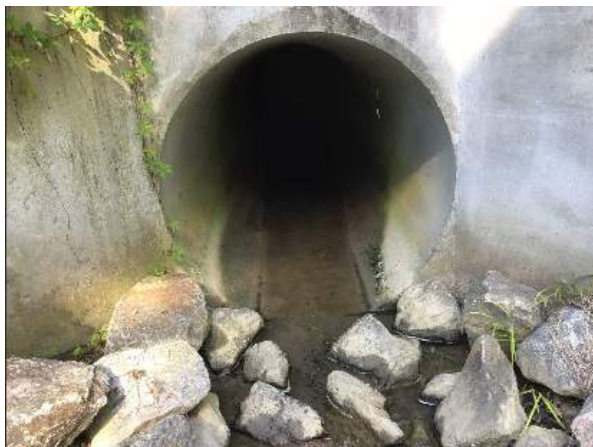
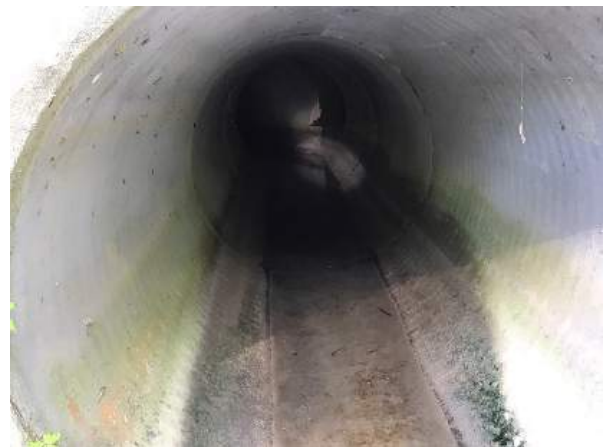
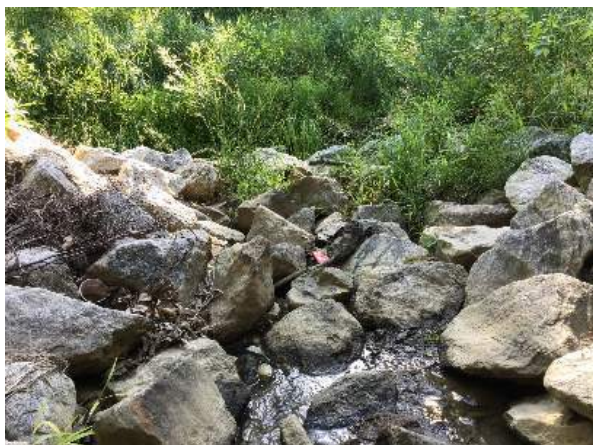
Outfall ID: 03	Date: 05/31/2022	Time: 09:04am	Inspector: Jessica Slagle & Hailey Fry
----------------	------------------	---------------	----------------------------------------

Indicator	Present?	Description	Relative Severity Index (1-3)
Odor	No	NA	NA
Turbidity	No	See Severity Index	NA
Floatables	No	NA	NA
Deposits/Stains	Yes	FlowLine	2
Poor Pool Quality	Yes	Floatables	2
Pipe Benthic Growth	No	NA	NA

Not suspected of an illicit discharge because the flow rate has been steady over the course of many years, there was no smell or turbidity, and investigation upstream could not determine a source. No changes to the flow were found upstream within the investigated reach or drainage area. Construction was found to be present in the contributing drainage area. Some trash present in outfall pool, it appears to be from people throwing over adjacent bridge edge and not necessarily from the outfalls flow, that is recommended to be removed. Riprap in outfall pool has been covered by concrete and is recommended to be corrected.

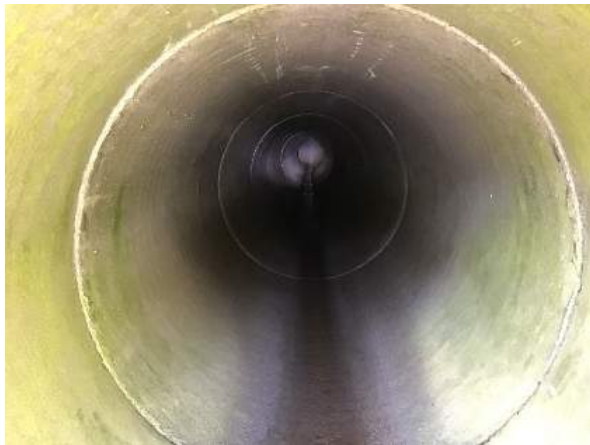
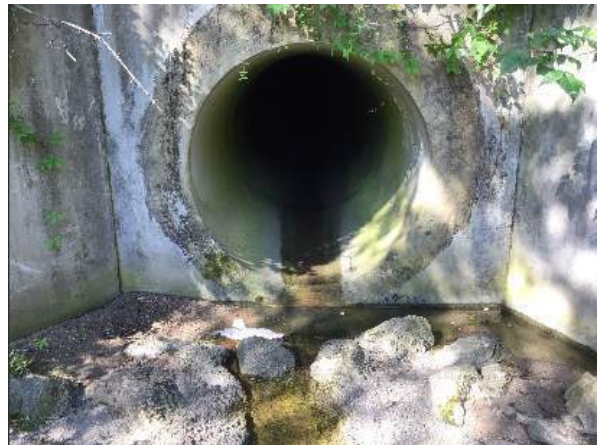
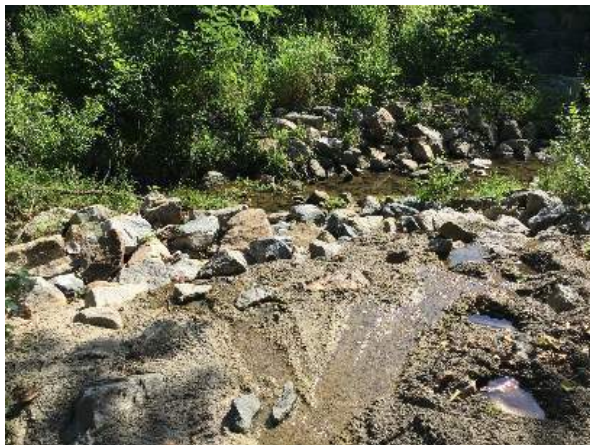
Outfall ID: 04	Date: 05/31/2022	Time: 09:21am	Inspector: Jessica Slagle & Hailey Fry
----------------	------------------	---------------	----------------------------------------

POTENTIAL POLLUTANT INDICATORS			
Indicator	Present?	Description	Relative Severity Index (1-3)
Odor	Yes	Rancid/sour	2
Turbidity	Yes	See Severity Index	2
Floatables	Yes	Trash	3
Deposits/Stains	Yes	Flowline, sediment, and debris	2
Poor Pool Quality	Yes	Odors, colors, excessive algae, floatables, oil sheen	2
Pipe Benthic Growth	Yes	Green	2

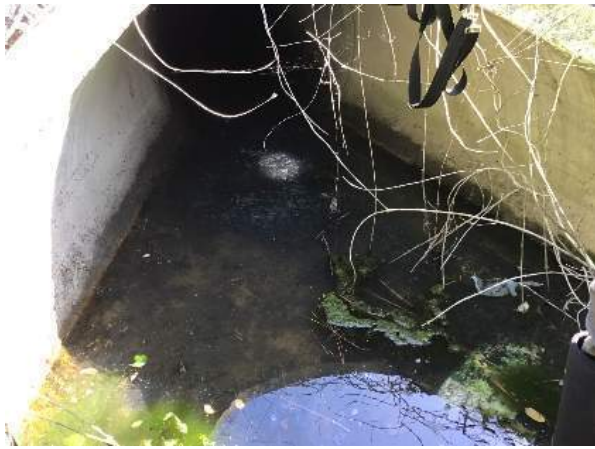
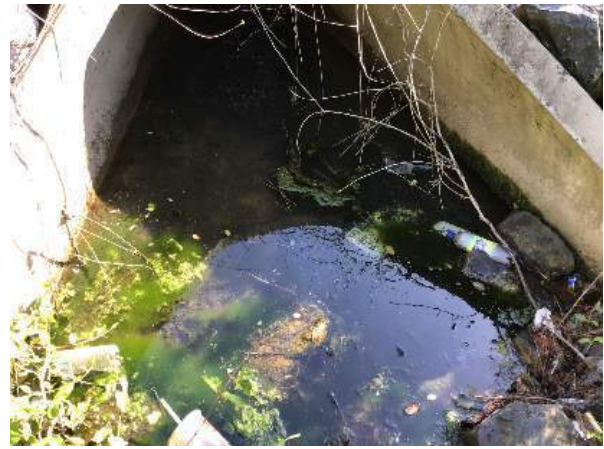
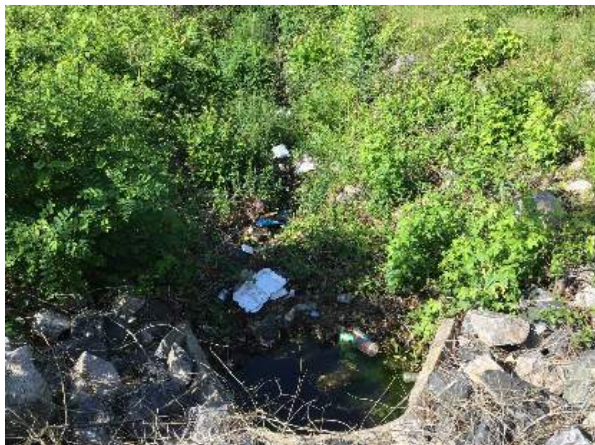
Outfall ID: 05	Date: 05/31/2022	Time: 09:13am	Inspector: Jessica Slagle & Hailey Fry
----------------	------------------	---------------	----------------------------------------

Indicator	Present?	Description	Relative Severity Index (1-3)
Odor	No	NA	NA
Turbidity	No	See Severity Index	NA
Floatables	No	NA	NA
Deposits/Stains	Yes	FlowLine, sediment, and trash	2
Poor Pool Quality	Yes	Riprap and debris block half of pipe	2
Pipe Benthic Growth	Yes	Brown	2

Notes:  
 Not suspected of an illicit discharge because the flow rate has been steady over the course of many years, there was no smell or turbidity, and investigation upstream could not determine a source. No changes to the flow were found upstream within the investigated reach or drainage area. Construction was found to be present in the contributing drainage area. Outfall is partially blocked by vegetation, sediment, and riprap/broken concrete which is recommended to be removed.

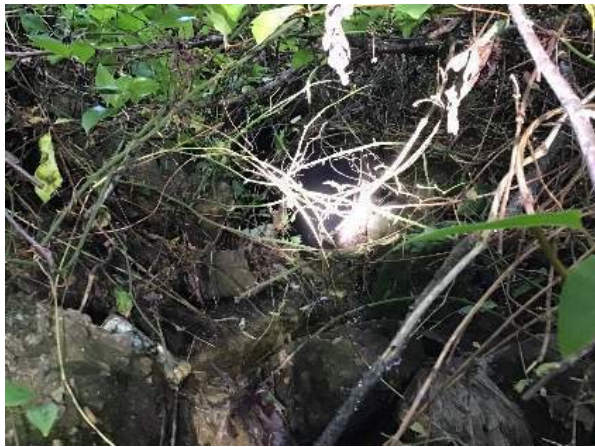
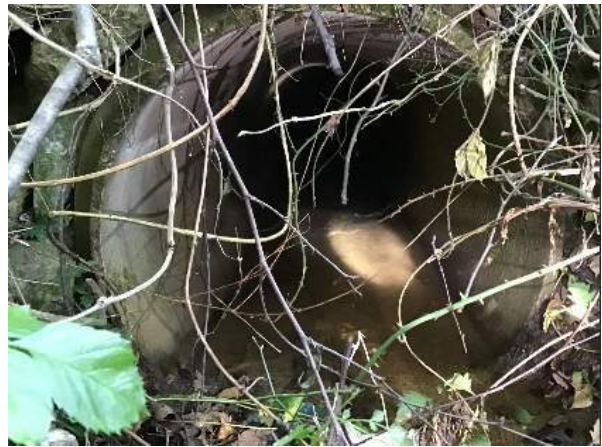
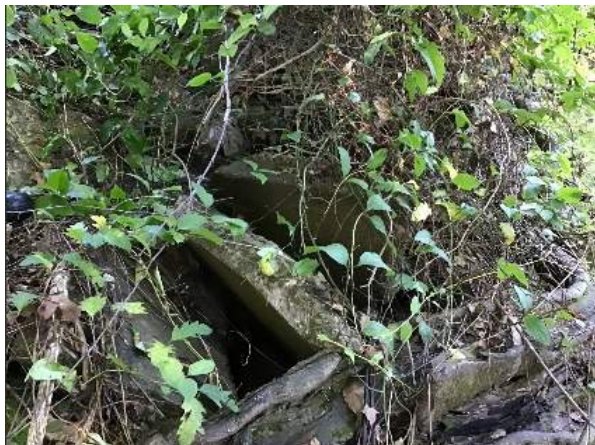
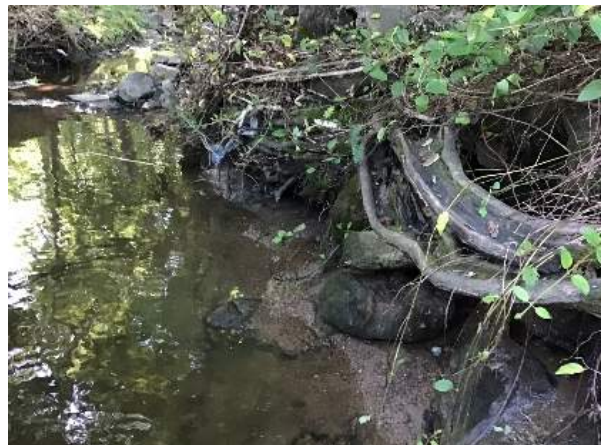
Outfall ID: 06	Date: 05/31/2022	Time: 09:31am	Inspector: Jessica Slagle & Hailey Fry
----------------	------------------	---------------	----------------------------------------

Indicator	Present?	Description	Relative Severity Index (1-3)
Odor	No	NA	NA
Turbidity	No	NA	NA
Floatables	No	NA	NA
Deposits/Stains	<b>Yes</b>	FlowLine, sediment, and debris	2
Poor Pool Quality	<b>Yes</b>	Moss, debris, and undercutting	2
Pipe Benthic Growth	No	NA	NA

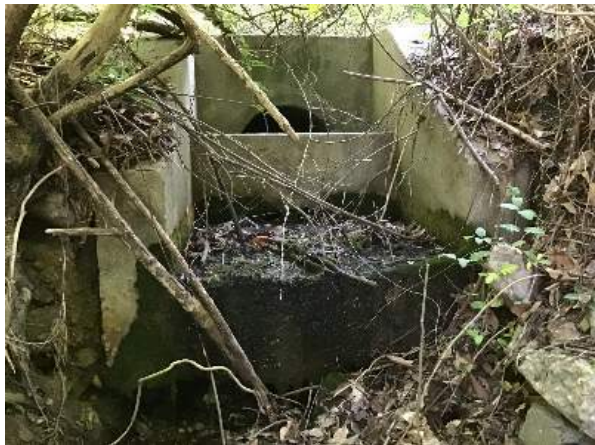
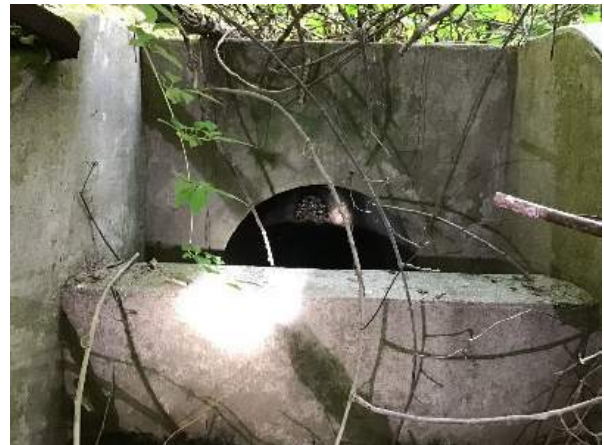
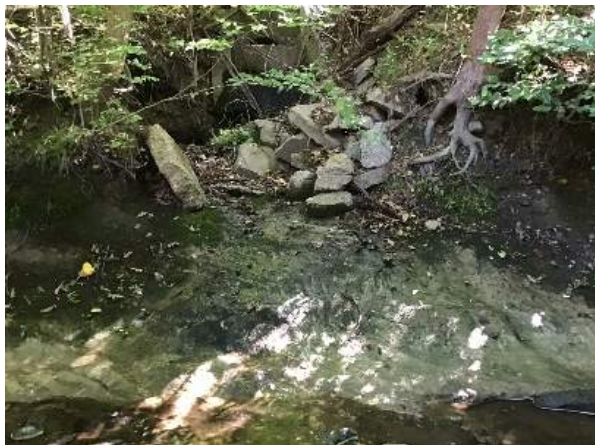
Outfall ID: 08	Date: 05/31/2022	Time: 9:44am	Inspector: Jessica Slagle & Hailey Fry
----------------	------------------	--------------	----------------------------------------

Indicator	Present?	Description	Relative Severity Index (1-3)
Odor	No	NA	NA
Turbidity	No	See Severity Index	NA
Floatables	No	NA	NA
Deposits/Stains	Yes	FlowLine and sediment	2
Poor Pool Quality	Yes	Floatables, trash, sediment, and debris	2
Pipe Benthic Growth	No	NA	NA

**Notes:**  
 The pipe looked clear of illicit discharge indicator. Despite hearing flow nothing was observed. The pipe has become disconnected from the flume and is likely disjointed further upstream as well. It is recommended CCTV be used to determine locations of broken joints and have them repaired to prevent further erosion and outfall failure.

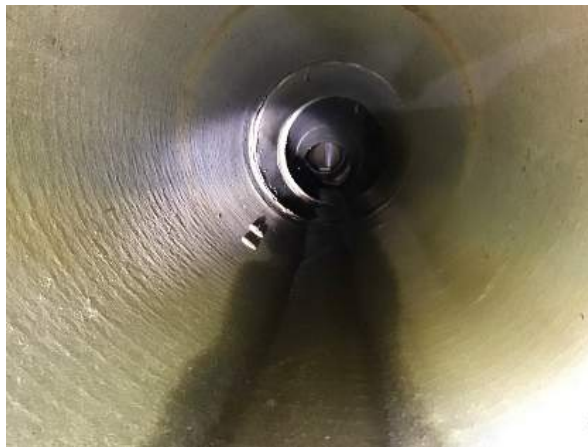
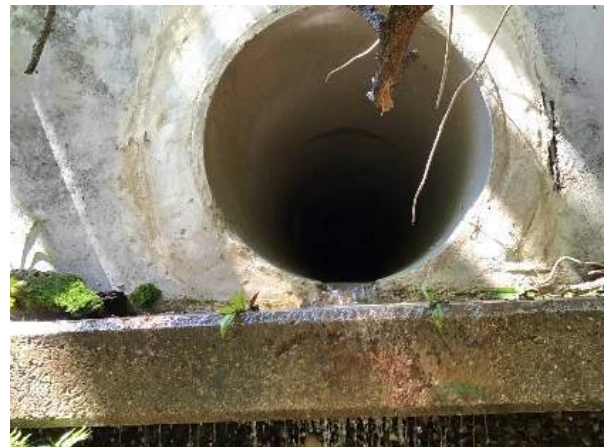
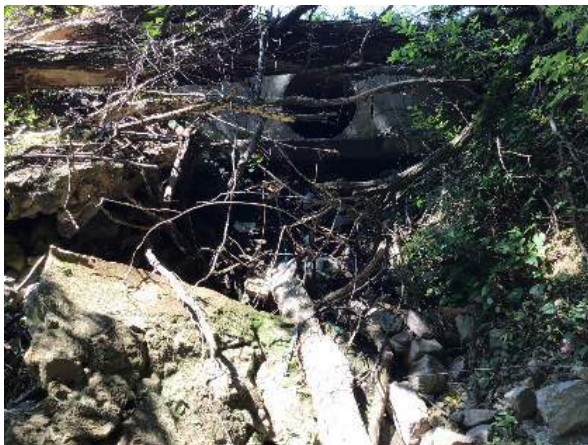
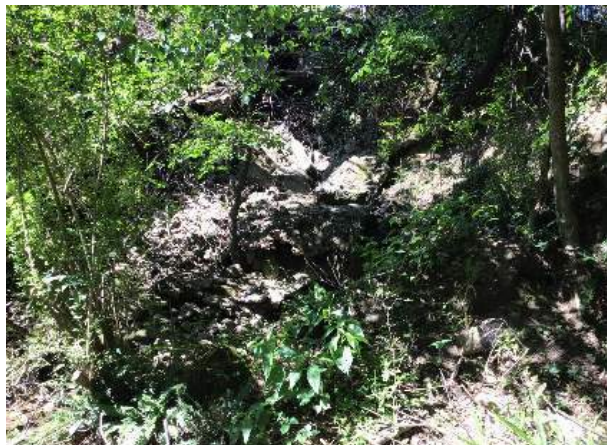
Outfall ID: 10	Date: 05/31/2022	Time: 10:46am	Inspector: Jessica Slagle & Hailey Fry
----------------	------------------	---------------	----------------------------------------

Indicator	Present?	Description	Relative Severity Index (1-3)
Odor	No	NA	NA
Turbidity	Yes	See Severity Index	2
Floatables	Yes	Sheen, suds	2
Deposits/Stains	Yes	FlowLine	2
Poor Pool Quality	No	NA	NA
Pipe Benthic Growth	Yes	Orange	2

Not suspected of an illicit discharge because the flow rate has been steady over the course of many years. It is important to note this is the outfall to an upstream BMP (BMP #30). The BMP has noted excessive duckweed. It is suspected the excessive duckweed indicates the pond likely has turned it anaerobic. Construction was found to be present in the contributing drainage area. Headwall of pipe is beginning to erode.

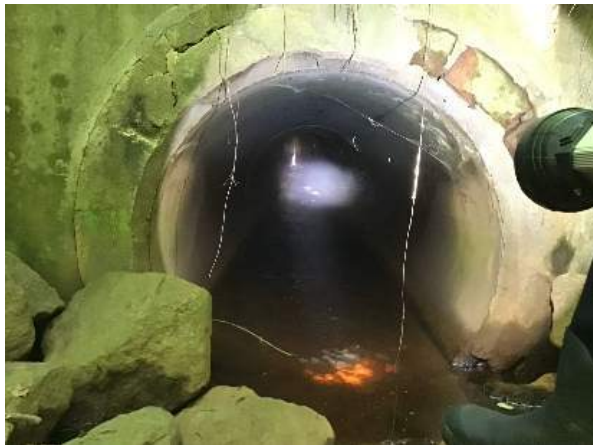
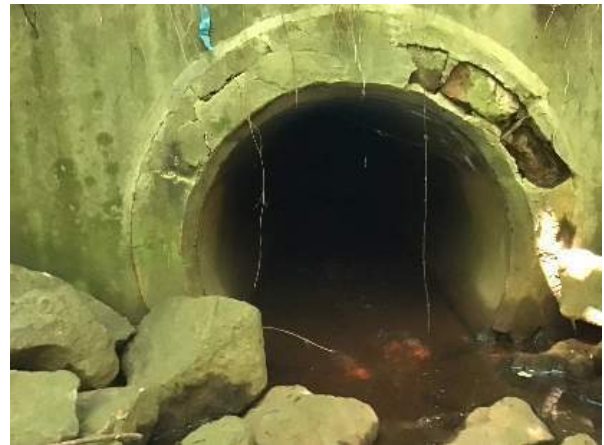
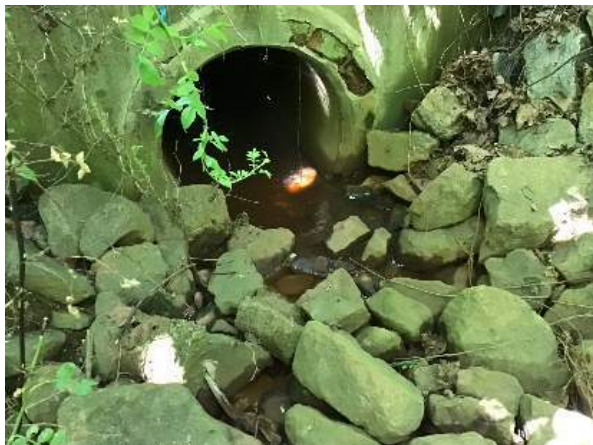
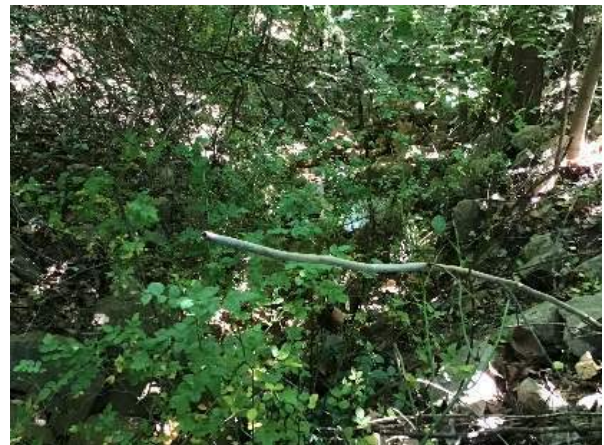
Outfall ID: 11	Date: 05/31/2022	Time: 11:11am	Inspector: Jessica Slagle & Hailey Fry
----------------	------------------	---------------	----------------------------------------

Indicator	Present?	Description	Relative Severity Index (1-3)
Odor	No	NA	NA
Turbidity	No	See Severity Index	NA
Floatables	No	NA	NA
Deposits/Stains	Yes	FlowLine	2
Poor Pool Quality	Yes	Floatables, and debris	2
Pipe Benthic Growth	No	NA	NA

The pipe looked clear of both flow and illicit discharge indicators. It is recommended the outfall be cleared of tree branches and debris currently obstructing the outfall.

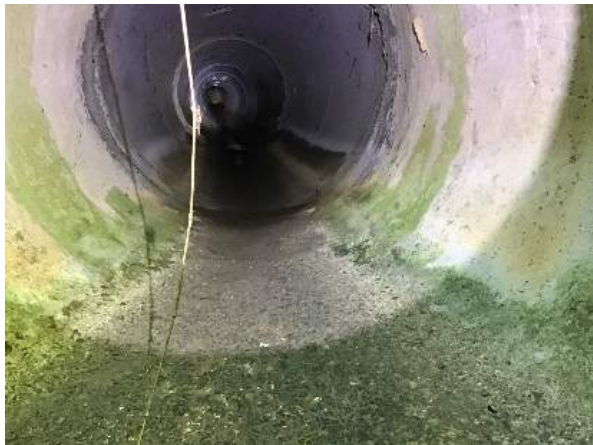
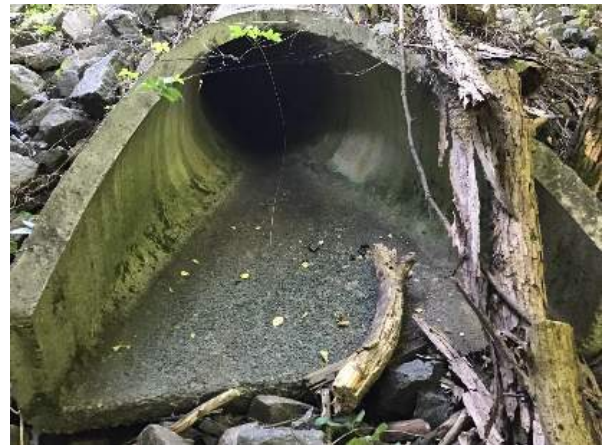
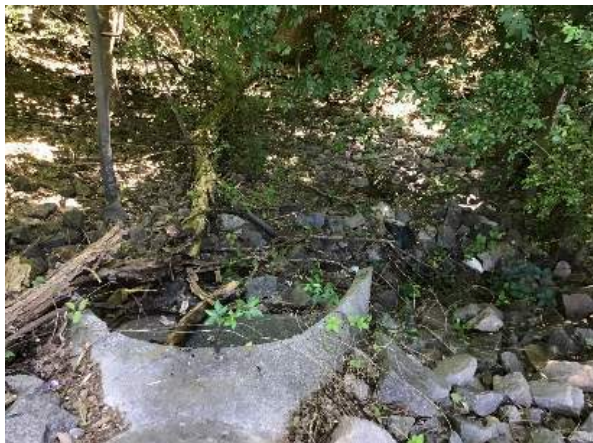
Outfall ID: 12	Date: 05/31/2022	Time: 11:25am	Inspector: Jessica Slagle & Hailey Fry
----------------	------------------	---------------	----------------------------------------

Indicator	Present?	Description	Relative Severity Index (1-3)
Odor	No	NA	NA
Turbidity	No	See Severity Index	NA
Floatables	No	NA	NA
Deposits/Stains	No	NA	NA
Poor Pool Quality	Yes	Floatables and some riprap blocking pipe	2
Pipe Benthic Growth	No	NA	NA

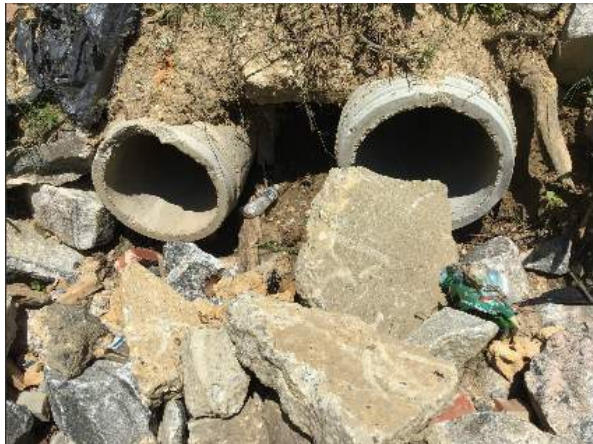
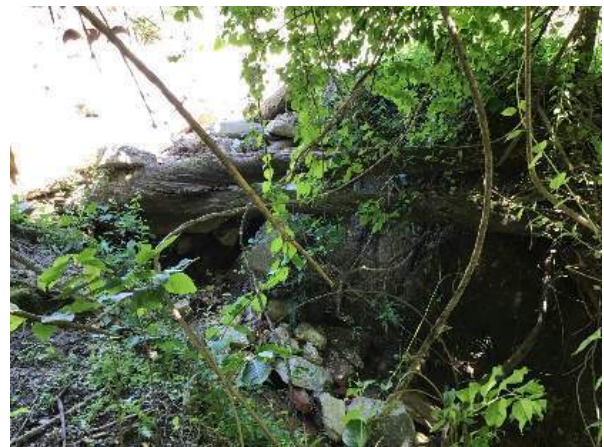
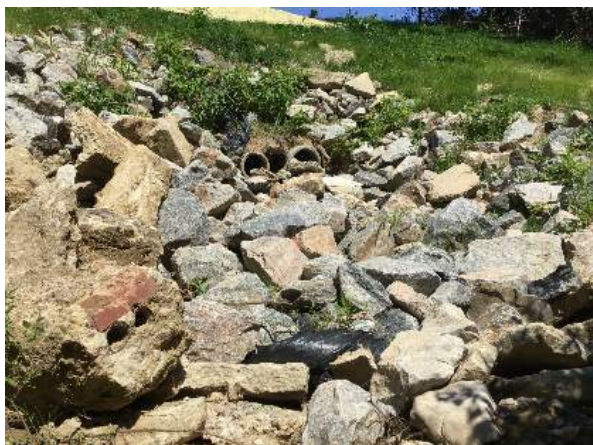
Outfall ID: 14	Date: 05/31/2022	Time: 11:39am	Inspector: Jessica Slagle & Hailey Fry
----------------	------------------	---------------	----------------------------------------

Indicator	Present?	Description	Relative Severity Index (1-3)
Odor	No	NA	NA
Turbidity	No	See Severity Index	NA
Floatables	No	NA	NA
Deposits/Stains	<b>Yes</b>	Sediment	2
Poor Pool Quality	<b>Yes</b>	Landscape debris, construction debris, channelized	2
Pipe Benthic Growth	No	NA	NA

**Notes:**  
 Not suspected of an illicit discharge because the flow rate has been steady over the course of many years, there was no smell or turbidity, and investigation upstream could not determine a source. No changes to the flow were found upstream within the investigated reach or drainage area. Construction was found to be present in the contributing drainage area. Pipe is partially submerged and filled with sediment. Some trash, debris and vegetation is present in the outfall pool that is recommended to be removed. Channelization is occurring just downstream of outfall pool which may require stabilization in the future.

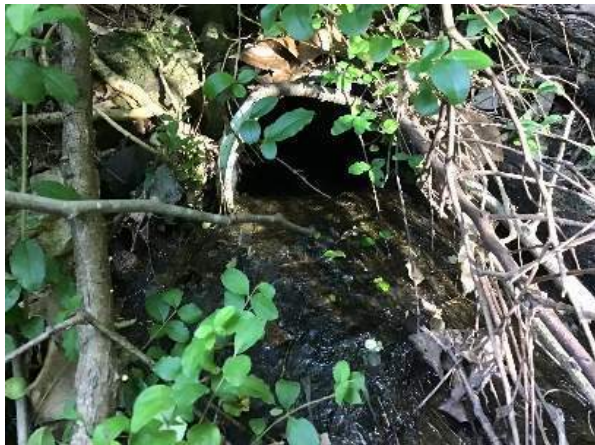
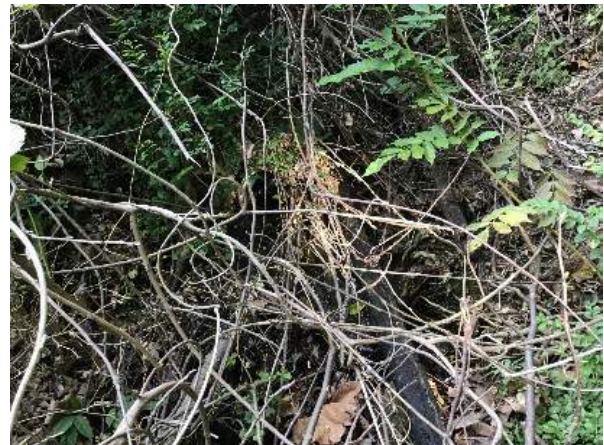
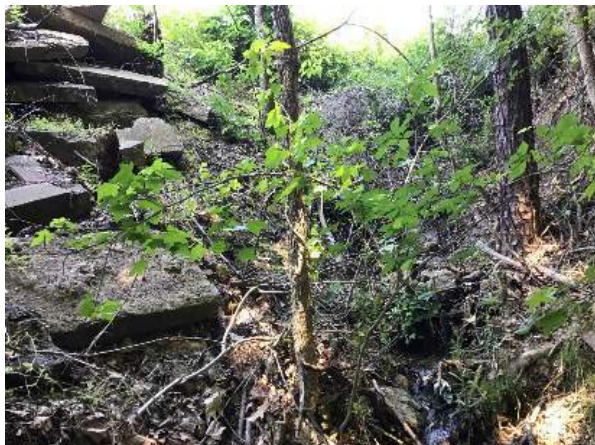
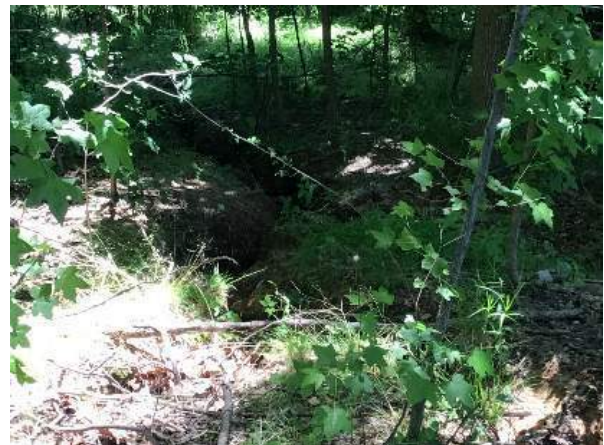
Outfall ID: 16	Date: 05/31/2022	Time: 11:53am	Inspector: Jessica Slagle & Hailey Fry
----------------	------------------	---------------	----------------------------------------

Indicator	Present?	Description	Relative Severity Index (1-3)
Odor	No	NA	NA
Turbidity	No	See Severity Index	NA
Floatables	No	NA	NA
Deposits/Stains	<b>Yes</b>	Sediment	2
Poor Pool Quality	<b>Yes</b>	Floatables, debris and sediment	2
Pipe Benthic Growth	No	NA	NA

The pipe looked clear of both flow and illicit discharge indicators. There was a significant amount of sediment buildup in the pipe as well as in the outfall pool. It is recommended the sediment, trash and landscape debris be removed from the pipe as well as the outfall pool.

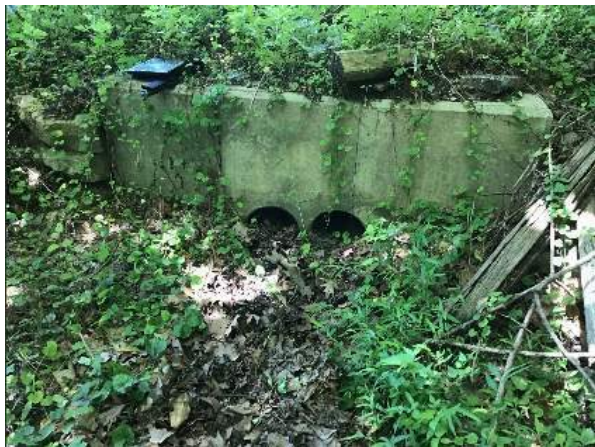
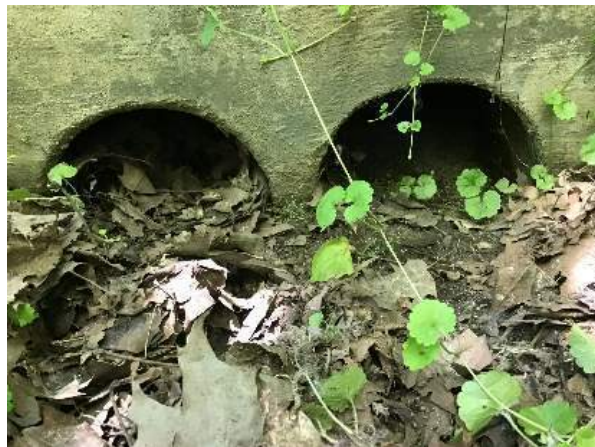
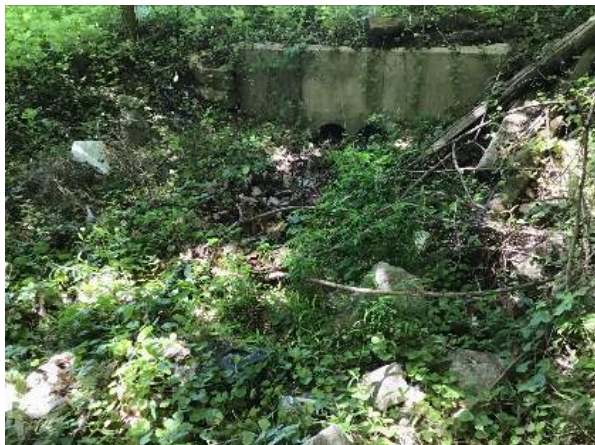
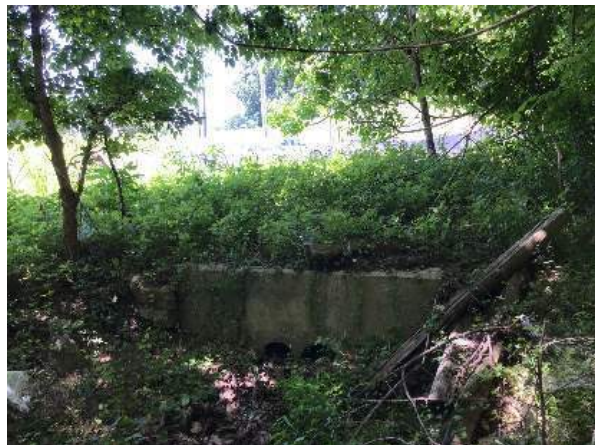
Outfall ID: 17	Date: 05/31/2022	Time: 12:31pm	Inspector: Jessica Slagle & Hailey Fry
----------------	------------------	---------------	----------------------------------------

Indicator	Present?	Description	Relative Severity Index (1-3)
Odor	No	NA	NA
Turbidity	No	See Severity Index	NA
Floatables	No	NA	NA
Deposits/Stains	Yes	FlowLine	2
Poor Pool Quality	Yes	Floatables and pieces of broken pipe	2
Pipe Benthic Growth	No	NA	NA

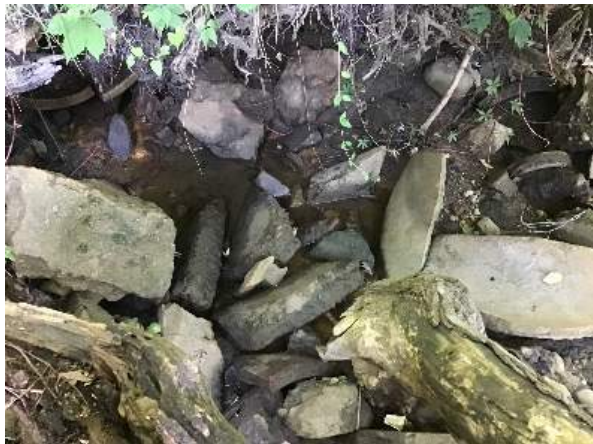
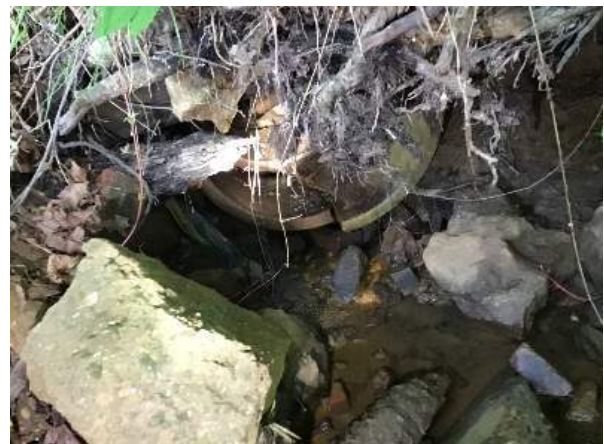
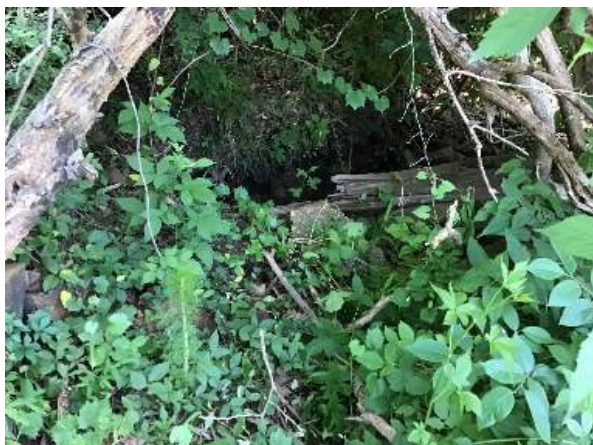
Outfall ID: 18	Date: 05/31/2022	Time: 12:43pm	Inspector: Jessica Slagle & Hailey Fry
----------------	------------------	---------------	----------------------------------------

Outfall 18 was located along the Appomattox River, and extremely difficult to access due to excessive vegetation. The outfall was crushed by multiple tree branches and roots, it is recommended it be restored. Not suspected of an illicit discharge because the flow rate has been steady over the course of many years, there was no smell or turbidity, and investigation upstream lead to conversation with maintenance staff, Kenny. Based on maintenance investigation it is believed that there is a water main break at the round-a-bout where College Ave and Hayden St meet. Changes to the flow were found upstream between College Ave and Hayden St structures. Construction was found to be present in the contributing drainage area.

Indicator	Present?	Description	Relative Severity Index (1-3)
Odor	No	NA	NA
Turbidity	No	See Severity Index	NA
Floatables	No	NA	NA
Deposits/Stains	<b>Yes</b>	Trash, debris and sediment	2
Poor Pool Quality	<b>Yes</b>	Floatables and debris	2
Pipe Benthic Growth	No	NA	NA

**Notes:**  
 The pipe looked clear of both flow and illicit discharge indicators. It is recommended the outfall be cleared of vegetation, trash and sediment in the area.

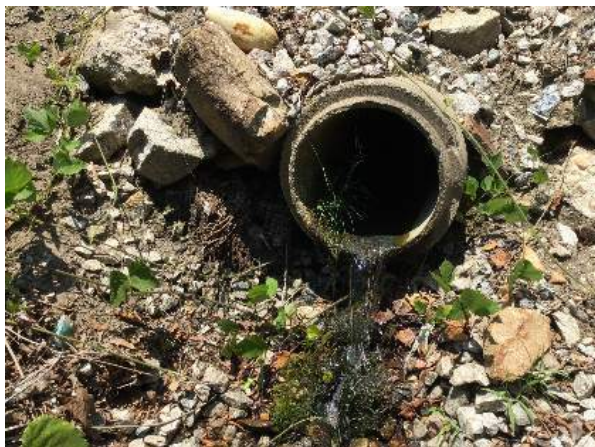
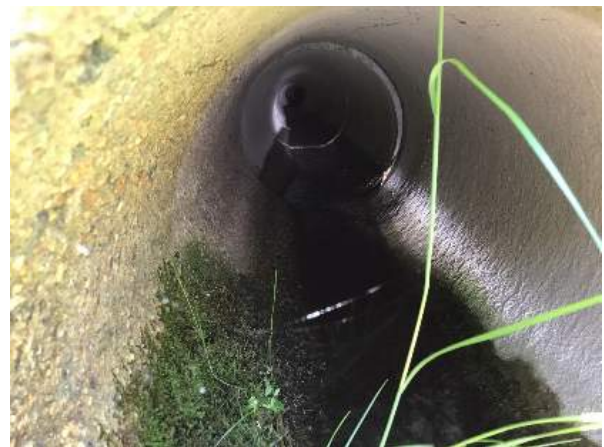
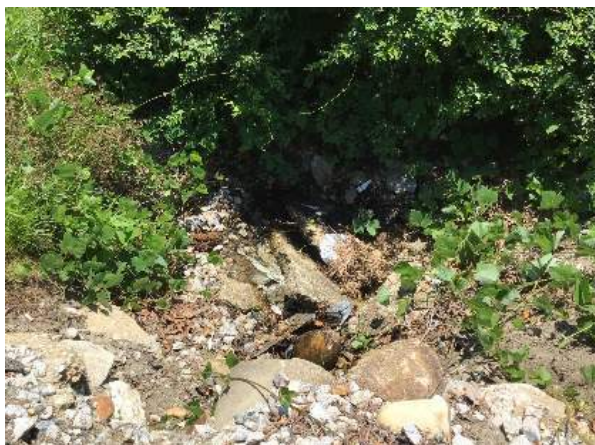
Outfall ID: 22	Date: 05/31/2022	Time: 01:21pm	Inspector: Jessica Slagle & Hailey Fry
----------------	------------------	---------------	----------------------------------------

Indicator	Present?	Description	Relative Severity Index (1-3)
Odor	No	NA	NA
Turbidity	No	See Severity Index	NA
Floatables	No	NA	NA
Deposits/Stains	Yes	Flowline	2
Poor Pool Quality	Yes	Floatables, debris, and vegetation	2
Pipe Benthic Growth	No	NA	NA

Notes:  
 The pipe looked clear of both flow and illicit discharge indicators. It is recommended that the current rip rap be relocated to ensure it is not above the pipe invert.

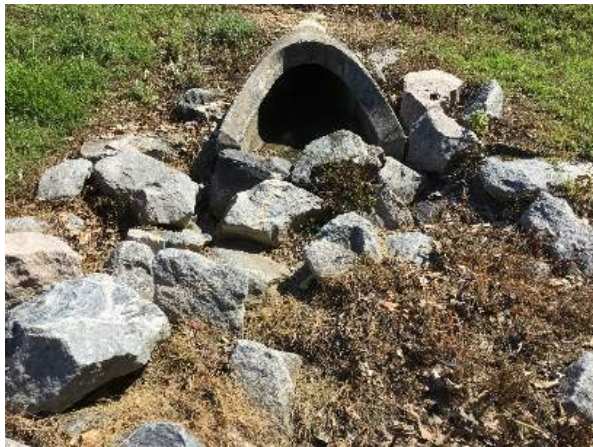
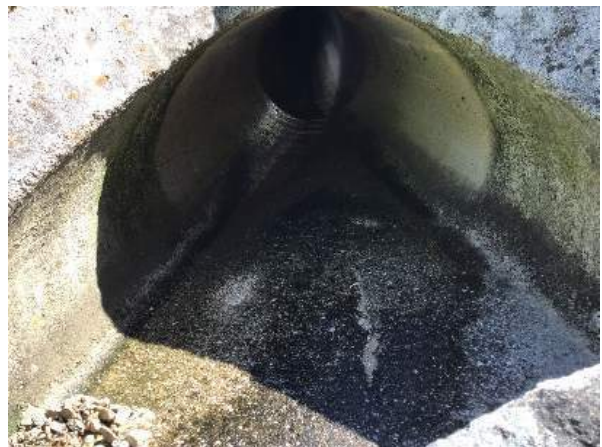
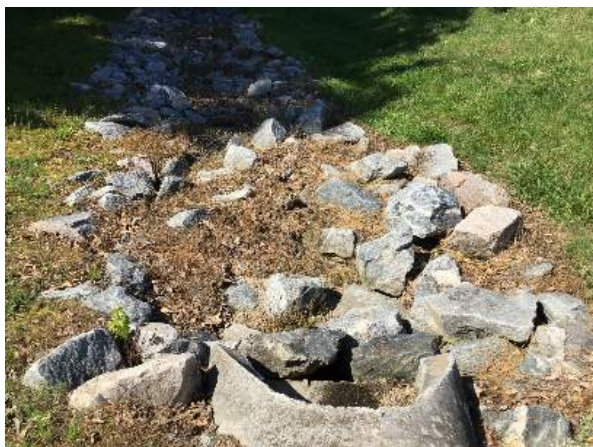
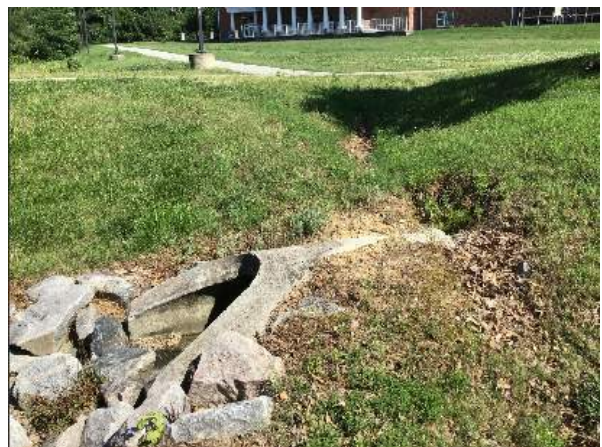
Outfall ID: 24	Date: 05/31/2022	Time: 09:59am	Inspector: Jessica Slagle & Hailey Fry
----------------	------------------	---------------	----------------------------------------

Indicator	Present?	Description	Relative Severity Index (1-3)
Odor	No	NA	NA
Turbidity	No	See Severity Index	NA
Floatables	No	NA	NA
Deposits/Stains	Yes	Flowline	2
Poor Pool Quality	No	NA	NA
Pipe Benthic Growth	Yes	Green	2

**Notes:**  
 Not suspected of an illicit discharge because the flow rate has been steady over the course of many years, there was no smell or turbidity, and investigation upstream could not determine a source. No changes to the flow were found upstream within the investigated reach or drainage area. Construction was found to be present in the contributing drainage area.

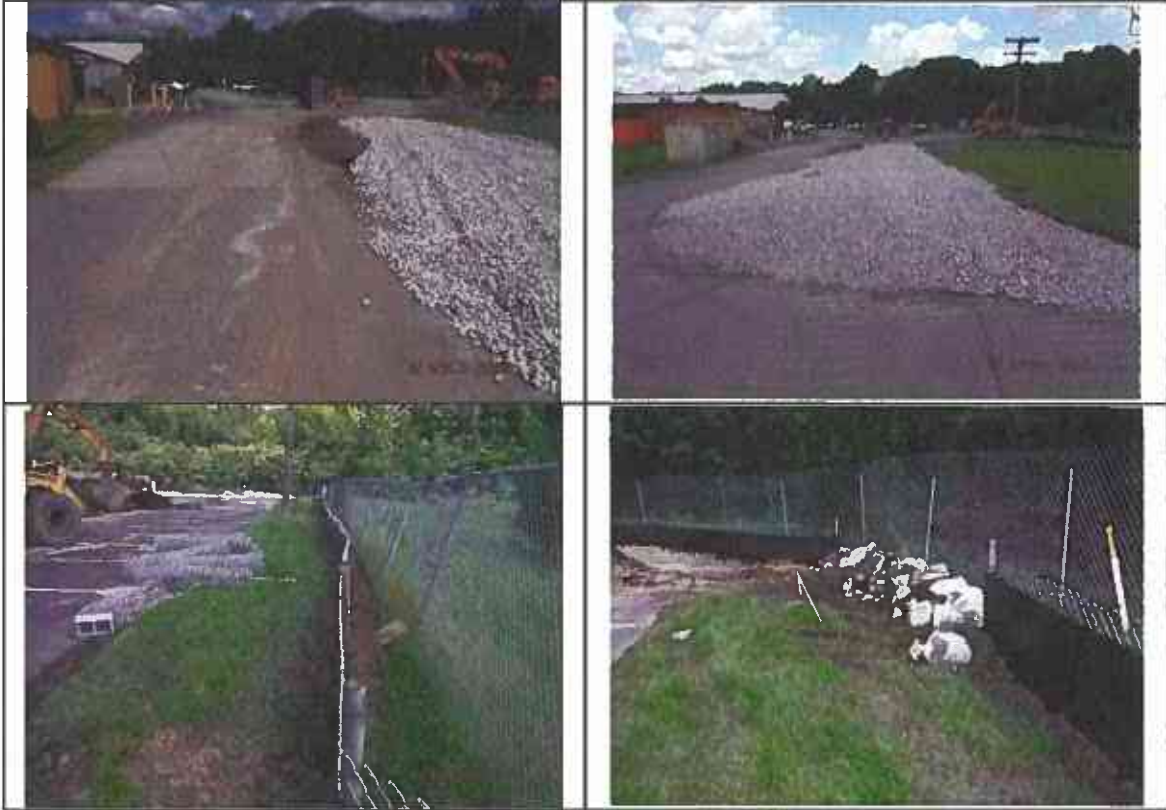
Item#	State/Local Regulation(1)	Violation		Description and Location of Problem/Violation(2), Required or Recommended Corrective Actions, and Other Comments/Notes
		Initial	Repeat	
1	Std. 3.02			Add additional stone to small grass area between CE & existing pavement. Some tracking observed and will be an issue going forward.
2				
3				
4

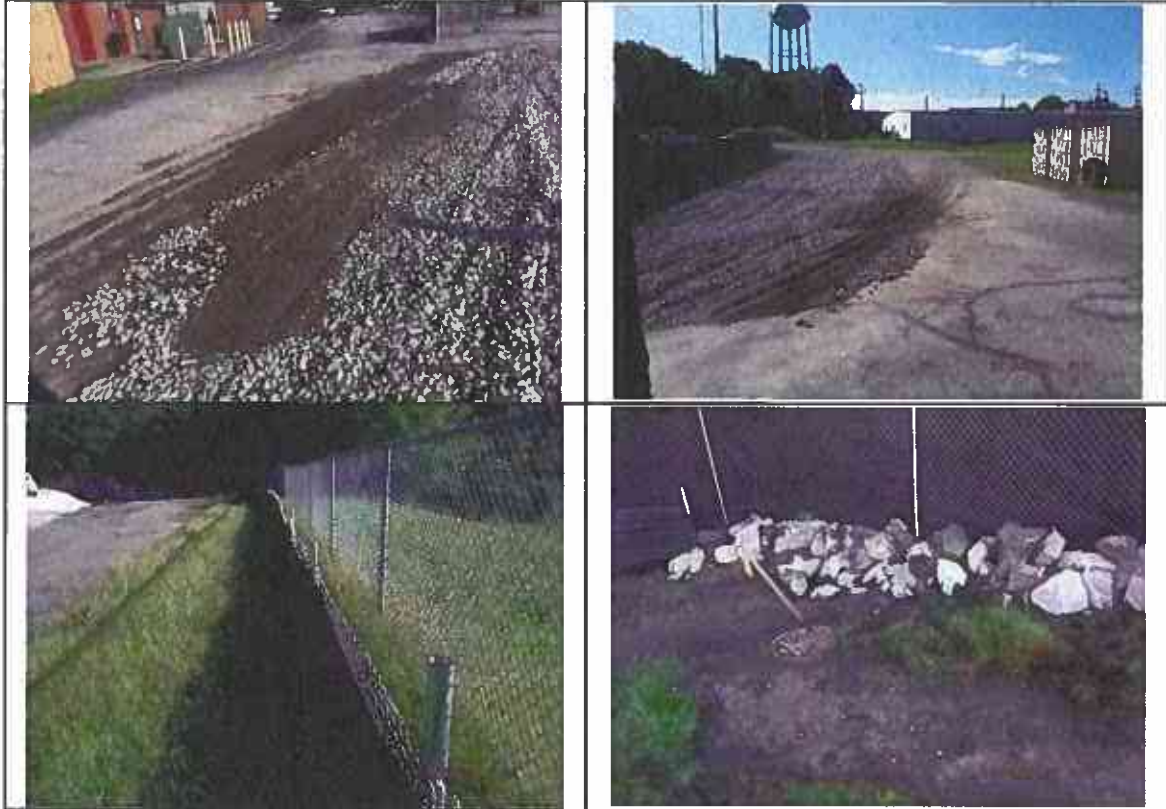
Item#	State/Local Regulation(1)	Violation		Description and Location of Problem/Violation(2), Required or Recommended Corrective Actions, and Other Comments/Notes
		Initial	Repeat	
1	Std. 3.02			Add additional stone to small grass area between CE & existing pavement. Some tracking observed on roadway and this will be an issue going forward.
2				
3				
4

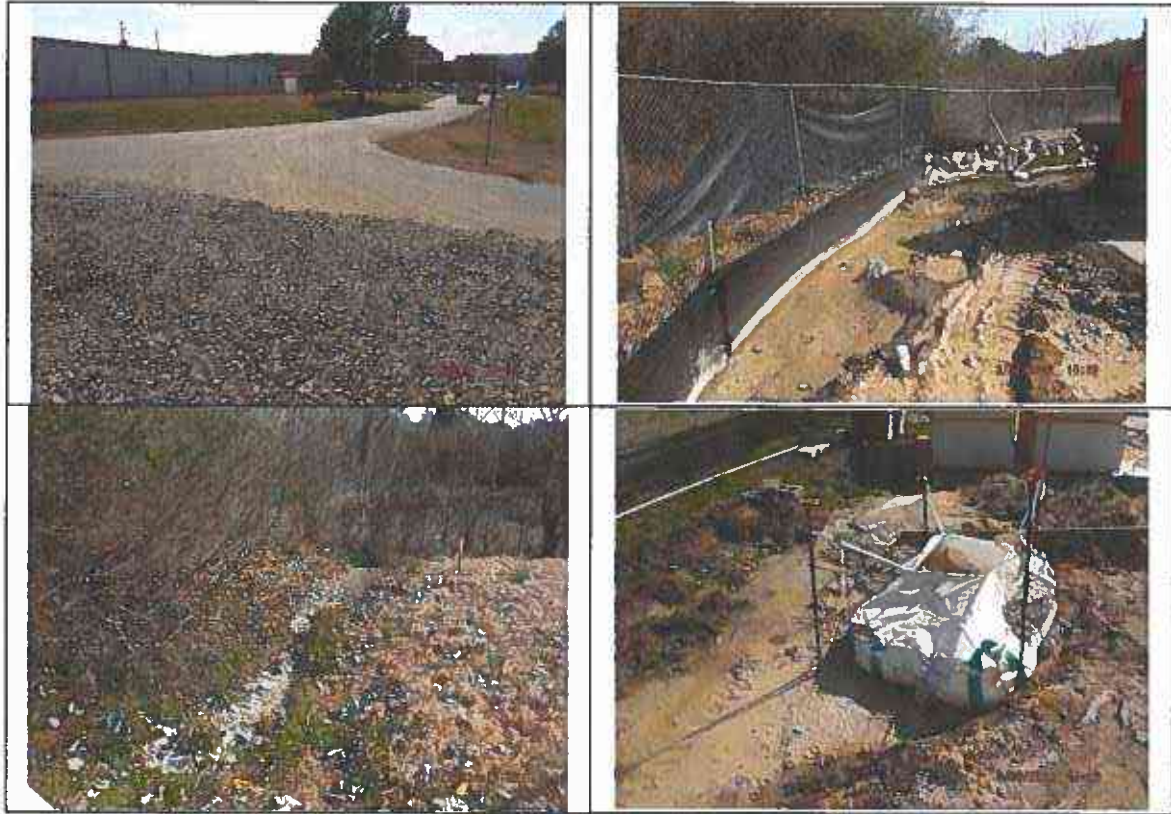
Item#	State/Local Regulation(1)	Violation		Description and Location of Problem/Violation(2), Required or Recommended Corrective Actions, and Other Comments/Notes
		Initial	Repeat	
1	9VAC25-870-56			Excess trash observed along site perimeter and near adjacent stormwater basin. Ensure all trash is disposed of in dumpsters.
2	MS-17			Sediment tracking observed on roadway. Either additional CE stone is needed or regular street sweeping is needed.
3				
4

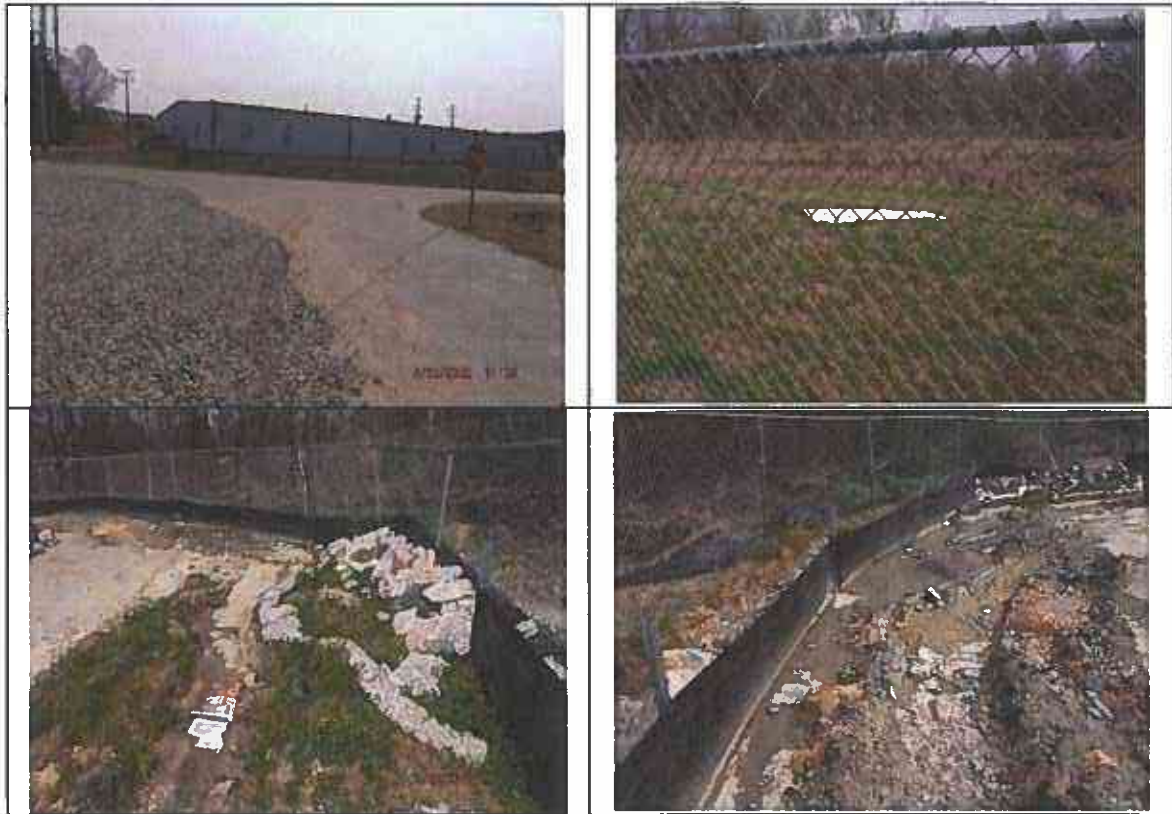
Item#	State/Local Regulation(1)	Violation		Description and Location of Problem/Violation(2), Required or Recommended Corrective Actions, and Other Comments/Notes
		Initial	Repeat	
1	9VAC25-870-56	3/22	3/29	Excess trash observed along site perimeter and near adjacent stormwater basin. Ensure all trash is disposed of in dumpsters.
2				
3				
4
