**Virginia State University**  
**MS-4 Permit: VAR040119**  
**July 1, 2021 - June 30, 2022 Annual Report**

Prepared for  
**Virginia State University**  
Capital Outlay & Facilities Management  
PO Box 9414  
Virginia State University, VA 23806

October 1, 2022

Prepared by: Timmons Group  
1001 Boulders Parkway, Suite 300  
Richmond, VA 23225  
(804) 200-6500

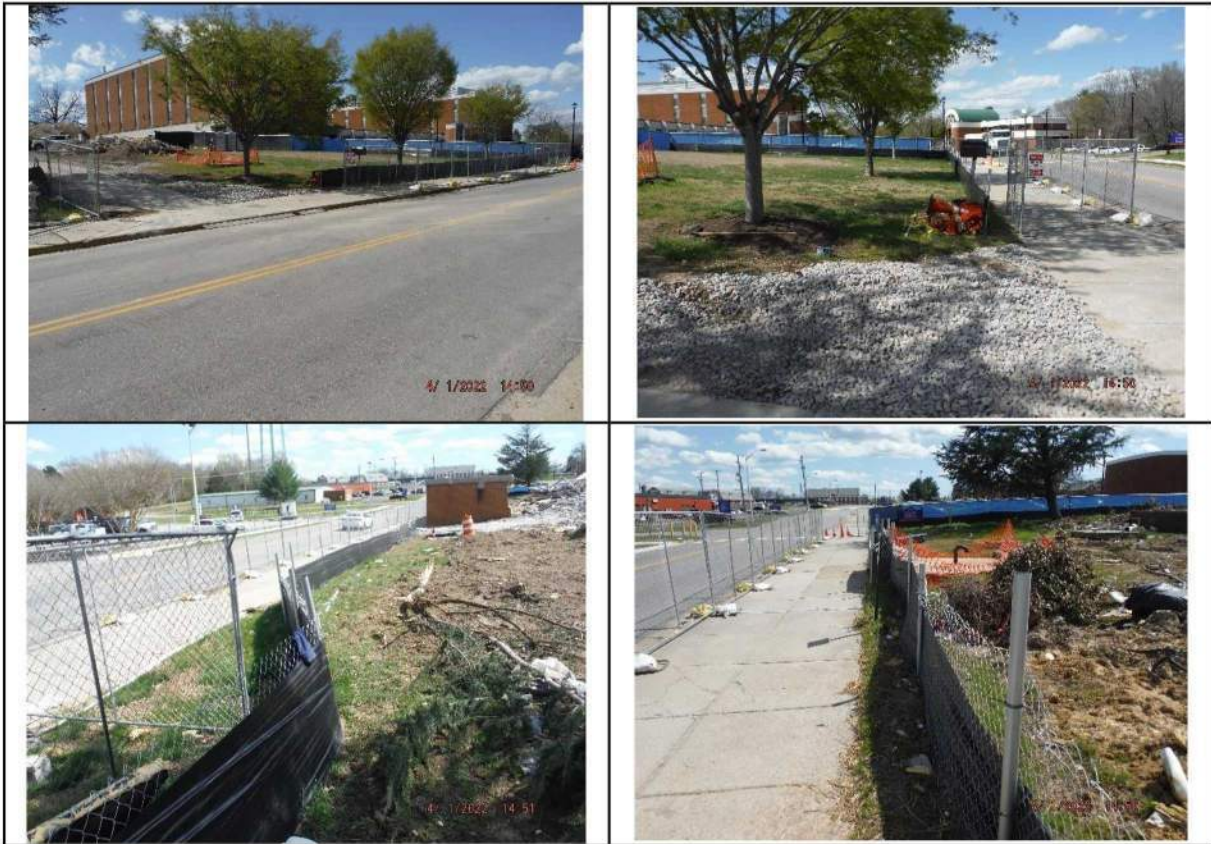
Item#	State/Local Regulation(1)	Violation		Description and Location of Problem/Violation(2), Required or Recommended Corrective Actions, and Other Comments/Notes
		Initial	Repeat	
1	9VAC25-870-56	3/22	3/29 4/1	Excess trash observed along site perimeter and near adjacent stormwater basin. Ensure all trash is disposed of in dumpsters.
2	MS-17	4/1		Sediment tracking observed on roadway. Either additional CE stone is needed or regular street sweeping is needed.
3				
4

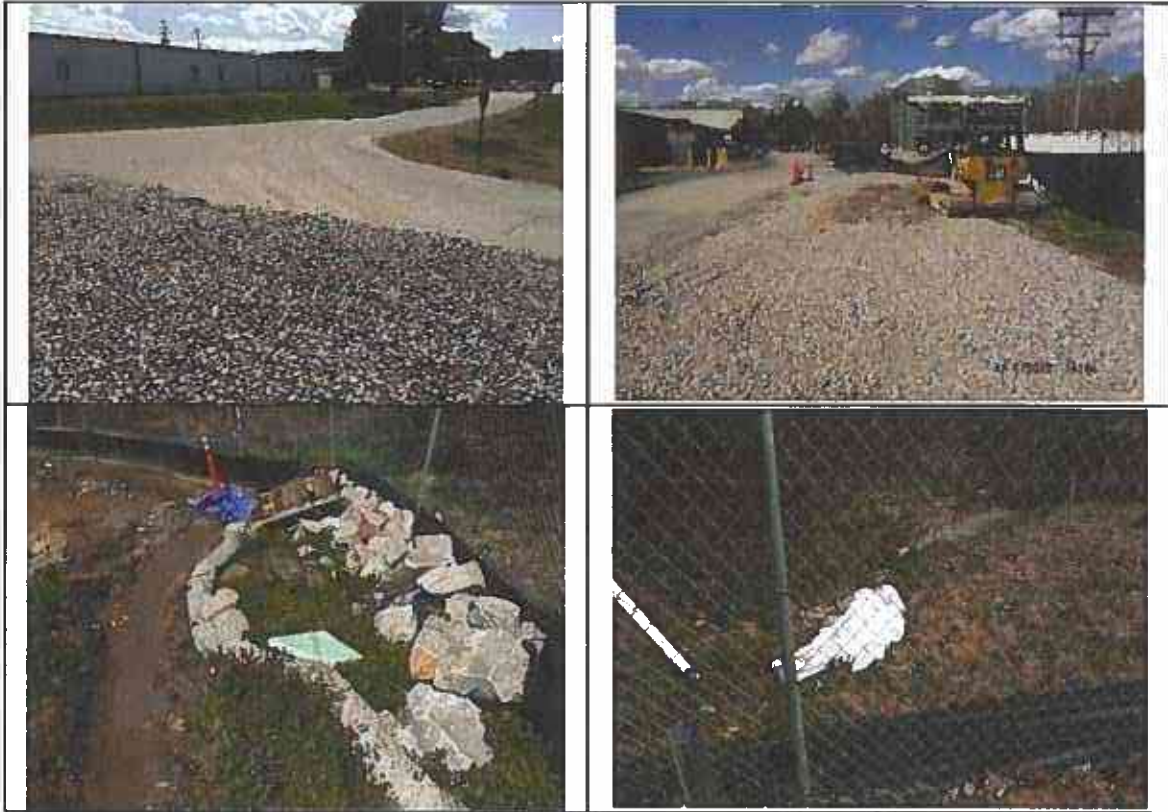
Item#	State/Local Regulation(1)	Violation <b>x3</b>		Description and Location of Problem/Violation(2), Required or Recommended Corrective Actions, and Other Comments/Notes
		Initial	Repeat	
1	9VAC25-870-56	3/22	3/29 4/1 4/8	Excess trash observed along site perimeter and near adjacent stormwater basin. Ensure all trash is disposed of in dumpsters.
2	MS-2	4/8		Soil stockpiles need additional stabilization.
3	MS-8&9	4/8		Erosional rill needs stabilization prior to entering Flexmat
4	9VAC25-870-56	4/8		Concrete should be contained within washouts. Washouts need to be emptied or replaced

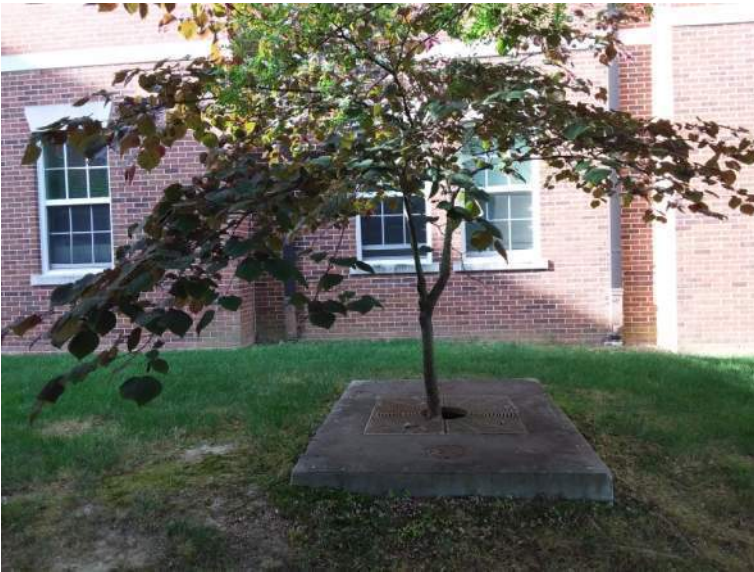
BMP #4- overall

Notes: BMP #4 appeared to be functioning in degraded condition during the time of inspection. We found an excessive amount of sediment, trash and debris inside this filterra unit. Remove all accumulated sediment, trash and debris from filterra and install a new 3" mulch layer.

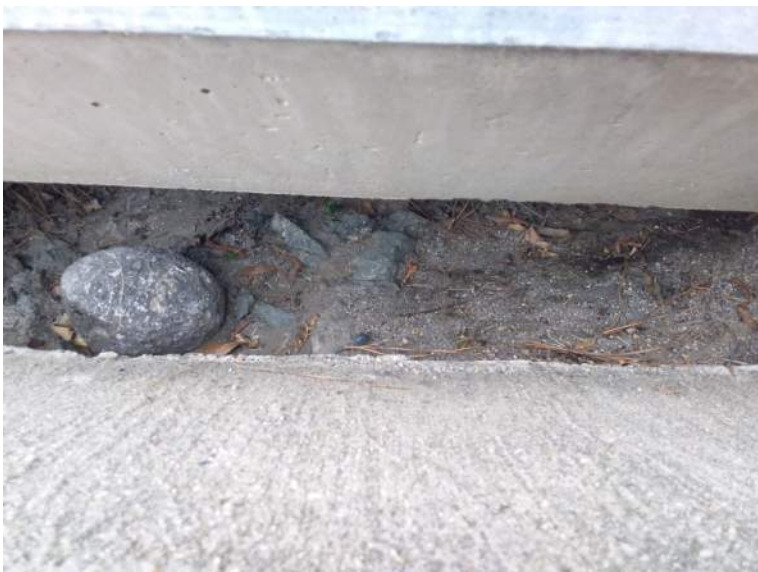
BMP #41- Overall

**Notes:** BMP #41 appeared to be functioning in degraded condition during the time of inspection. We found an excessive amount of sediment, trash and debris inside this filterra unit. Remove all accumulated sediment, trash and debris from filterra and install a new 3" mulch layer. Remove all inlet energy dissipater stones from throat/inlet and clean and replace.

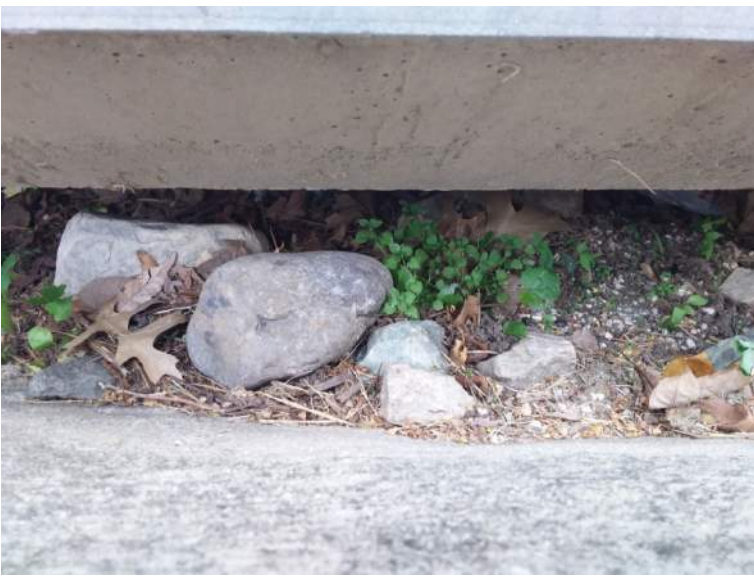
BMP #42- overall

Notes: BMP #42 appeared to be functioning in degraded condition during the time of inspection. We found an excessive amount of sediment, trash and debris inside this filterra unit. Remove all accumulated sediment, trash and debris from filterra and install a new 3" mulch layer. Remove all inlet energy dissipater stones from throat/inlet and clean and replace.

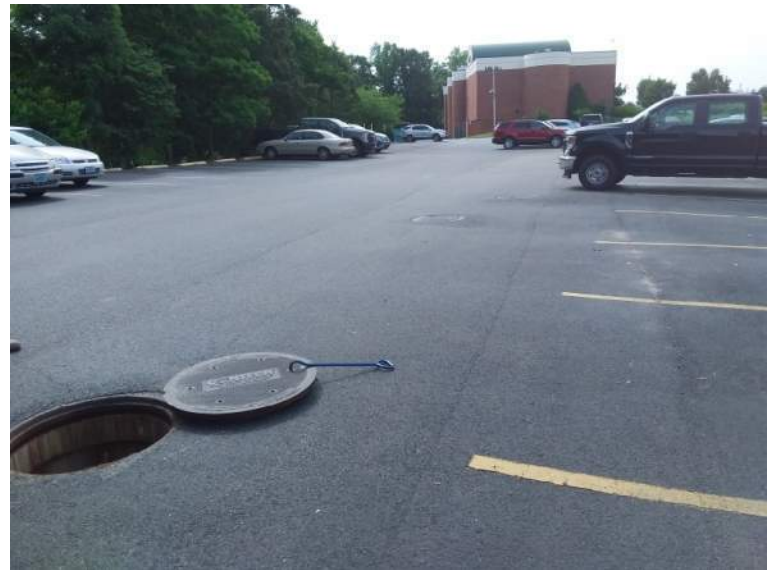
BMP #35- inlet pipe needs to be mortared

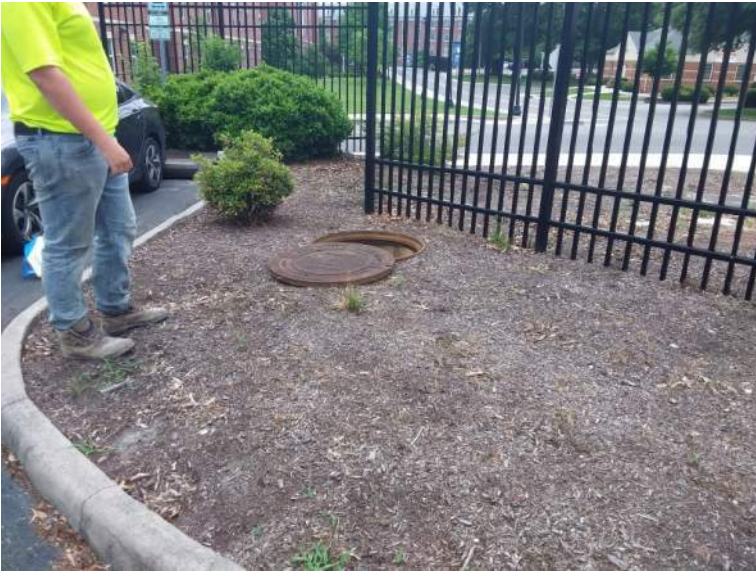
BMP #32- overall

<b>Inspector Name:</b>				<b>Type of BMP:</b>		
<b>BMP ID #: 32</b>				<b>Date/Time:</b>		
				<b>Maintenance required?</b>		
<b>Component:</b>	<b>Yes</b>	<b>No</b>	<b>Conditions When Maintenance is Needed</b>	<b>Yes</b>	<b>No</b>	<b>Comments:</b>
The access manhole or access doors are functioning properly and are structurally sound						
Sediment and oil are present (provide depths)						
Floatable pollutant accumulation is present in the Pre-treatment Bay						
The Cartridge Bay is visually inspected for sediment depth (provide depth)*(If sediment depth is greater than 6 inches, maintenance is required						
Proper draindown is occurring in the Cartridge Bay *(If at least 40 hours of dry weather have elapsed, since the most recent runoff event and the Bay contains more than 3 inches of water above the sediment layer, the Sorbtive BRICKs required cleaning or replacement						
The internal components show no signs of damage

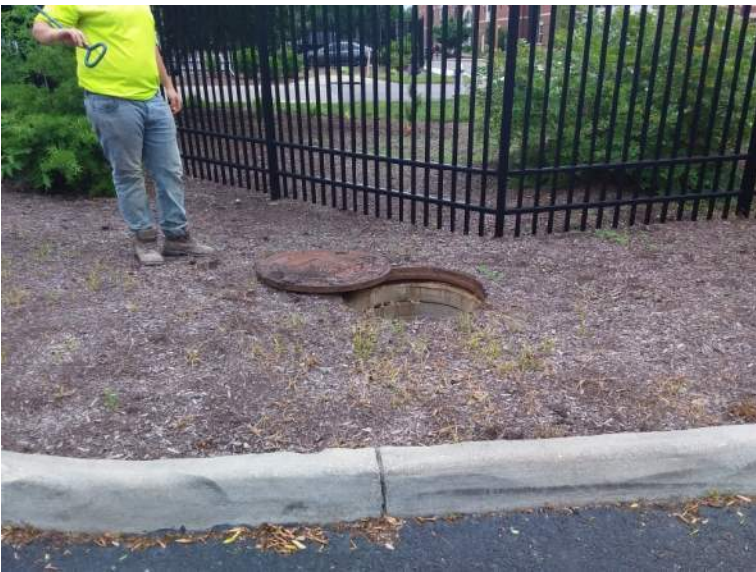
BMP #33- overall

<b>Inspector Name:</b>				<b>Type of BMP:</b>		
<b>BMP ID #: 33</b>				<b>Date/Time:</b>		
				<b>Maintenance required?</b>		
<b>Component:</b>	<b>Yes</b>	<b>No</b>	<b>Conditions When Maintenance is Needed</b>	<b>Yes</b>	<b>No</b>	<b>Comments:</b>
The access manhole or access doors are functioning properly and are structurally sound						
Sediment and oil are present (provide depths)						
Floatable pollutant accumulation is present in the Pre-treatment Bay						
The Cartridge Bay is visually inspected for sediment depth (provide depth)*(If sediment depth is greater than 6 inches, maintenance is required						
Proper draindown is occurring in the Cartridge Bay *(If at least 40 hours of dry weather have elapsed, since the most recent runoff event and the Bay contains more than 3 inches of water above the sediment layer, the Sorbtive BRICKs required cleaning or replacement						
The internal components show no signs of damage

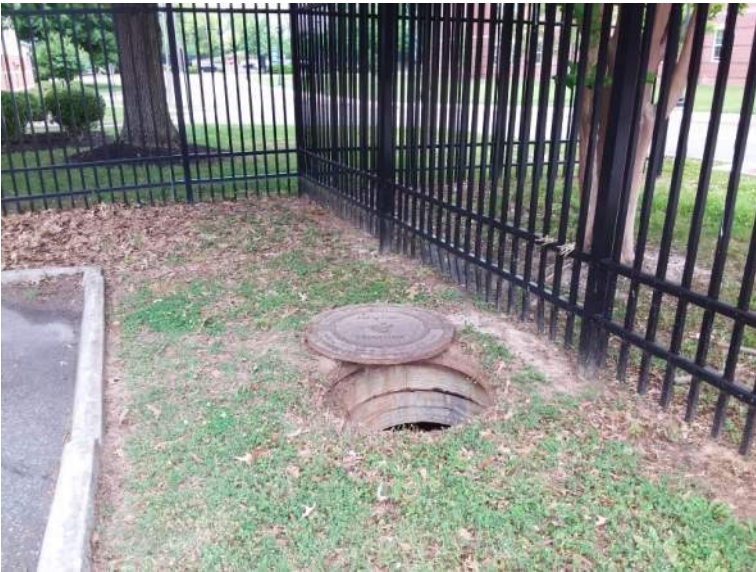
BMP #34- overall

<b>Inspector Name:</b>				<b>Type of BMP:</b>		
<b>BMP ID #: 34</b>				<b>Date/Time:</b>		
				<b>Maintenance required?</b>		
<b>Component:</b>	<b>Yes</b>	<b>No</b>	<b>Conditions When Maintenance is Needed</b>	<b>Yes</b>	<b>No</b>	<b>Comments:</b>
The access manhole or access doors are functioning properly and are structurally sound						
Sediment and oil are present (provide depths)						
Floatable pollutant accumulation is present in the Pre-treatment Bay						
The Cartridge Bay is visually inspected for sediment depth (provide depth)*(If sediment depth is greater than 6 inches, maintenance is required						
Proper draindown is occurring in the Cartridge Bay *(If at least 40 hours of dry weather have elapsed, since the most recent runoff event and the Bay contains more than 3 inches of water above the sediment layer, the Sorbtive BRICKs required cleaning or replacement						
The internal components show no signs of damage

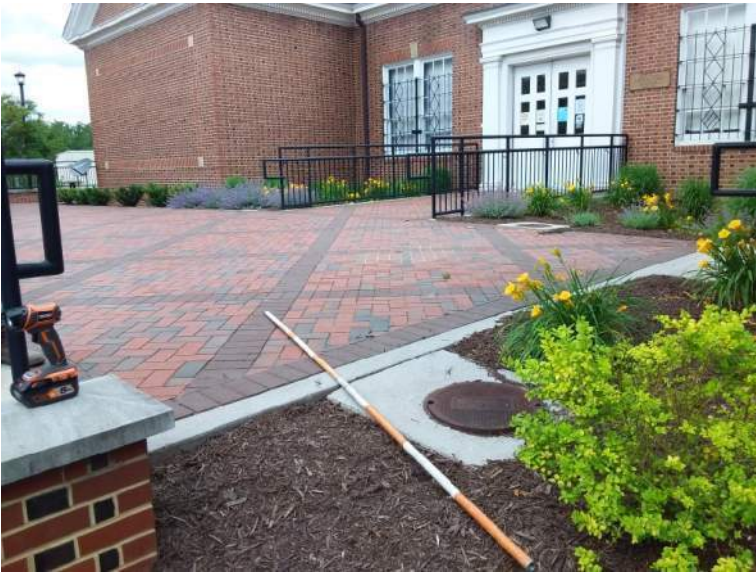
BMP #36- inside view

**Notes:** BMP #36 appears to be functioning in moderate condition. Approximately 22" of standing water found in the inspection port. Very little sediment found beneath the standing water. This system is not designed to hold water for extended periods of time. We suspect a clog or blockage may be present downstream causing the water to hold in this R-Tank System. Further investigation may be necessary to identify the cause of this issue.

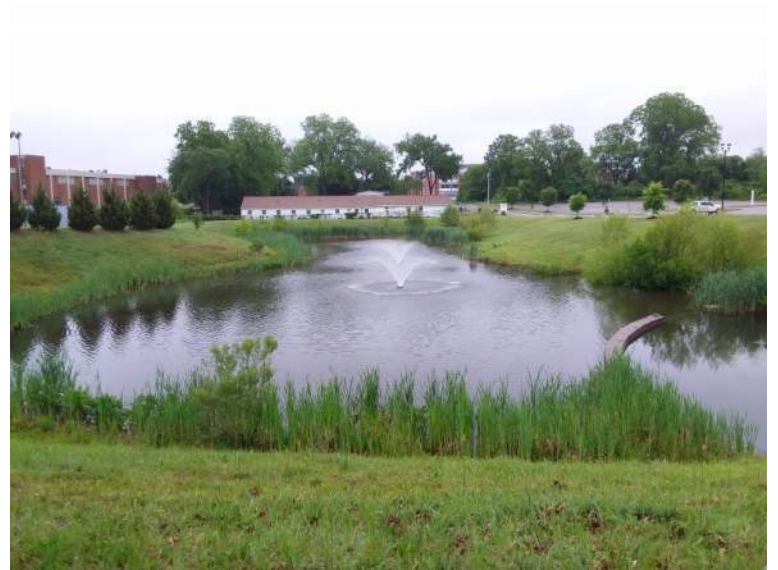
BMP #46- facing southeast

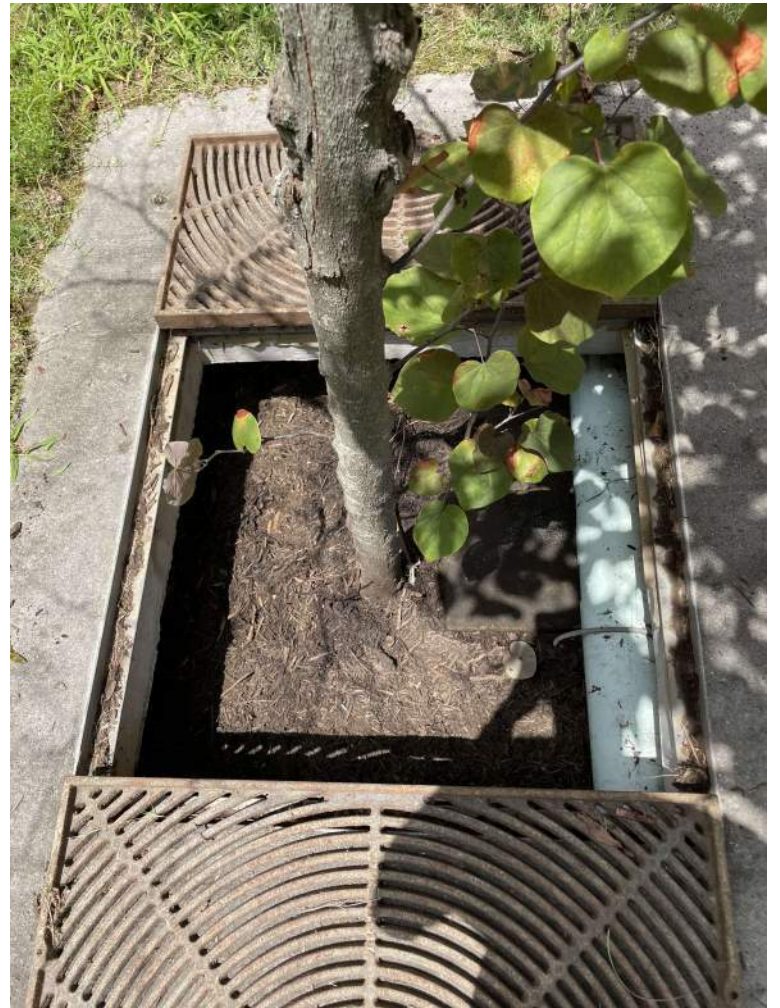
BMP #4- after maintenance

COMPLETION NOTES	<p>Completed maintenance of Roof Filterras (12 total) and Inlet Filterras (10 total). Removed trash and debris from facilities. Installed new mulch.</p>
------------------	------------------------------------------------------------------------------------------------------------------------------------------------------------------

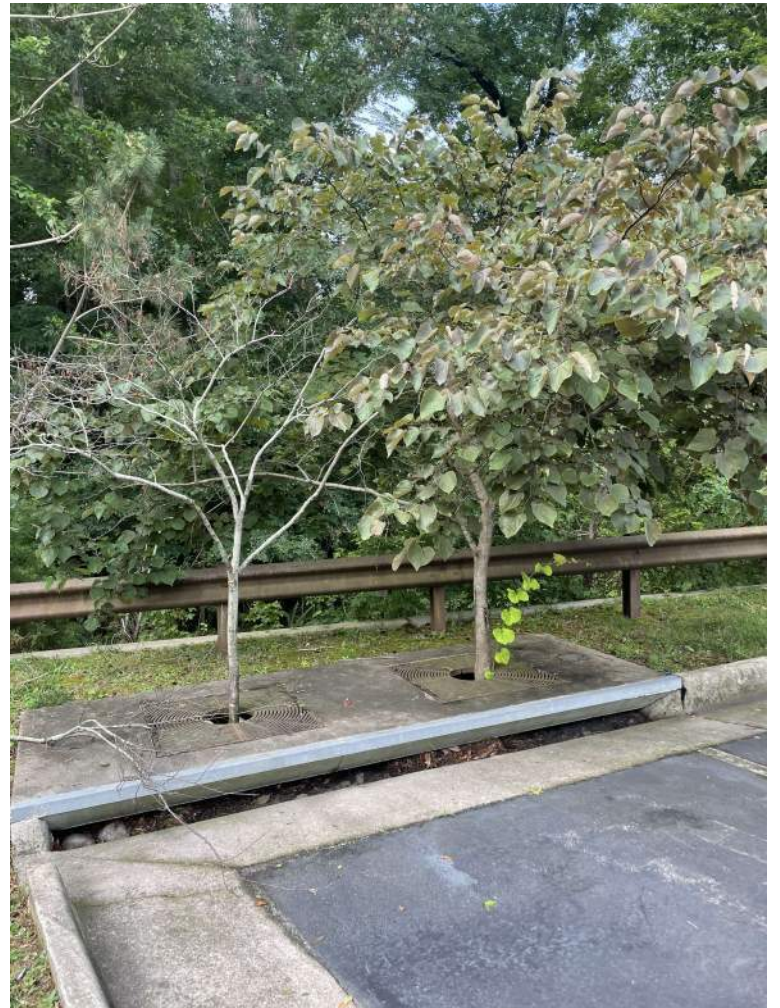
BMP #10- surrounding photo

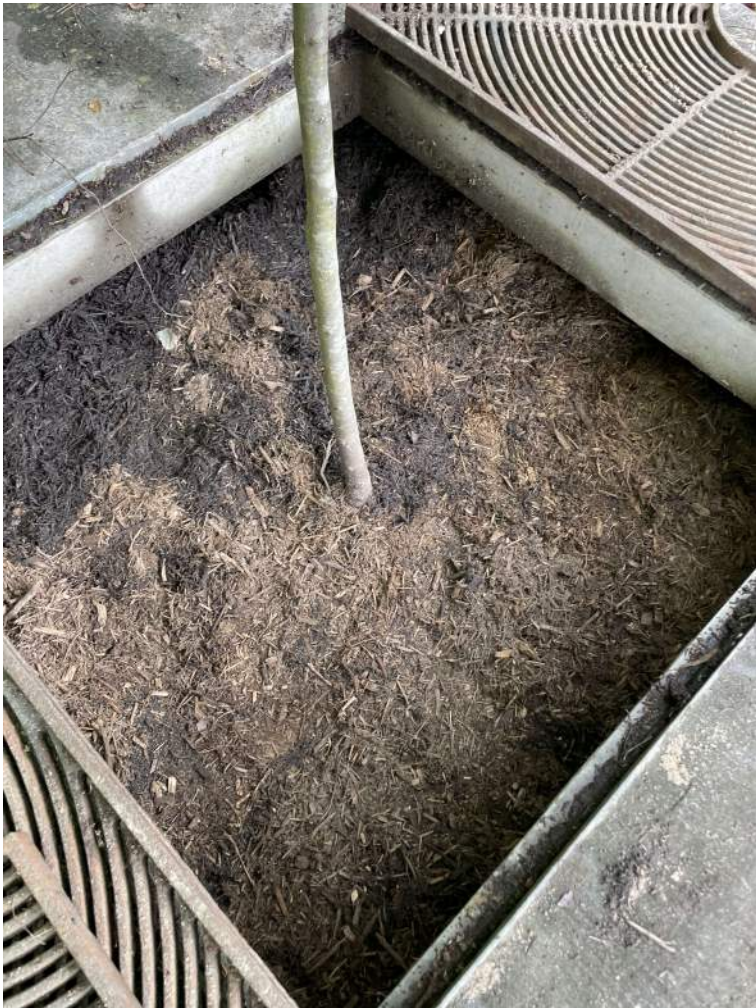
BMP #10- after maintenance

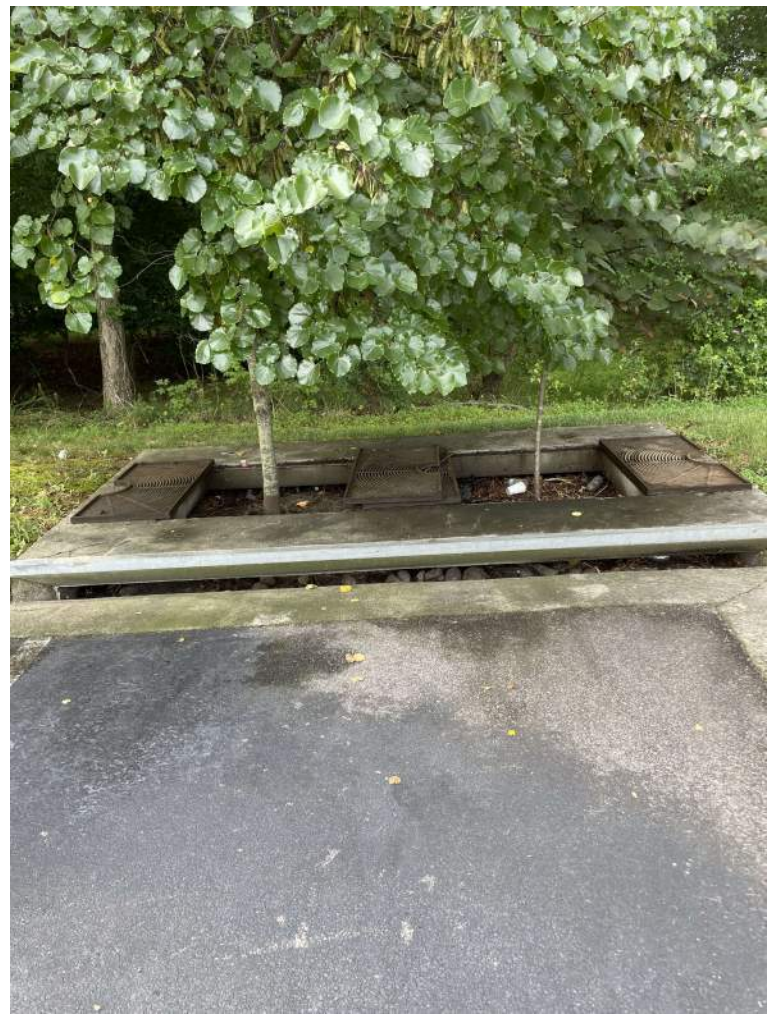
BMP #11- surrounding photo

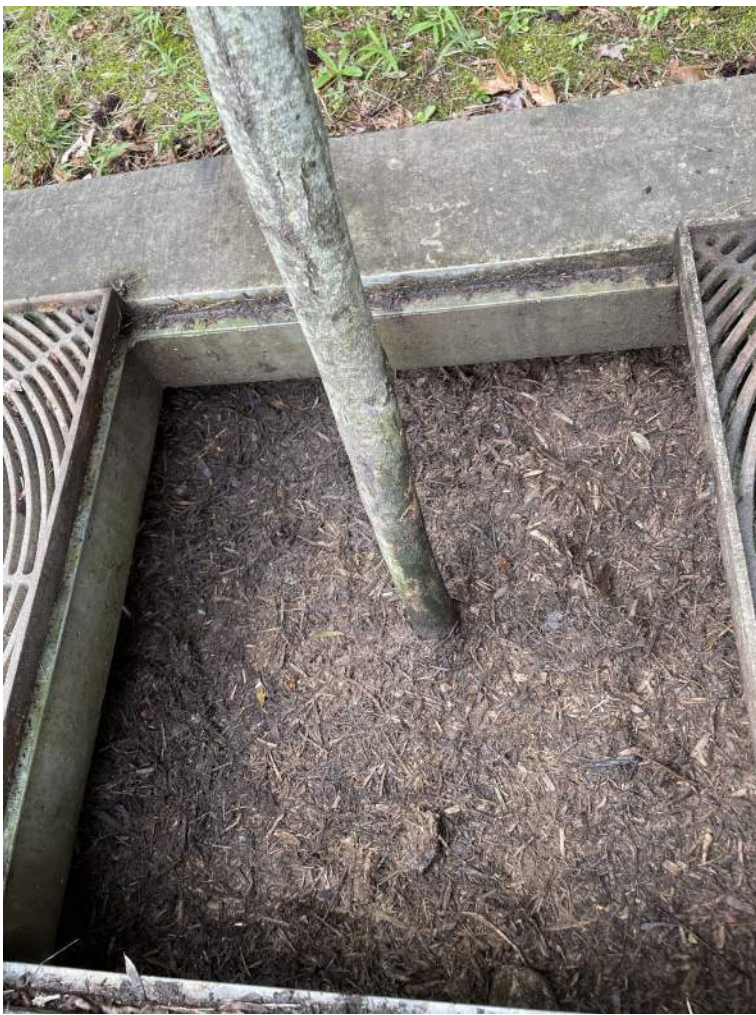
BMP #11- after maintenance

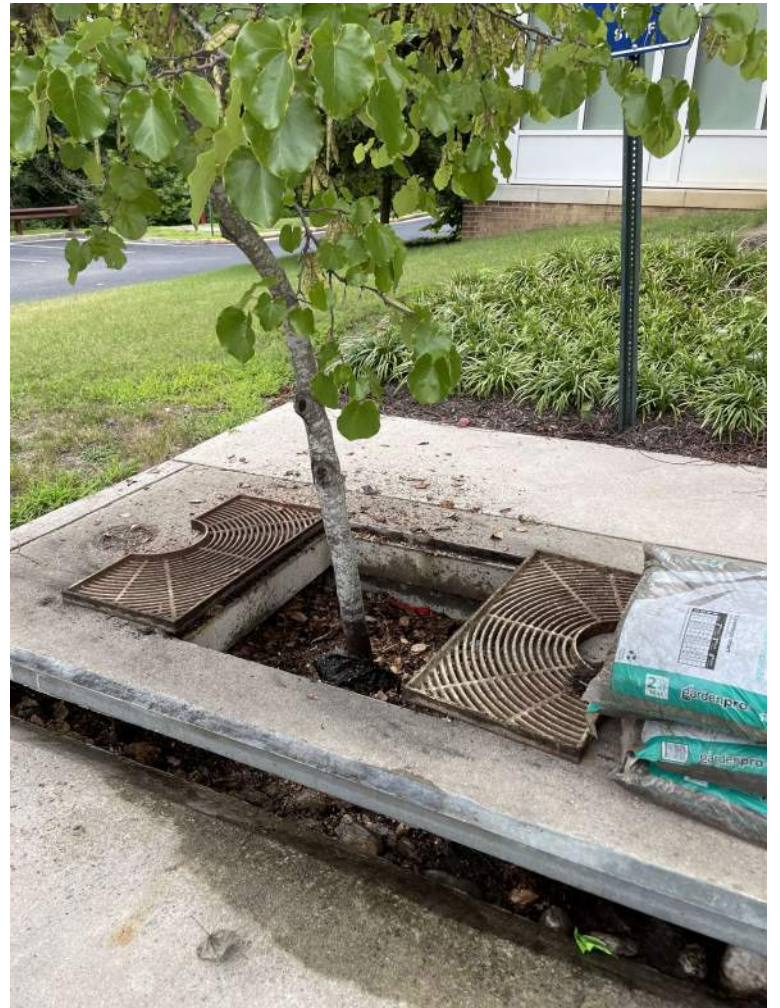
BMP #12- surrounding photo

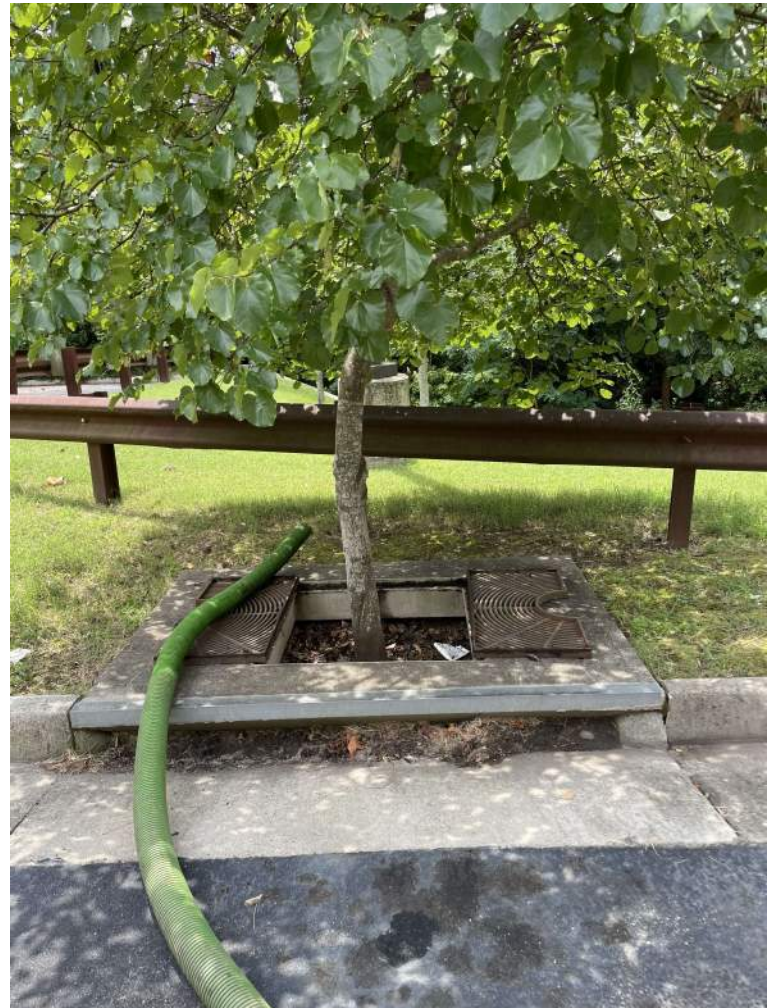
BMP #13- surrounding photo

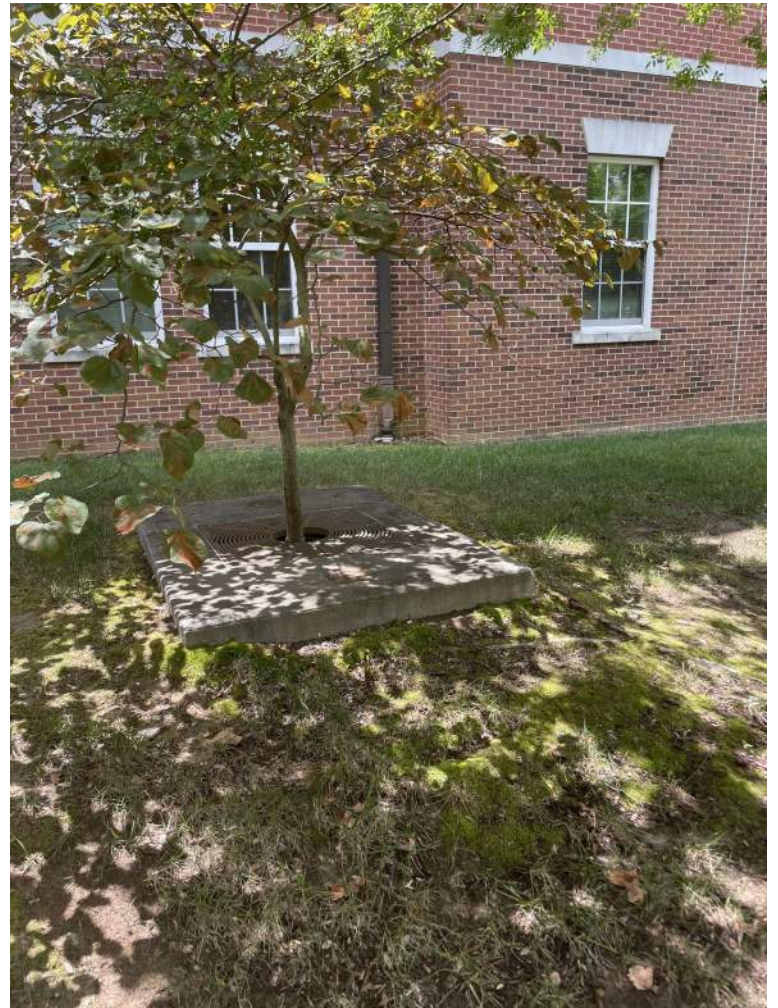
BMP #16- surrounding photo

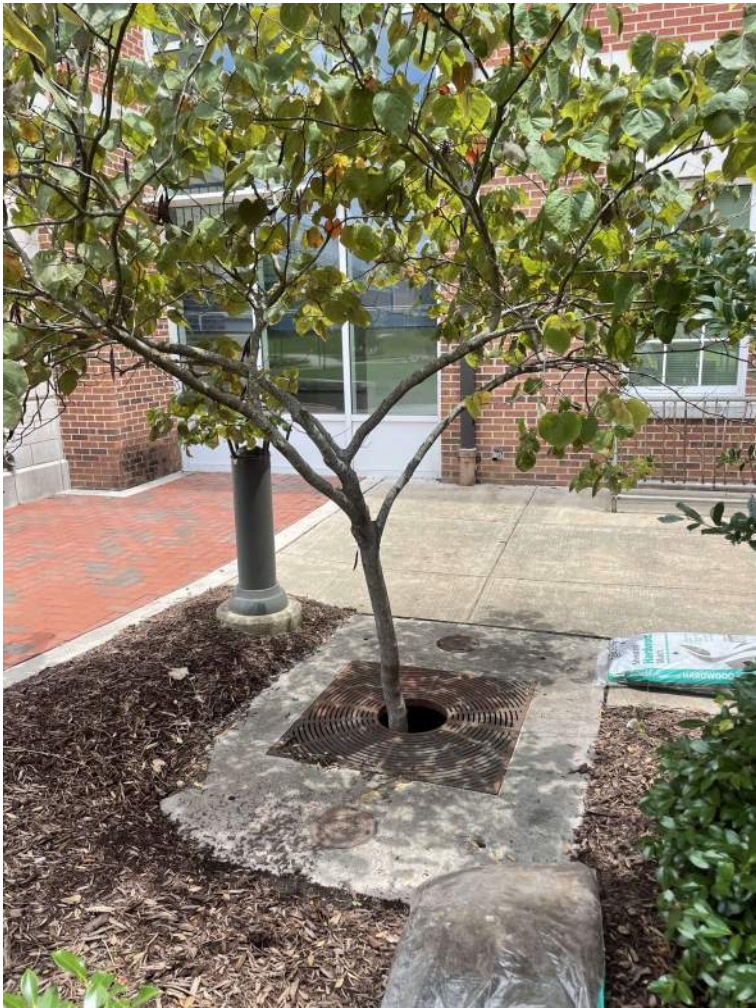
BMP #17- surrounding photo

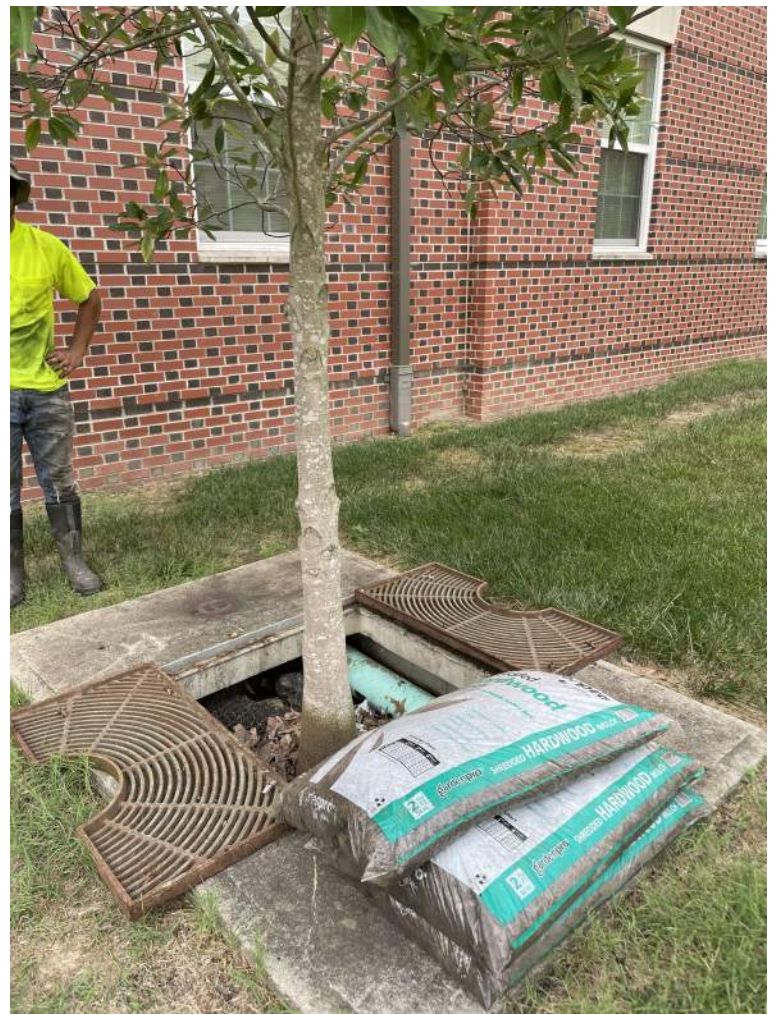
BMP #18- surrounding photo

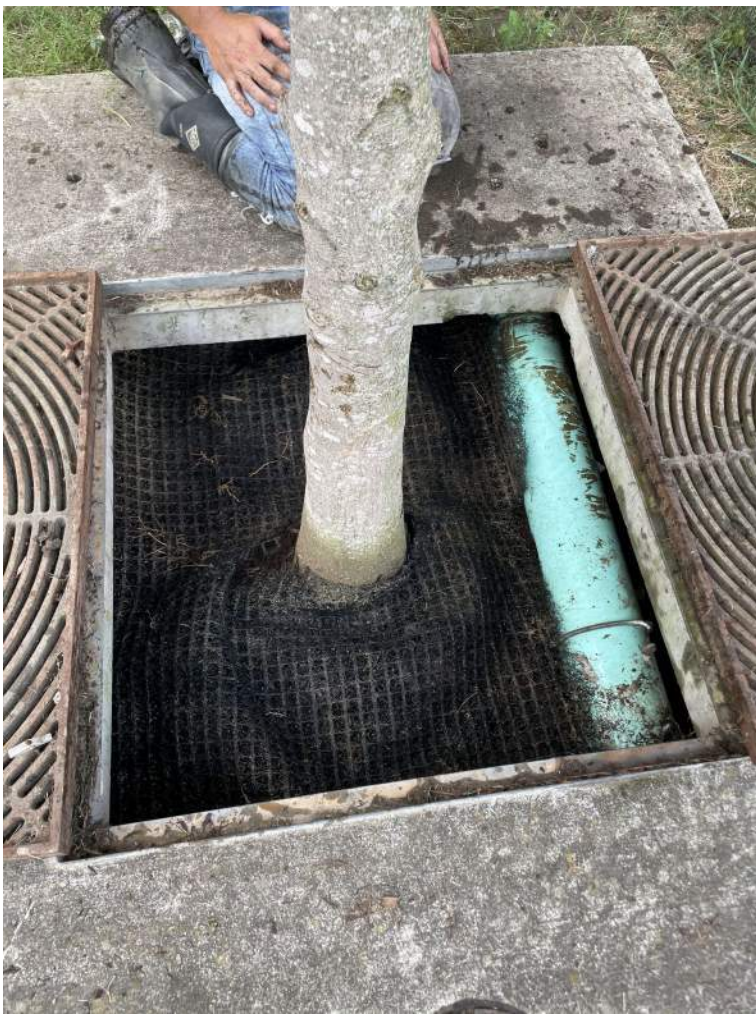
BMP #18- after maintenance

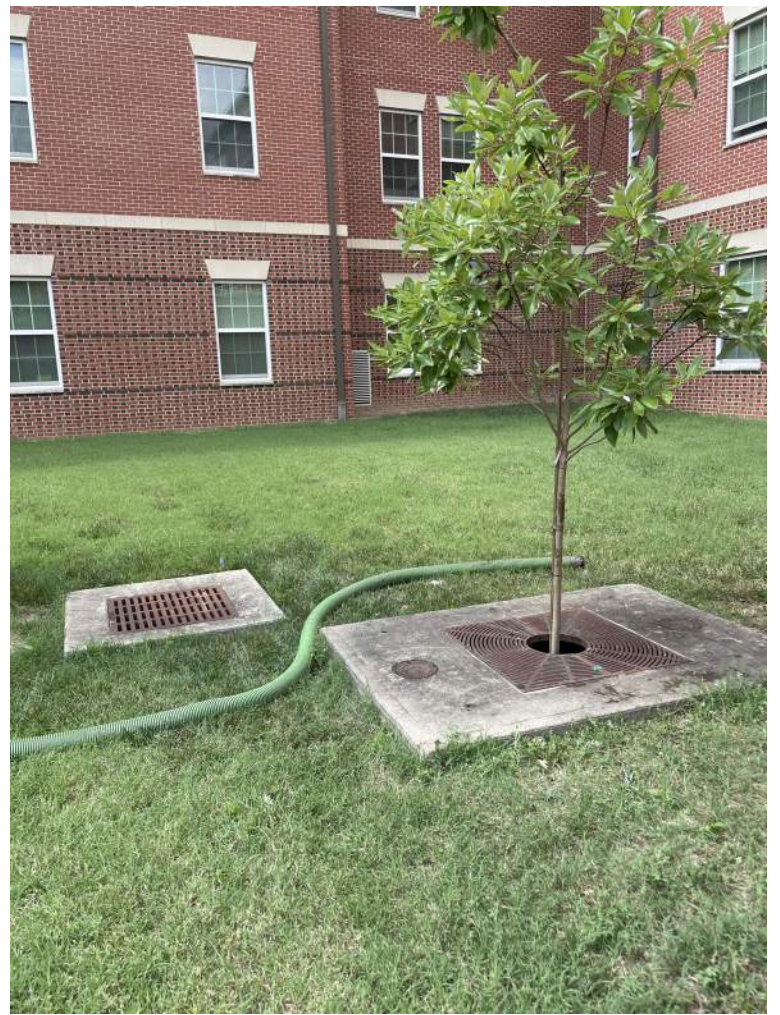
BMP #19- surrounding photo

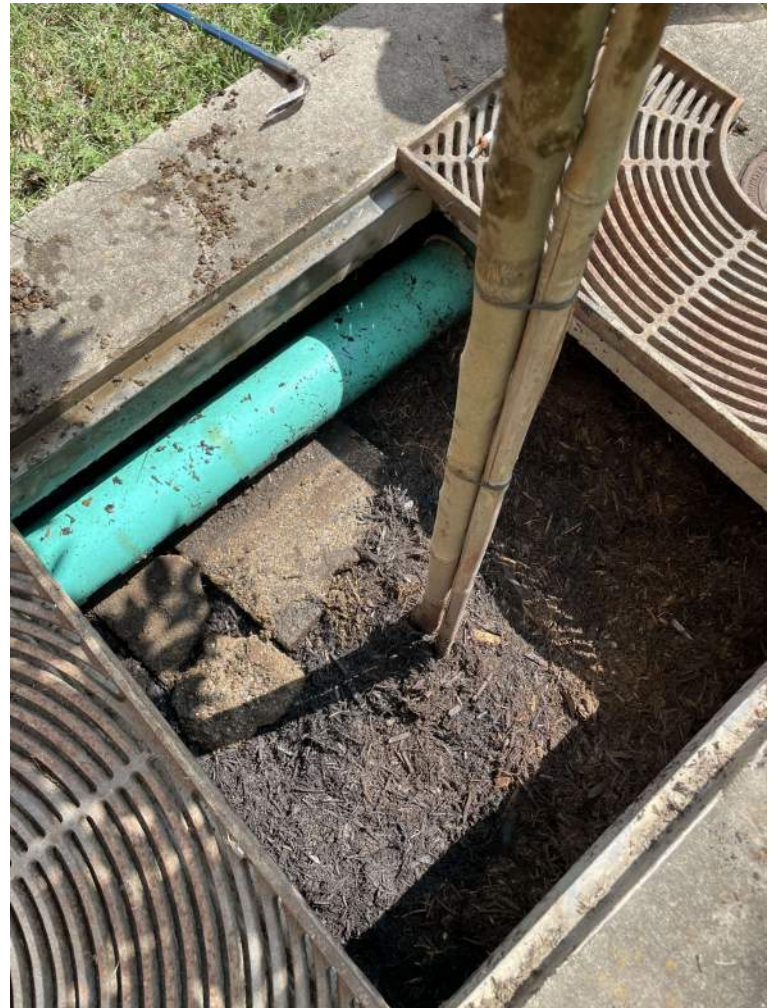
BMP #19- after maintenance

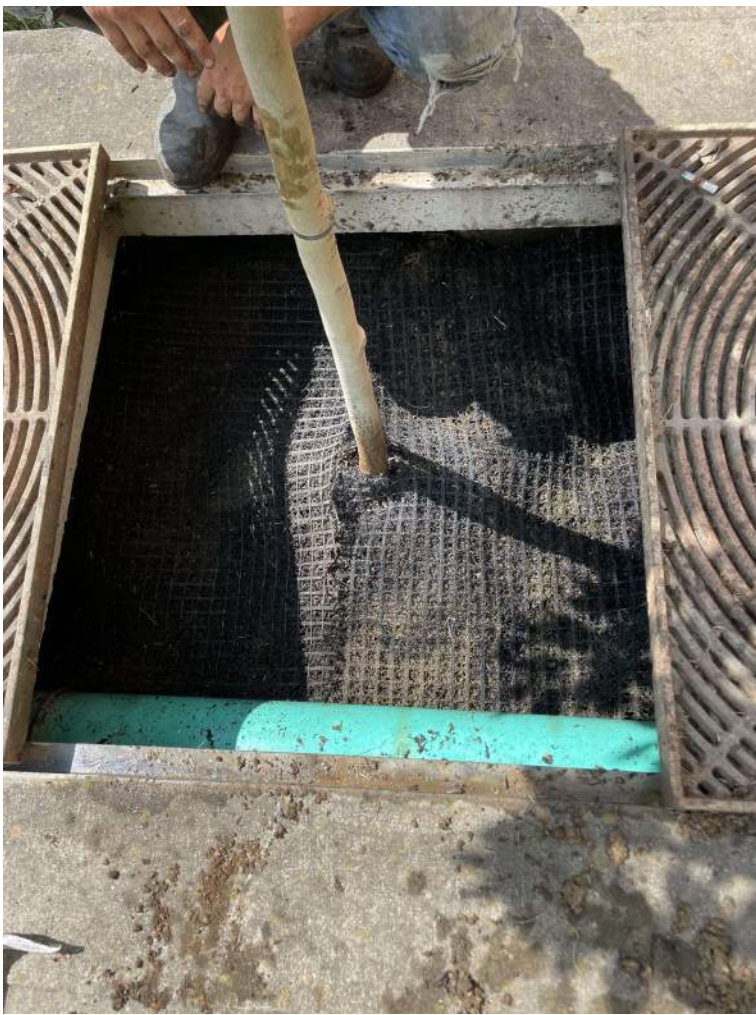
BMP #19- after maintenance

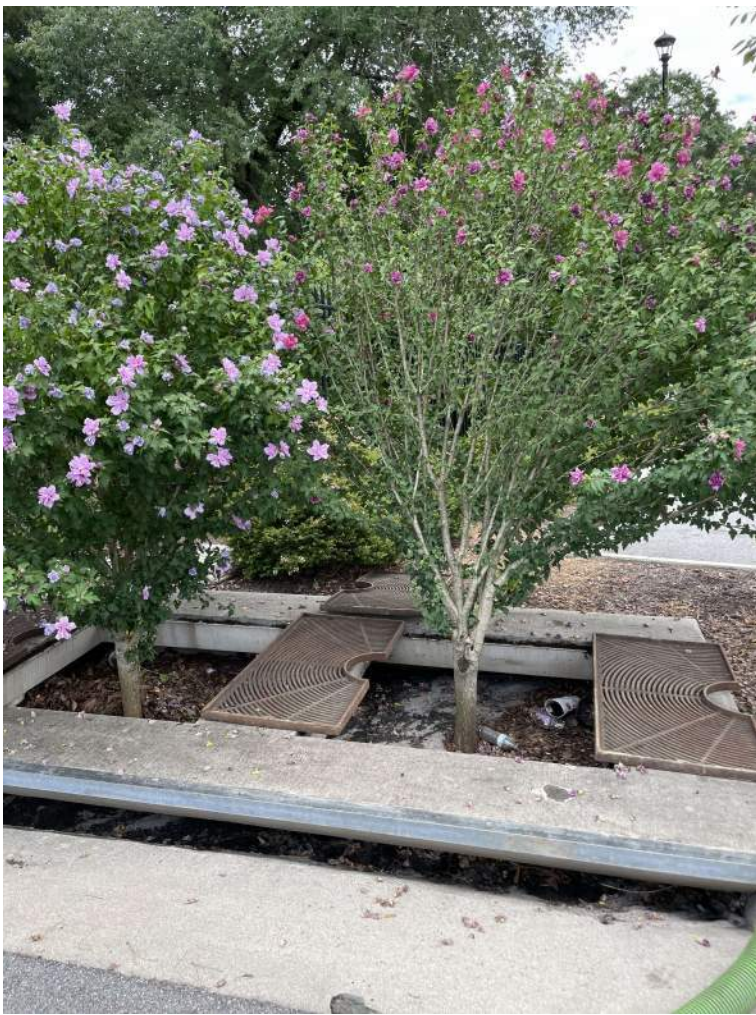
BMP #41- surrounding photo

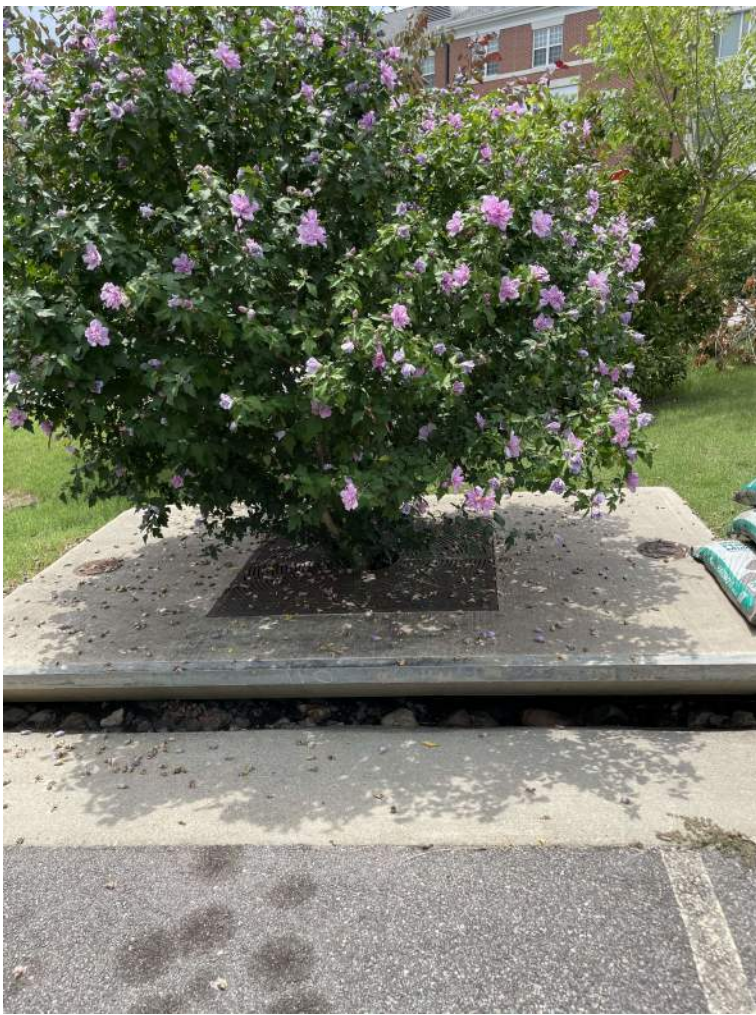
BMP #42- surrounding photo

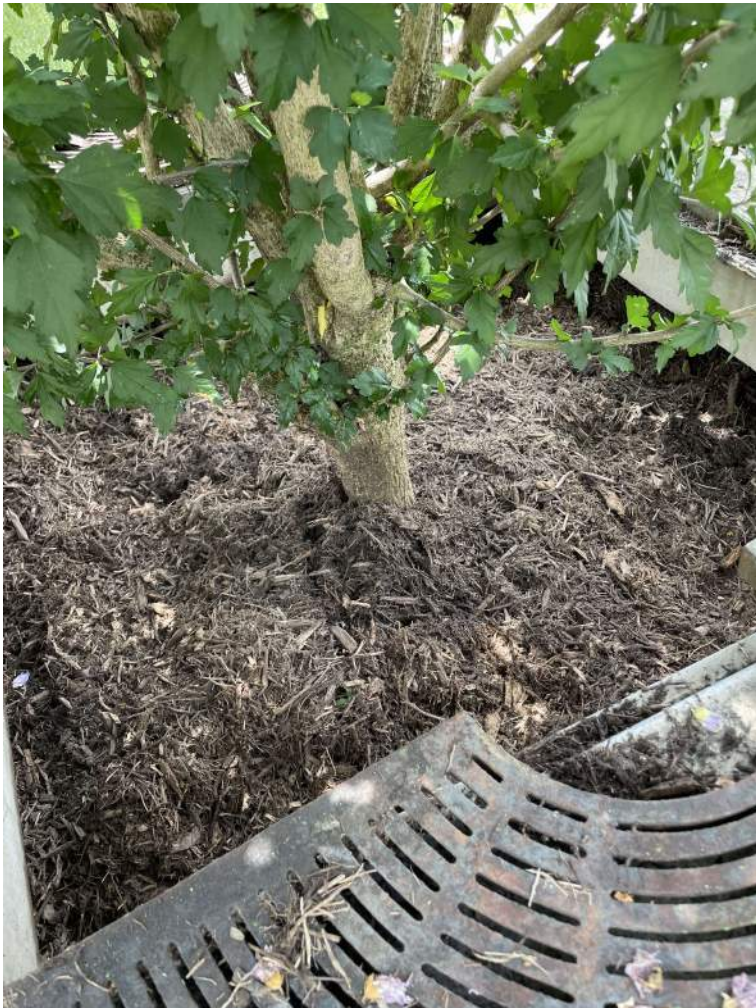
BMP #42- after maintenance

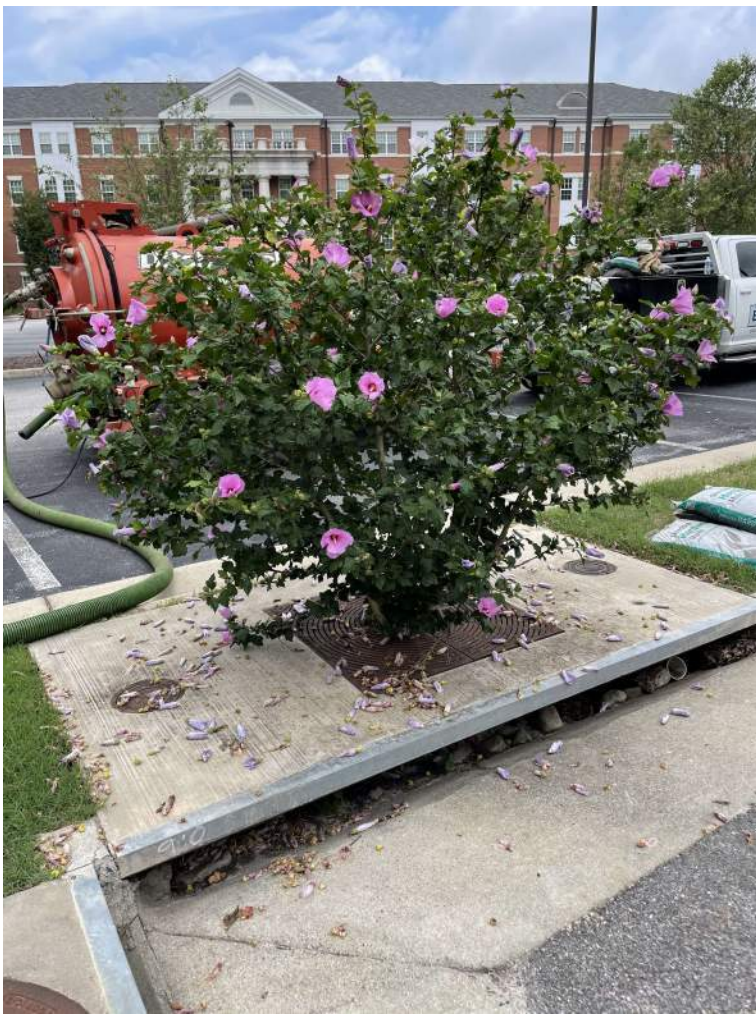
BMP #44- surrounding photo
